ON-SITE CHILD AIR BAG-RELATED FATALITY INVESTIGATION

CASE NUMBER - IN98-027
LOCATION - ARKANSAS
VEHICLE - 1995 TOYOTA COROLLA DX
CRASH DATE - September, 1998

1. <i>Report No.</i> IN98-027		2. <i>Government Accession No.</i>		3. <i>Recipient's Catalog No.</i>	
4. <i>Title and Subtitle</i> On-Site Child Air Bag-Related Fatality Investigation Vehicle - 1995 Toyota Corolla DX Location - Arkansas			5. <i>Report Date:</i> March 17, 2003

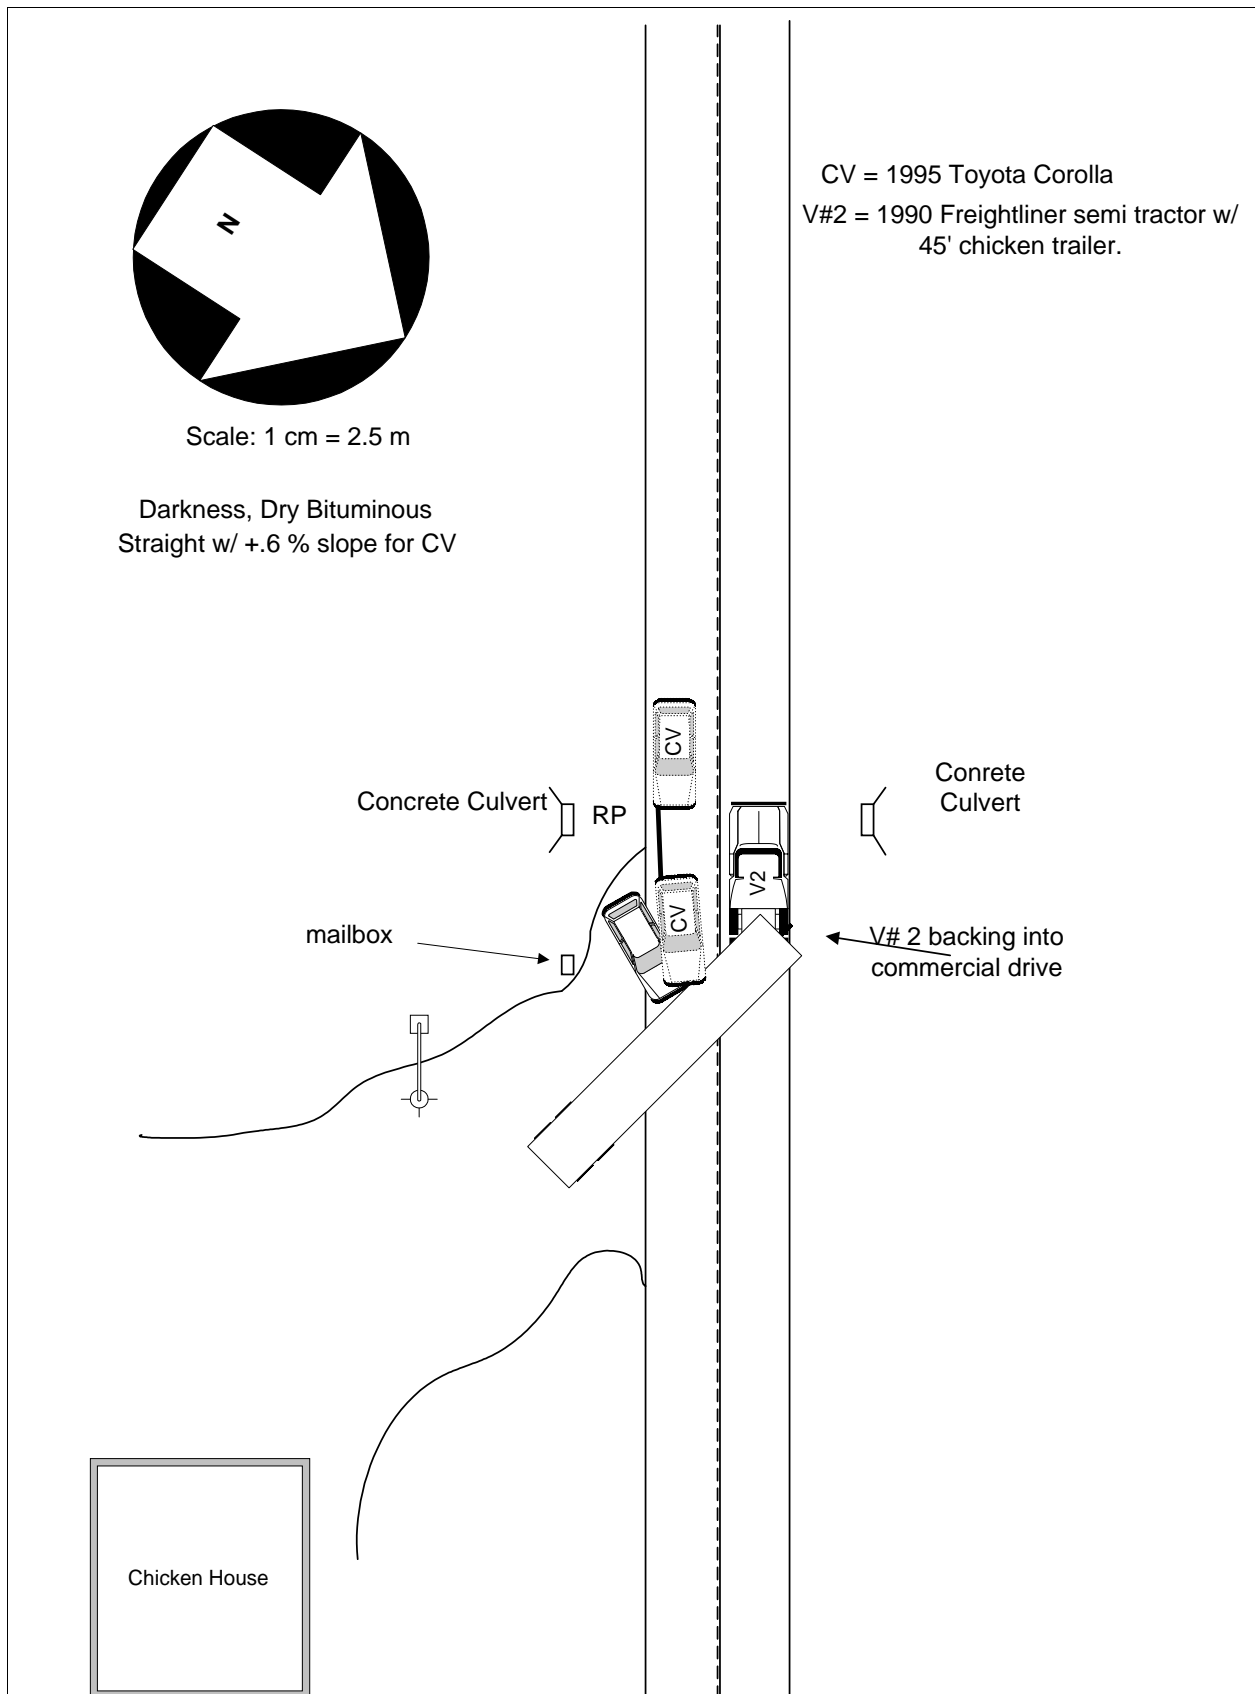
CRASH DIAGRAM

The front left corner of the case vehicle impacted the left dolly wheel attached to the undercarriage of the truck-tractor's semi-trailer. The case vehicle's front left narrow end engagement extended down the left side before snagging on the left front wheel rim. The case vehicle's initial engagement with the flat base of the trailer's left dolly wheel resulted in slicing damage to the front left bumper corner at the turn signal housing. The snagging action to the left front wheel caused the case vehicle to achieve the deployment threshold and resulted in the deployment of the case vehicle's driver and front right passenger supplemental restraints (air bags). The case vehicle rotated approximately 45 degrees counterclockwise post-impact and came to rest in contact with the tractor-trailer, heading northward.
