**CALSPAN ON-SITE REAR FACING CHILD SAFETY SEAT/AIR BAG DEPLOYMENT
FATALITY INVESTIGATION**

CALSPAN CASE NO. CA98-34

VEHICLE - 1997 FORD F150 PICK-UP

LOCATION - OHIO

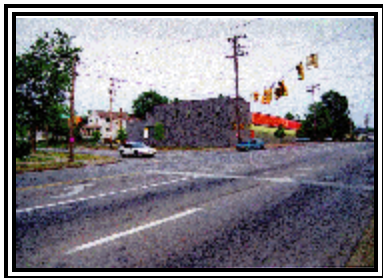
Figure 1: Overall southeasterly view of the intersection.

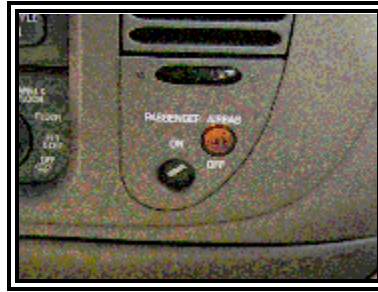
The Ford F150 was equipped with a Supplemental Restraint System that consisted of driver and front passenger air bags that deployed as a result of the crash. The SRS utilized a cut-off switch that could disable deployment of the front passenger air bag. The switch was in the ON position at the time of the crash documented by the on-scene police photographs (**Figure 8**). The front passenger air bag is active with the switch in this position and the indicator light is dark. During the course of the SCI inspection, the ignition key was used to place the cut-off switch in the OFF position (**Figure 9**). In this position the front passenger air bag is disabled and the indicator is illuminated. Visual inspection of the illuminated light indicated the switch functioned properly.

Figure 9: View of the air bag cut-off switch in the OFF position.
