**VERIDIAN ON-SITE AIR BAG RELATED
FETAL FATALITY INVESTIGATION
VERIDIAN CASE NO. CA98-055
VEHICLE: 1998 MITSUBISHI MIRAGE DE
LOCATION: PENNSYLVANIA
CRASH DATE: OCTOBER 1998**

1. <i>Report No.</i> CA98-055	2. <i>Government Accession No.</i>	3. <i>Recipient's Catalog No.</i>	
4. <i>Title and Subtitle</i> Veridian On-Site Air Bag Related Fetal Fatality Investigation Vehicle: 1998 Mitsubishi Mirage Location: Pennsylvania		5. <i>Report Date:</i> April 2001

14. <i>Sponsoring Agency Code</i>	
15. <i>Supplementary Notes</i> On-site investigation of an air bag deployment crash that resulted in a placental abruption and the still birth of a 33 week fetus.

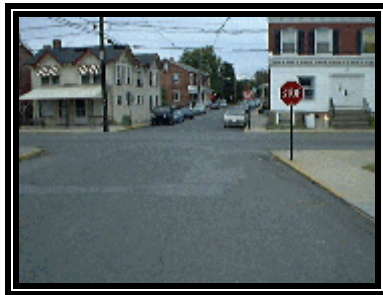
The 19 year old female driver of the Mitsubishi Mirage was traveling in a northerly direction on an approach to the four-leg intersection (**Figure 2**). The driver stopped her vehicle for the regulatory stop sign and check for approaching vehicles in both the east and west travel directions. She noted the intersection area was clear of approaching eastbound traffic and she initiated a right turn onto the two lane intersecting street. The 1998 Kenworth straight truck was traveling in a westbound direction on an approach to the intersection (**Figure 3**). Due to non-contact vehicles parked at the north curbline, the driver of the truck was straddling the centerline of the street as he approached the intersection. As the driver of the Mitsubishi initiated the right turning maneuver, she observed the truck immediately prior to the impending crash. She braked rapidly in an attempt to avoid the crash.

Figure 2 - Approach of the 1998 Mitsubishi Mirage to the intersection prior to the right turn

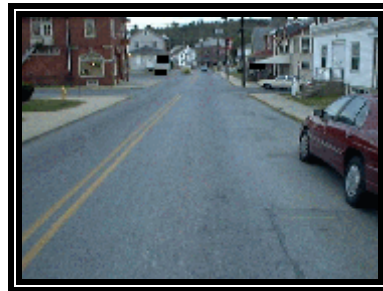
Figure 3 - Trajectory of the 1998 Kenworth medium/heavy truck, 30 m from POI

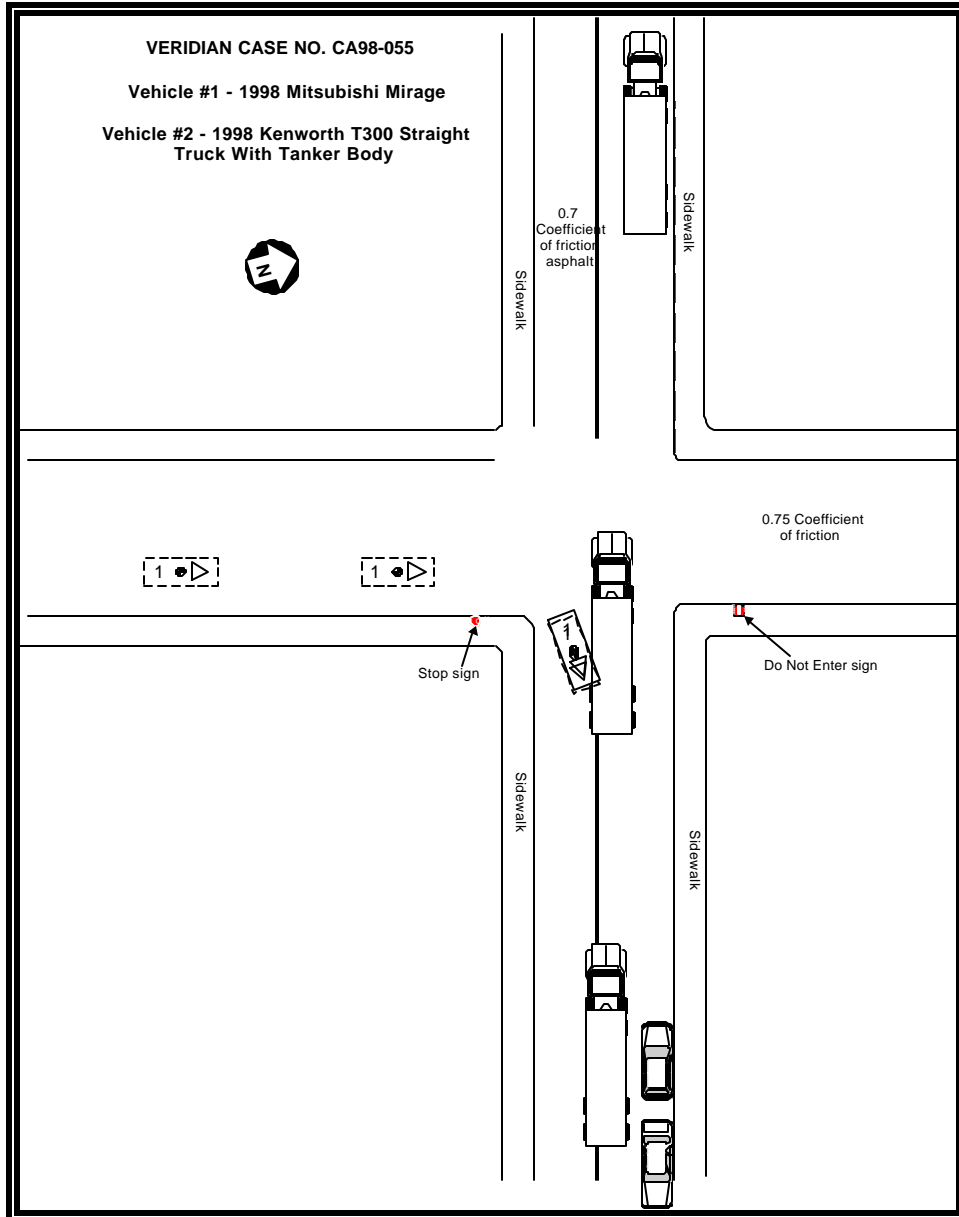
Figure 11. Crash Schematic.

The Mitsubishi rotated counterclockwise and came to rest diagonal in its travel lane. The straight truck continued through the intersection and came to a controlled stop in its lane approximately 45 m (150') from the point of impact (POI). The Crash Schematic is attached as **Figure 11**, Page 10.
