**VERIDIAN ON-SITE REDESIGNED AIR BAG DEPLOYMENT INVESTIGATION  
VERIDIAN CASE NO. CA98-056  
VEHICLE: 1998 CHEVROLET LUMINA  
LOCATION: NEW YORK  
CRASH DATE: OCTOBER 1998**

14. <i>Sponsoring Agency Code</i>	
15. <i>Supplementary Notes</i> On-site investigation of a head-on crash that resulted in deployment of the redesigned frontal air bags in a 1998 Chevrolet Lumina and the death of the belted 81 year old female driver.

**VERIDIAN REDESIGNED AIR BAG DEPLOYMENT INVESTIGATION**  
**VERIDIAN CASE NO. CA98-056**  
**VEHICLE: 1998 CHEVROLET LUMINA**  
**LOCATION: NEW YORK**  
**CRASH DATE: OCTOBER 1998**

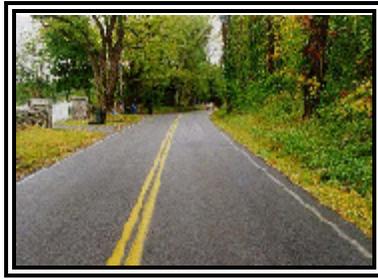
The 1998 Chevrolet Lumina was traveling in a southerly direction on the two lane roadway (**Figure 2**), approaching the crash site at an estimated travel speed of 48-56 km/h (30-35 mph). The driver was en route to her residence. It was, therefore, assumed that she was familiar with the roadway. Her travel path and pre-crash driving actions could not be verified since traffic flow was very light and there were no independent witnesses to the crash events.

**Figure 2. Pre-crash southbound trajectory of the Chevrolet Lumina.**

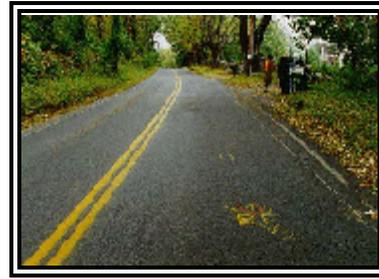
**Figure 3. Pre-crash northbound trajectory of the Ford pickup truck.**

An 11.6 m (38.0') yaw mark from the right front tire of the Ford pickup truck was documented at the crash site (**Figure 3**). This mark began near the center of the northbound travel lane and terminated near the centerline of the roadway. It appeared that prior to the initiation point of the mark, the Ford pickup was traveling in a northerly direction with the left portion of the vehicle in the southbound travel lane. The pickup truck driver may have been inattentive to the driving task and may have been surprised by the presence of the Lumina. His observation that the Lumina was weaving between lanes prior to the crash was questionable and was not supported by the at-impact orientation of the Lumina.

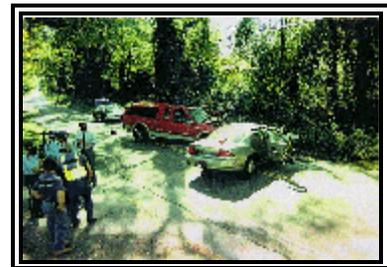
The Chevrolet Lumina came to rest straddling both travel lanes, facing in a southwesterly direction, approximately perpendicular to the roadway. The Ford pickup came to rest in the southbound lane, facing in a northwesterly direction. The right rear portion of the pickup truck extended back into the northbound travel lane. **Figure 4** is a view of the final rest positions of the vehicles.

**Figure 4. Overall view of the crash site and final rest positions of the vehicles.**
