Remote, Redesigned Air Bag Special Study
FOR NHTSA'S INTERNAL USE ONLY
Dynamic Science, Inc., Case Number (1999-75-801E)
1998 Saturn SC2
Colorado
May/1999

Summary

This remote investigation focused on the redesigned air bag system deployment of a 1998 Saturn SC2 two-door sedan. This moderate injury crash occurred in May, 1999 in the early morning. The weather was clear and the bituminous roadways were dry. The crash occurred in a four-legged intersection. The northbound roadway is a straight two-way divided roadway and is comprised of three northbound travel lanes, a grass covered center median, and two southbound lanes. The southbound roadway is a straight two-way undivided roadway and is comprised of two southbound lanes, two northbound lanes, and a left hand turn lane. The intersection is controlled by overhead traffic signals; the lights were green for northbound and southbound traffic. The asphalt road is level at the area of impact.

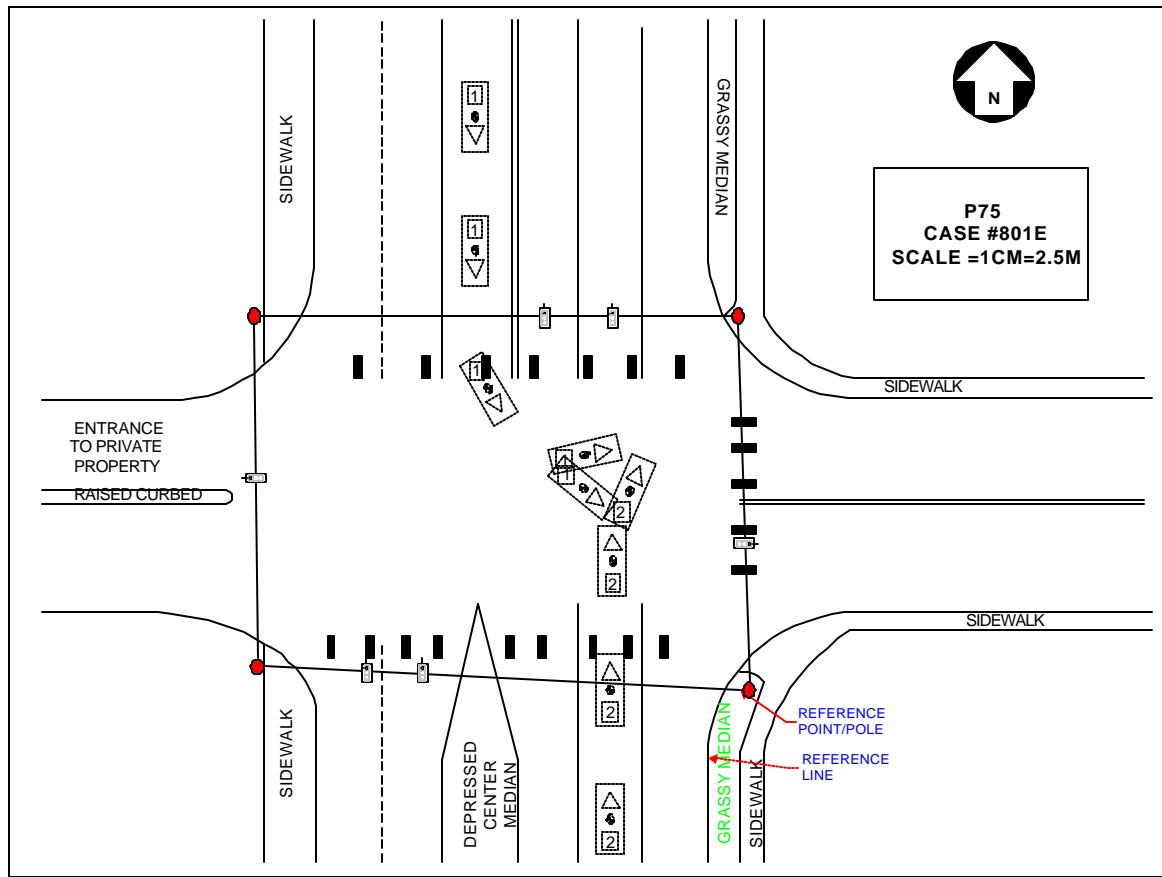
Scene Diagram

The driver of Vehicle 1 failed to see Vehicle 2 approaching and initiated the left turn in the path of the oncoming vehicle. Vehicle 2 did not take an avoidance actions. The front plane of Vehicle 2 (11FYEW2) struck the right side of Vehicle 1 in the intersection. Both vehicles came to rest in the intersection.
