Remote, Redesigned Air Bag Special Study

Dynamic Science, Inc., Case Number (1999-79-801E)

1999 Mitsubishi Mirage

April 1999

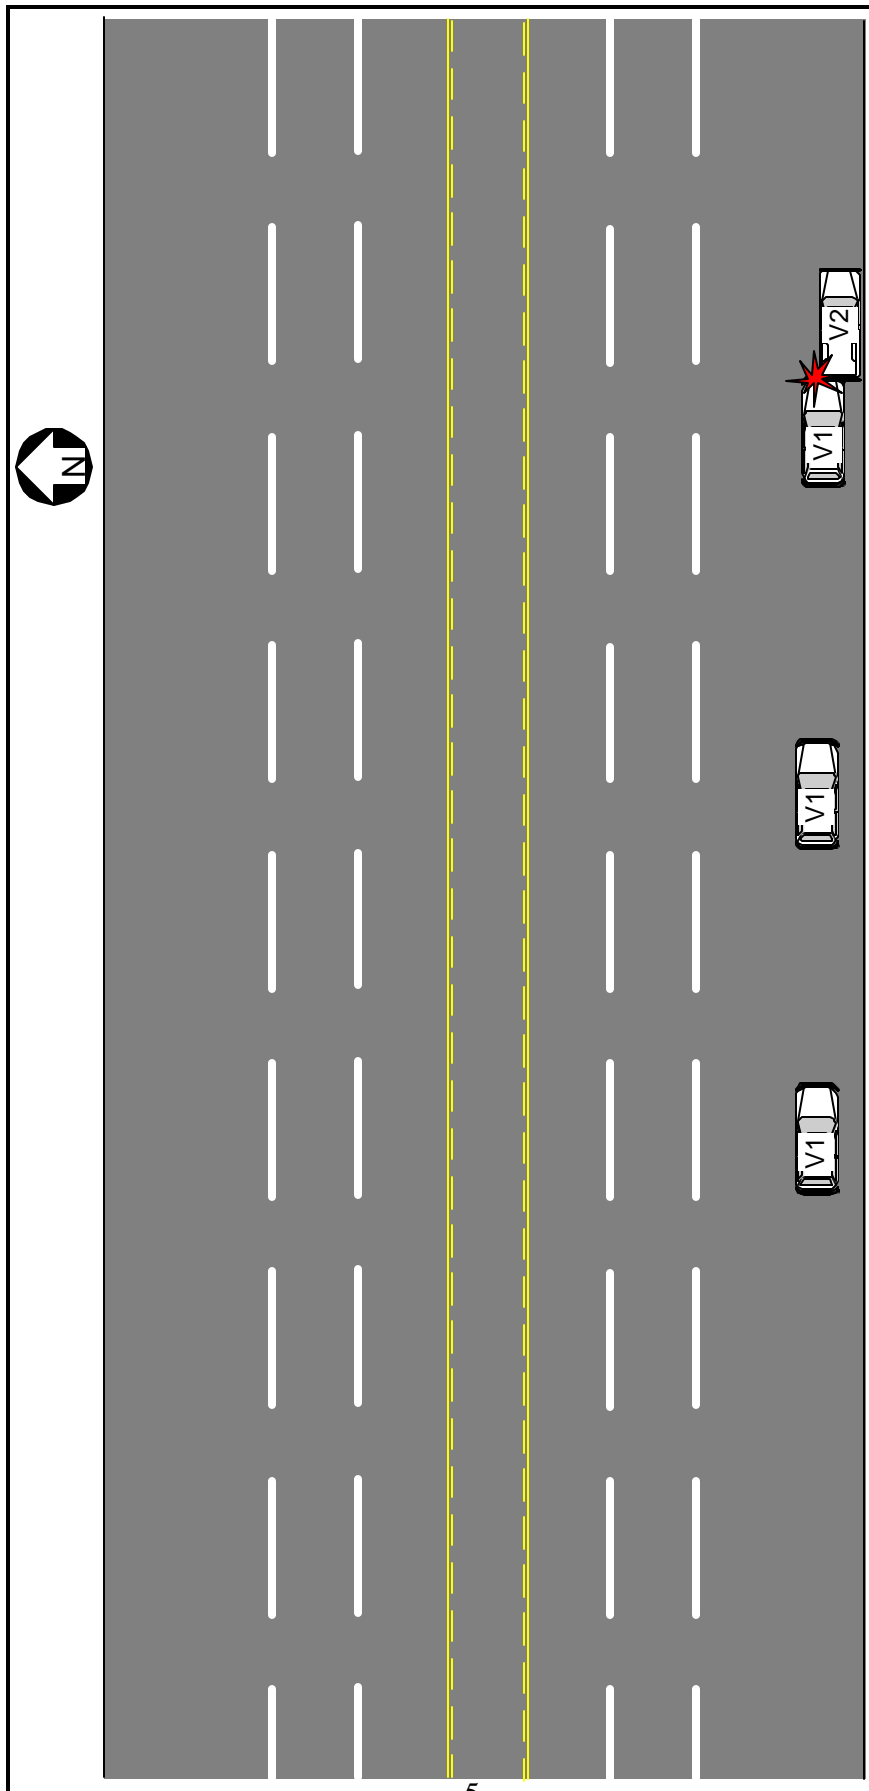
Scene Diagram

This vehicle versus parked vehicle front to back crash occurred during the noon hour of April, 1999. This crash took place on a seven lane, two way, divided roadway. The three eastbound travel lanes are separated from the three westbound travel lanes by a center left turn lane. The center left turn lane is shared by the east and the westbound traffic. The traffic volume was light/moderate. The bituminous roadway surface was travel worn, but dry and free of defects and bordered by curbs. Parking is permitted adjacent to the curb on both sides of the roadway. There are no traffic controls present for this roadway. The posted speed limit is 56 km/h (35mph).
