**TRANSPORTATION SCIENCES
CRASH RESEARCH SECTION**

**VERIDIAN ON-SITE AIR BAG/INFANT FATALITY INVESTIGATION
VERIDIAN CASE NO. CA99-07
VEHICLE: 1995 SATURN SC2
LOCATION: ALABAMA
CRASH DATE: APRIL 1999**

<p>14. <i>Sponsoring Agency Code</i></p>	
<p>15. <i>Supplementary Notes</i> On-site investigation of an air bag deployment death of a 6 week old female front right passenger in a 1995 Saturn SC2.</p>			
<p>16. <i>Abstract</i> This on-site investigation focused on the injury mechanisms and cause of death of a 6 week old infant female positioned in the front right of a 1995 Saturn SC2. The vehicle was equipped with frontal air bags for the driver and right passenger positions which deployed during the crash. The infant was positioned in a rear-facing child safety seat (RFCSS) that was improperly secured by the manual 3-point lap and shoulder belt system. The frontal area of the Saturn impacted and underrode the rear of a stopped (disabled) 1988 Pontiac Grand Prix. The impact deployed the Saturn's frontal air bag system. The 23 year old female driver of the Saturn was unrestrained. She sustained multiple soft tissue injuries from contact with the knee bolster and the front left air ba

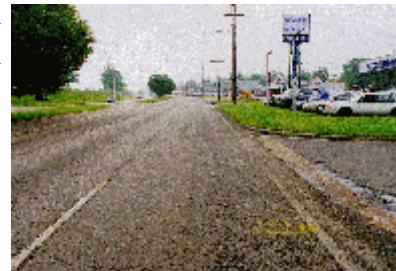
The crash occurred in a mid block area of a divided minor arterial roadway in an urban/commercial area (**Figure 2**). The eastbound travel lanes consisted of three through lanes with a designated left turn lane. The asphalt road surface was level with a slight curve to the left for eastbound traffic flow. The outboard edge of the roadway was bordered by a 0.4 m (1.3') paved shoulder and a 12.7 cm (5.0") barrier curb. Driveways for an automobile dealership intersected the outboard curbline. At the time of the daylight crash, the conditions were clear and dry. Traffic flow was moderate-to-heavy due to the rush hour time frame. The posted speed limit was 72 km/h (45 mph). The schematic is included as **Figure 12** (Page 14).

Figure 2. Approach view of the crash site.

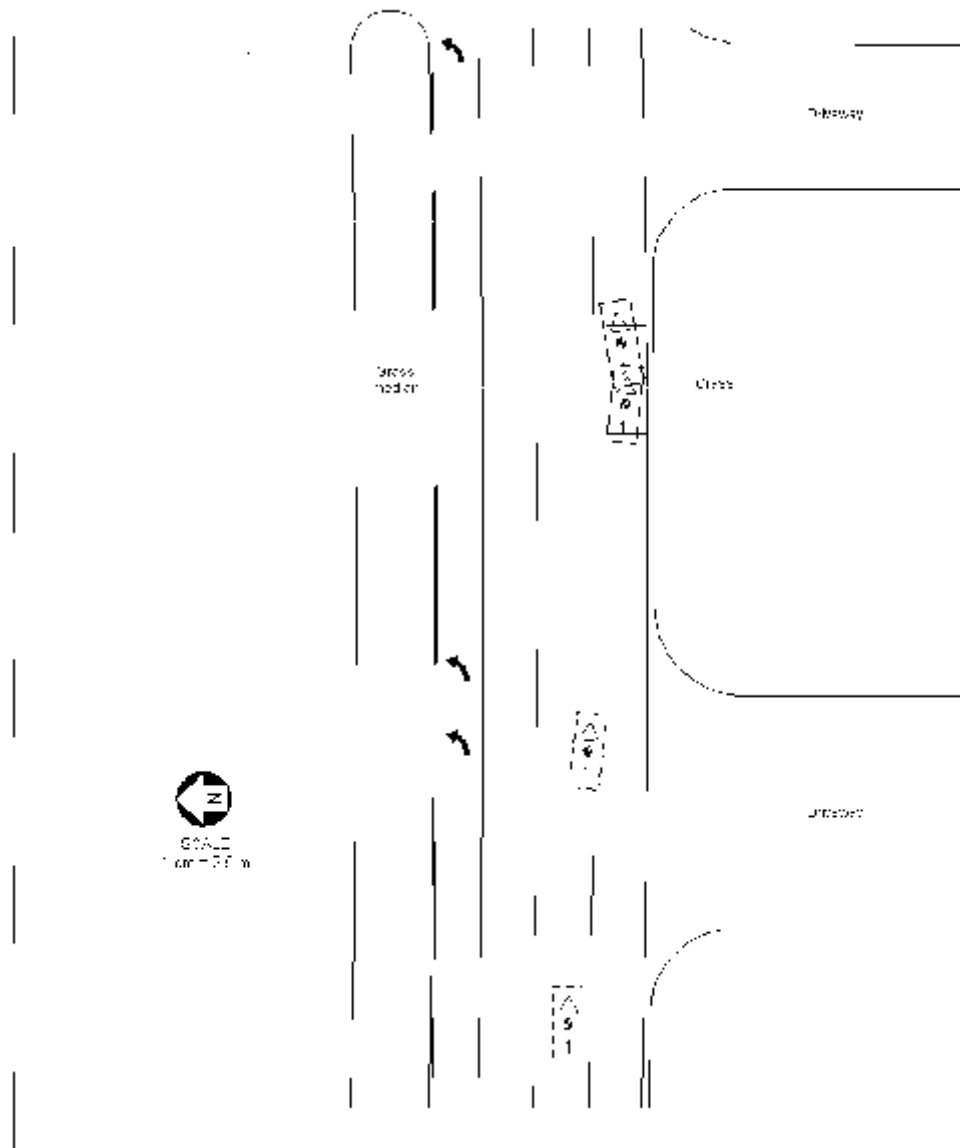
Figure 12. Crash schematic.
