ON-SITE SIDE IMPACT INFLATABLE OCCUPANT PROTECTION INVESTIGATION

CASE NUMBER - IN99-071
LOCATION - ILLINOIS
VEHICLE - 1999 TOYOTA AVALON XLS
CRASH DATE - April, 1999

February 25, 2003

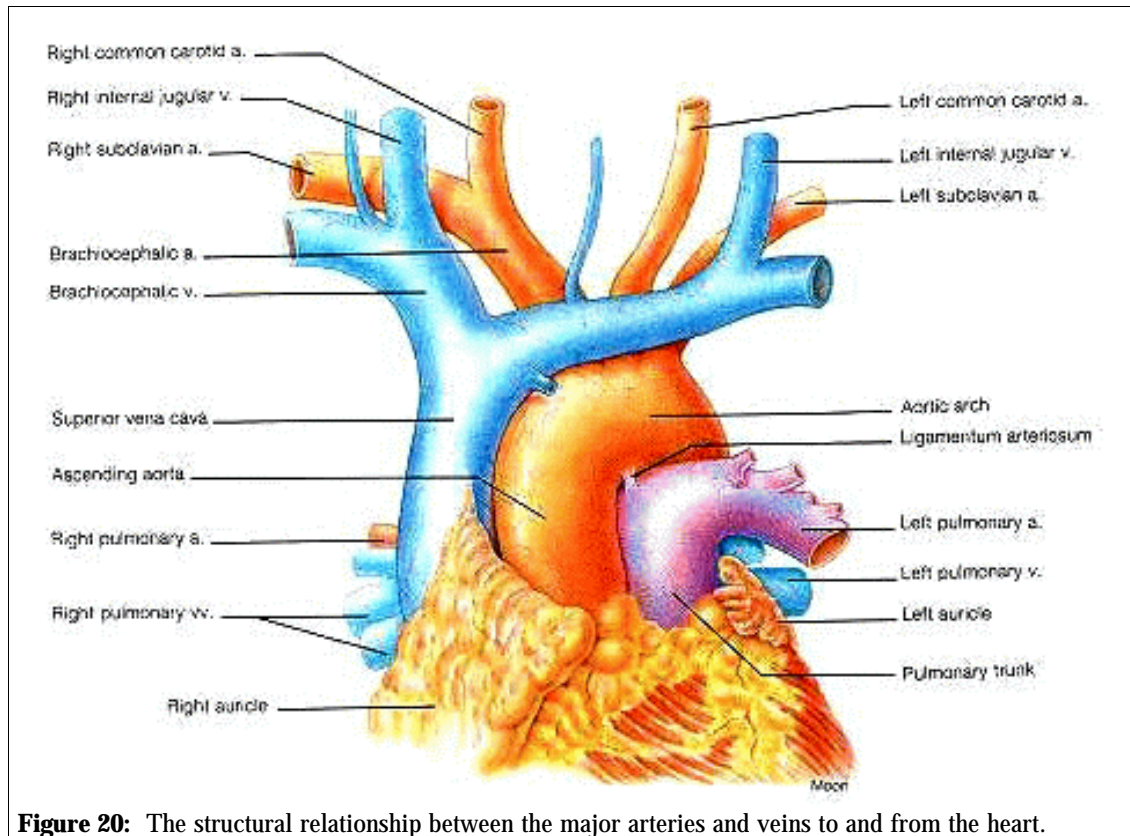
The front right passenger sustained serious injuries and was pronounced dead at the scene; however, he was transported by ambulance to a hospital for autopsy purposes. According to his autopsy the injuries he sustained included: a laceration of the brachiocephalic (innominate) vein—see **Figure 20** in the section below entitled: **SELECTED ANATOMICAL FIGURES**; multiple (unspecified) right rib fractures; and lacerations of his right diaphragm, liver, and mesentery of small bowel—see **Figure 21** in the section below entitled: **SELECTED ANATOMICAL FIGURES**. These lesions resulted in 800 milliliters of right hemothorax, 300 milliliters of hemoperitoneum, and 200 milliliters of retroperitoneal hemorrhage. The right hemothorax was attributed to the combination of the rib fractures and the lacerated brachiocephalic vein. The front right passenger’s total blood loss was greater than 20% by volume. In addition, he sustained “typical” seat belt restraint injuries to the base of his right neck and to his lower abdomen but, according to the coroner, the belt injuries did not contribute to his death. This occupant’s primary chest injuries were caused by the intruding interior surface of the right front door.

Figure 20: The structural relationship between the major arteries and veins to and from the heart.
