# INDIANA UNIVERSITY

## TRANSPORTATION RESEARCH CENTER

## ON-SITE AIR BAG INVESTIGATION

CASE NUMBER - IN99-076  
LOCATION - ILLINOIS  
VEHICLE - 1991 CHEVROLET CORSICA LT  
CRASH DATE - June, 1999

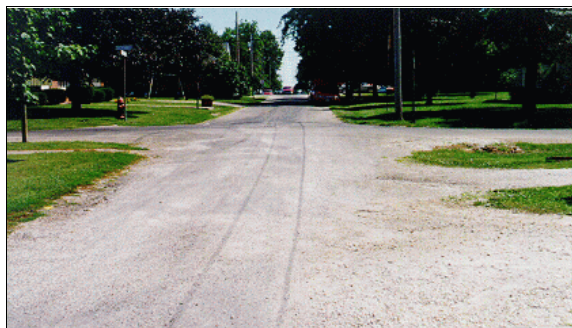
**Figure 1:** Case vehicle's intended travel path southward as she began to accelerate forward after backing out of driveway (case photo #01)

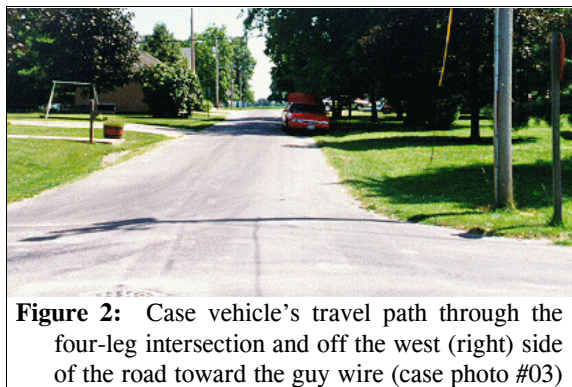
**Figure 2:** Case vehicle's travel path through the four-leg intersection and off the west (right) side of the road toward the guy wire (case photo #03)
