Case 400 : Narrative

Case Vehicle (A): 1999 Chevrolet
Type: S10 LS, 3-door cab pickup, 4x4
Driver: 28-year-old male
CDC: 12-FREN-1, 11-LDAW-3, 12-LBMS-2

This is a fatal crash. The driver of the case vehicle sustained fatal head and brain injuries due to head contact with a tree during a left-side impact.

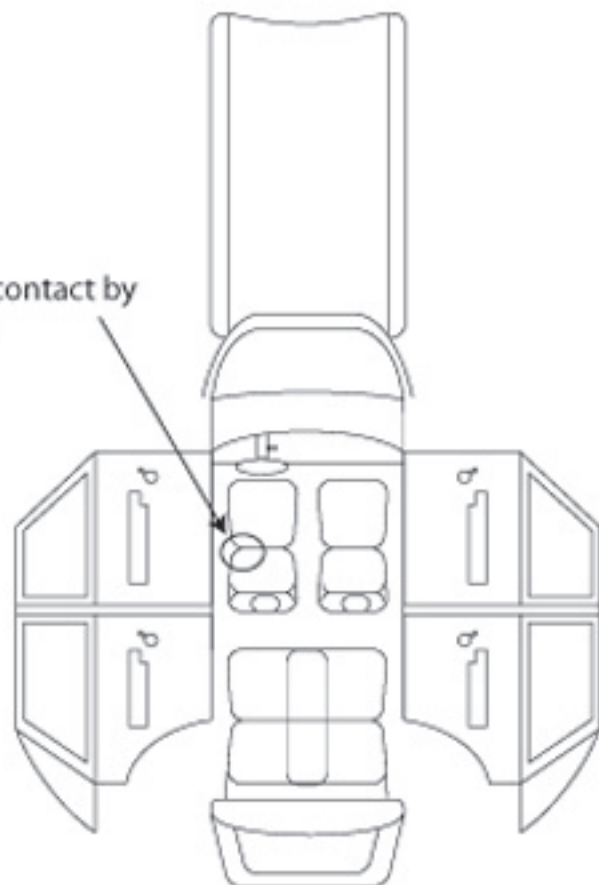
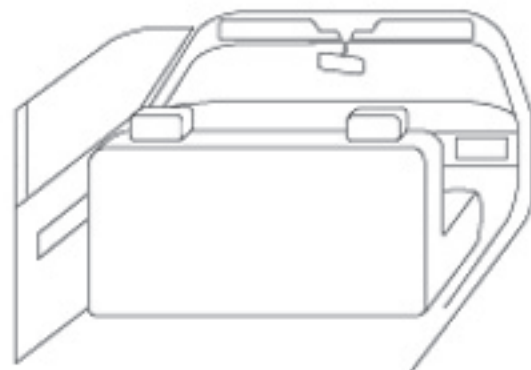
seat contact by door

Evidence of belt use - yes:
D-ring, deep gouges
Webbing at D-ring marks
Scratches on continuous loop
Belt at loop is twisted
Webbing is bloody

Driver's head
outside of window
and contacted tree

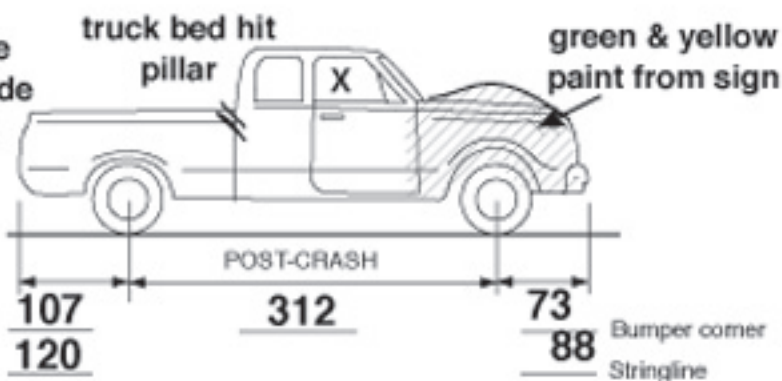
impact #2 with tree
317 cm along left side
33-cm max crush
at fender

hole in hood
