Case 407 : Narrative

Case Vehicle (A): 2003 Chrysler
Type: Sebring LX, 4-door sedan
Driver: 65-year-old female
CDC: 12-FDEW-3

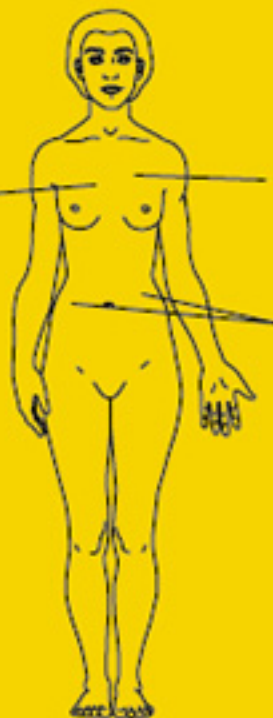
Contusions, upper
aspect of right breast
(1)

Abrasion, upper
aspect of left breast
(1)

Contusions, across
the abdomen
(1)

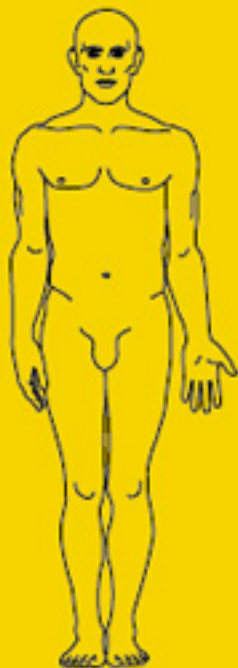
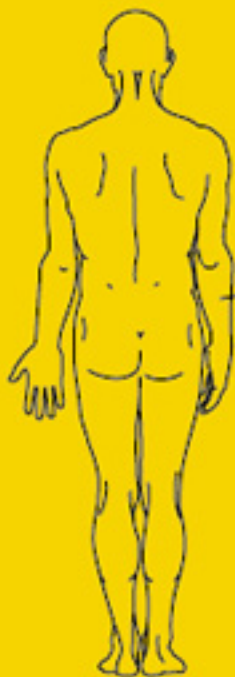
Abrasion, posterior
aspect of right forearm,
5-cm below elbow
(1)

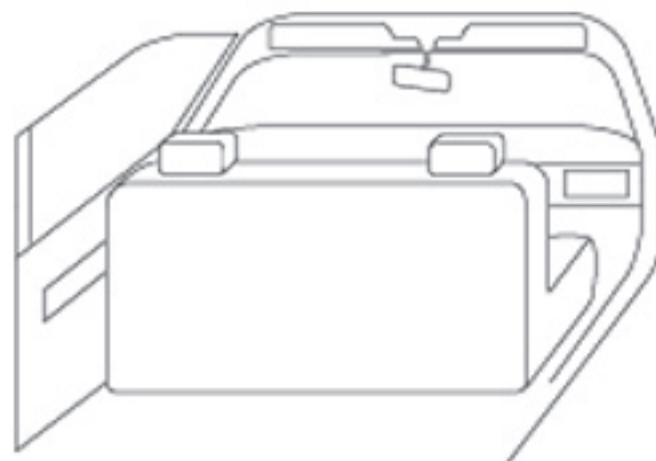
DR Belt: Yes
 Pretensioner activated and locked in an extended position
 Mark on webbing from D-ring
 Continuous loop is abraded

RF Belt: Yes
 Pretensioner activated and locked in an extended position
 Mark on webbing from D-ring
 Scratches on D-ring
