Case 415 : Narrative

Case Vehicle (A): 1999 Ford	Vehicle (B): 1996 Nissan
Type: Escort, 2-door coupe	Type: Sentra, 4-door sedan
Driver: 76-year-old female	Driver: 23-year-old male
CDC: 11-FYEW-2	CDC: 02-RFEW-3

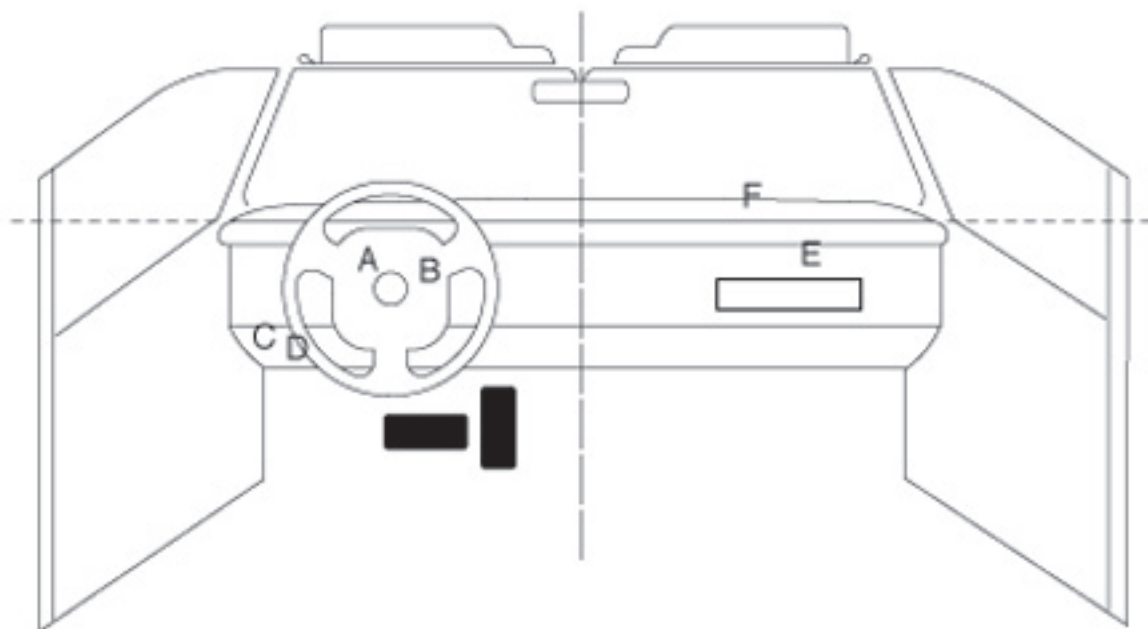
- A: steering-wheel airbag, facial makeup on fabric
- B: steering-wheel airbag flap, scuff
- C: dimmer light switch on knee bolster, scuff
- D: knee bolster - scuff on left
- E: IP above glove box, scuff
- F: dash-mounted airbag, facial makeup

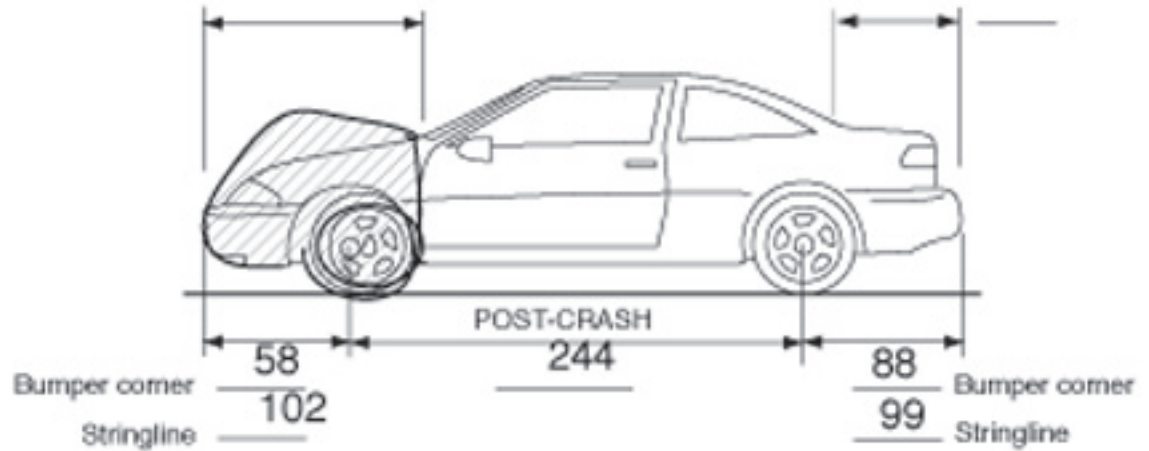
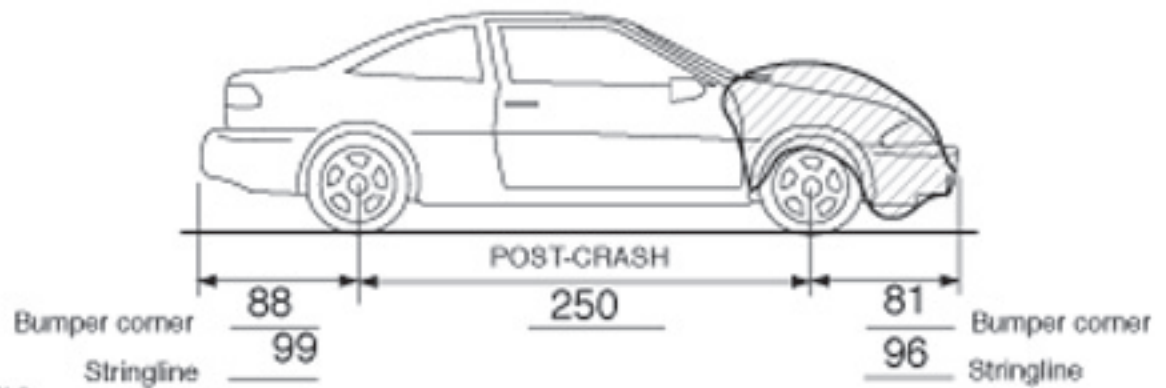
79 cm direct damage
29 cm max crush
