# Case 489 : Narrative

Case Vehicle (A): 2000 Dodge
Type: Caravan, 4-door minivan
Driver: 36-year-old male
CDC: 12-FRWN-3, 12-FZEN-3

# 489: Vehicle Report

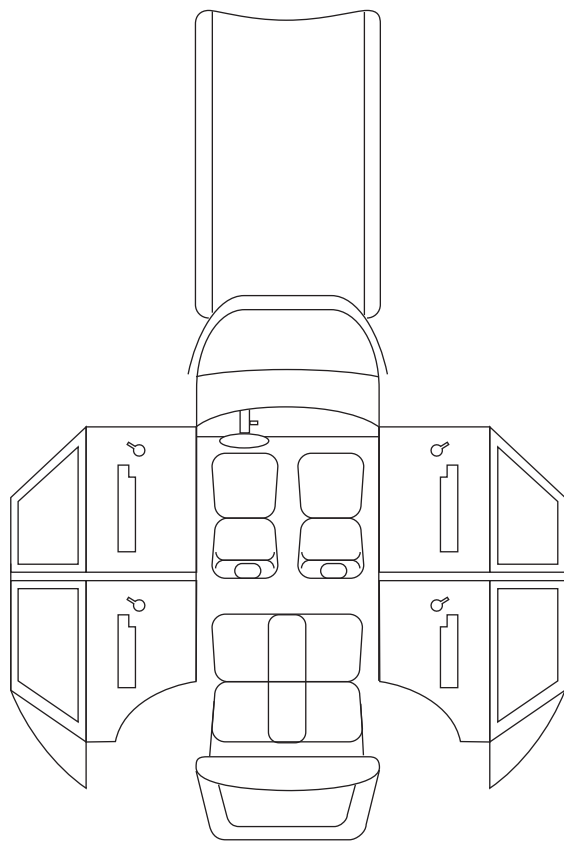
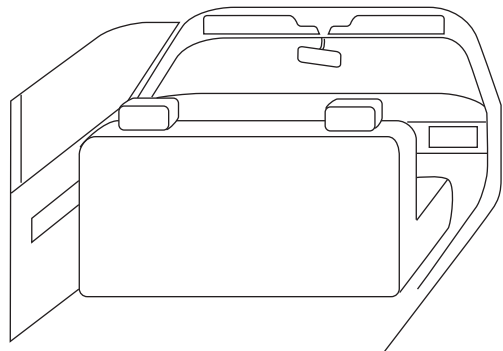
- A: airbag; blood
- B: knee bolster below steering column; dent
- C: knee bolster; scuff
- D: windshield; crack
- E: brake pedal, deformed
- F: steering-wheel rim; upper half deformed

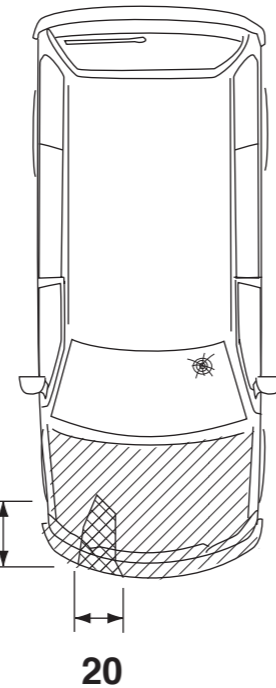
impact #2  
Width of direct damage to front
