# Case 491 : Narrative

Case Vehicle (A): 1999 Chevrolet	Vehicle (B): Unknown International
Type: S-10 LS, 4x2, 2-door pickup	Type: Tractor-trailer
Driver: 18-year-old male	Driver: Unknown
CDC: 12-FYEW-4	CDC: 99-0000-0

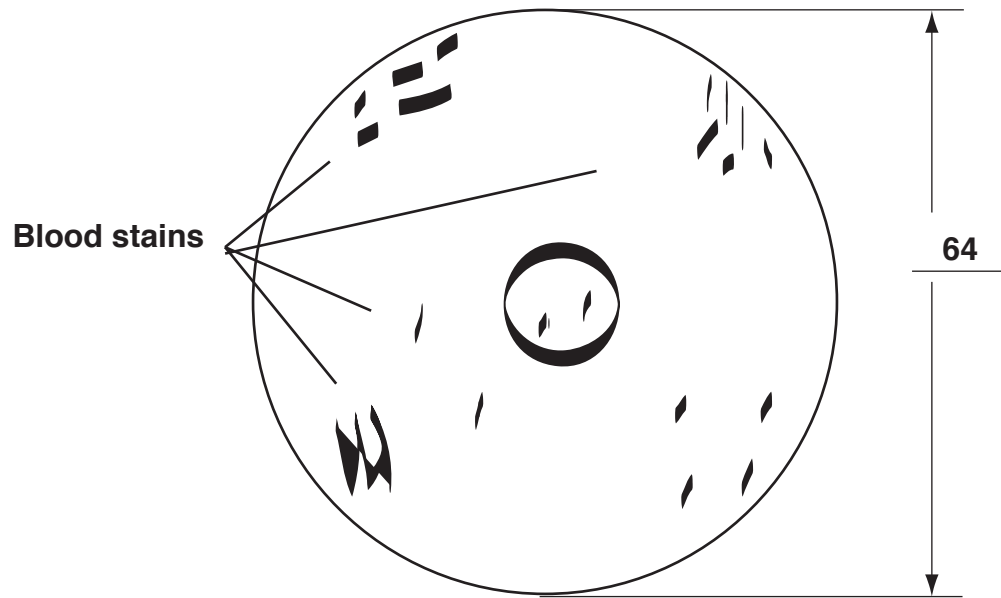
Driver Airbag

Vents:  Y N  
if yes, how many: 2

Tethers:  Y N  
if yes, how many: 4

at 1 and 11 o'clock

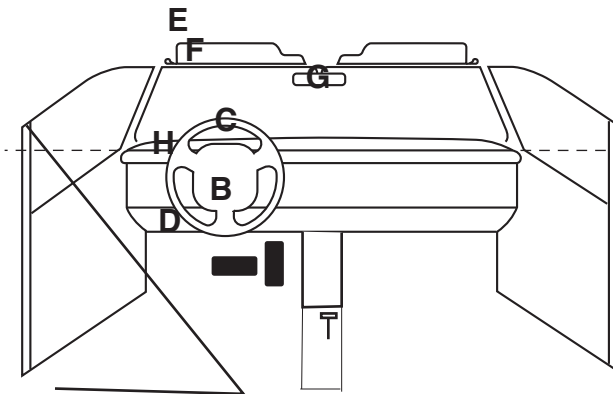
- A = driver seatbelt, load marks**
- B = steering-wheel airbag, blood deposit**
- C = upper steering-wheel rim, deflected fwd 7 cm**
- D = knee bolster, deformed**
- E = roof, blood deposit**
- F = sunvisor, scuffmark**
- G = rear-view mirror, dislodged/cracked**
- H = upper instrument panel shroud, blood**
