Case 506 : Narrative

Case Vehicle (A): 2005 Jaguar
Type: X-Type, 4-door sedan
Driver: 25-year-old male
CDC: 12-FCEN-2

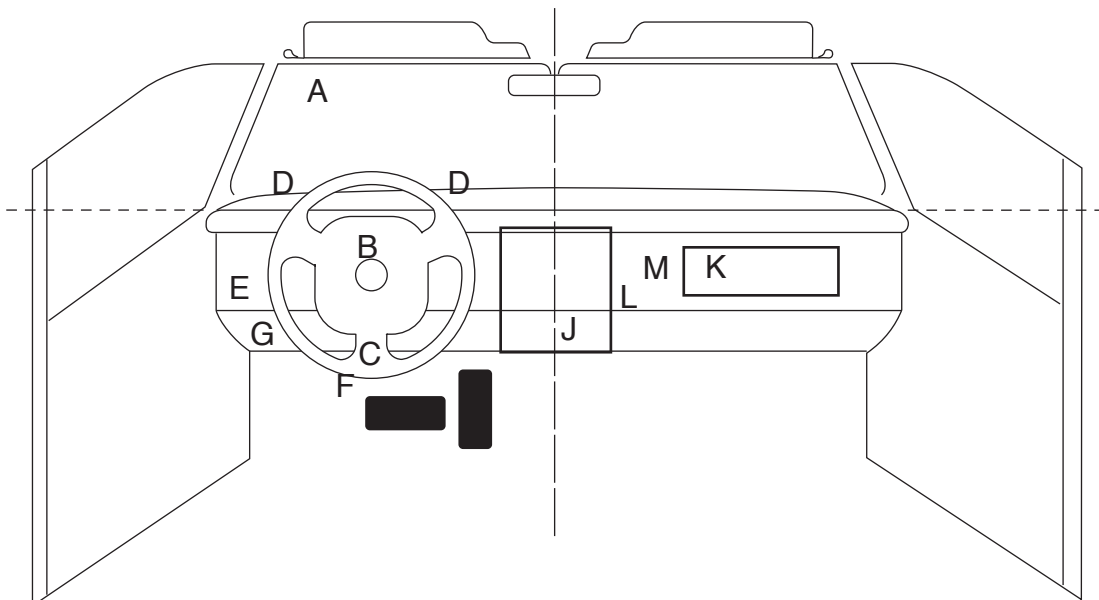
- A: windshield - crack, skin
- B: steering wheel - forward deflection
- C: steering-wheel rim - scuff to lower rim
- D: upper IP - scuffs to lt and rt of wheel
- E: light knob - broken
- F: steering column - scuff
- G: knee bolster - dent
- H: armrest between seats - skin
- I: transmission selector - broken
- J: ashtray - broken, bent
- K: glove box - dent
- L: vertical console - broke, dent
- M: mid IP - dent
- N: rear of front seatbacks - scuffs
- O: rear of center armrest - plastic scraped off

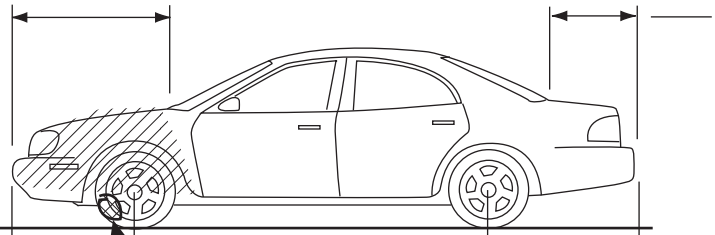
POST-CRASH
Bumper corner 81 Stringline 85 271 (0) 93 Bumper corner Stringline 105

cut in tire/rim
from curb

driver contact

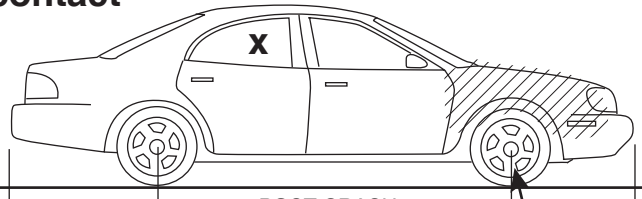
POST-CRASH
Bumper corner 93 Stringline 105 271 (0) 75 Bumper corner Stringline 85

hood
edge
contact
