CALSPAN ON-SITE AIR BAG DEPLOYMENT/ PEDESTRIAN CRASH
INVESTIGATION

CALSPAN CASE NO. 94-17

VEHICLE #1 - 1993 SATURN SR2 (AIR BAG-EQUIPPED)

CRASH DATE - [REDACTED], 1993

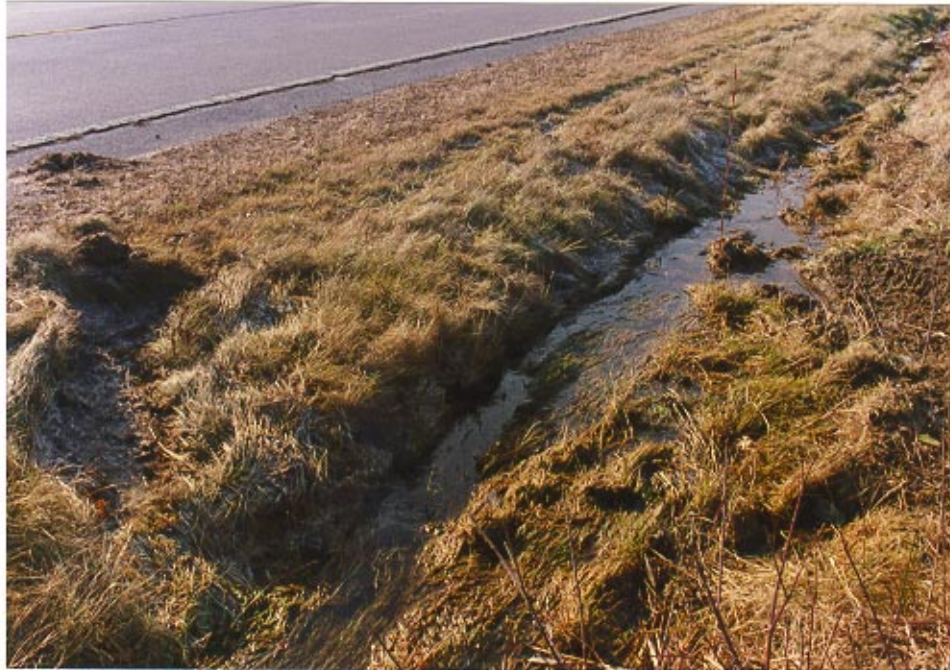
19. The FRP of Vehicle #1 with the left rear tire print noted on the left side of the photograph and the left front indicated by the calibrated rod (right upper portion of the photograph).

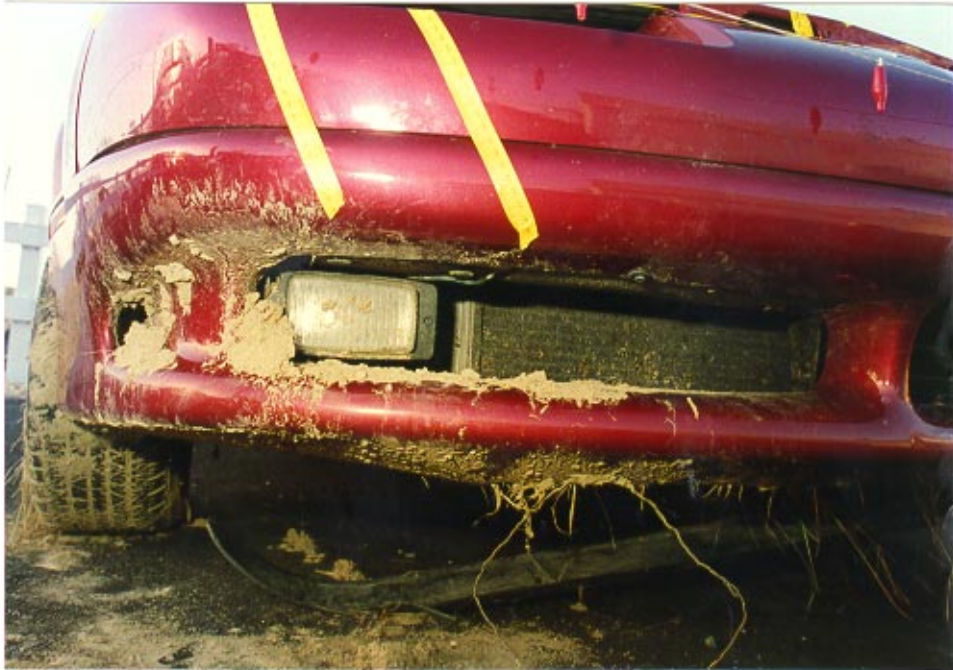
31. View of the lower right front valence panel and air dam.
