**SAFETY COMPLIANCE TESTING FOR
FMVSS NO. 216
ROOF CRUSH RESISTANCE**

**MAZDA MOTOR CORPORATION
2003 MAZDA 6, PASSENGER CAR
NHTSA NO. C35401**

**GENERAL TESTING LABORATORIES, INC.
1623 LEEDSTOWN ROAD
COLONIAL BEACH, VIRGINIA 22443**

FINAL REPORT

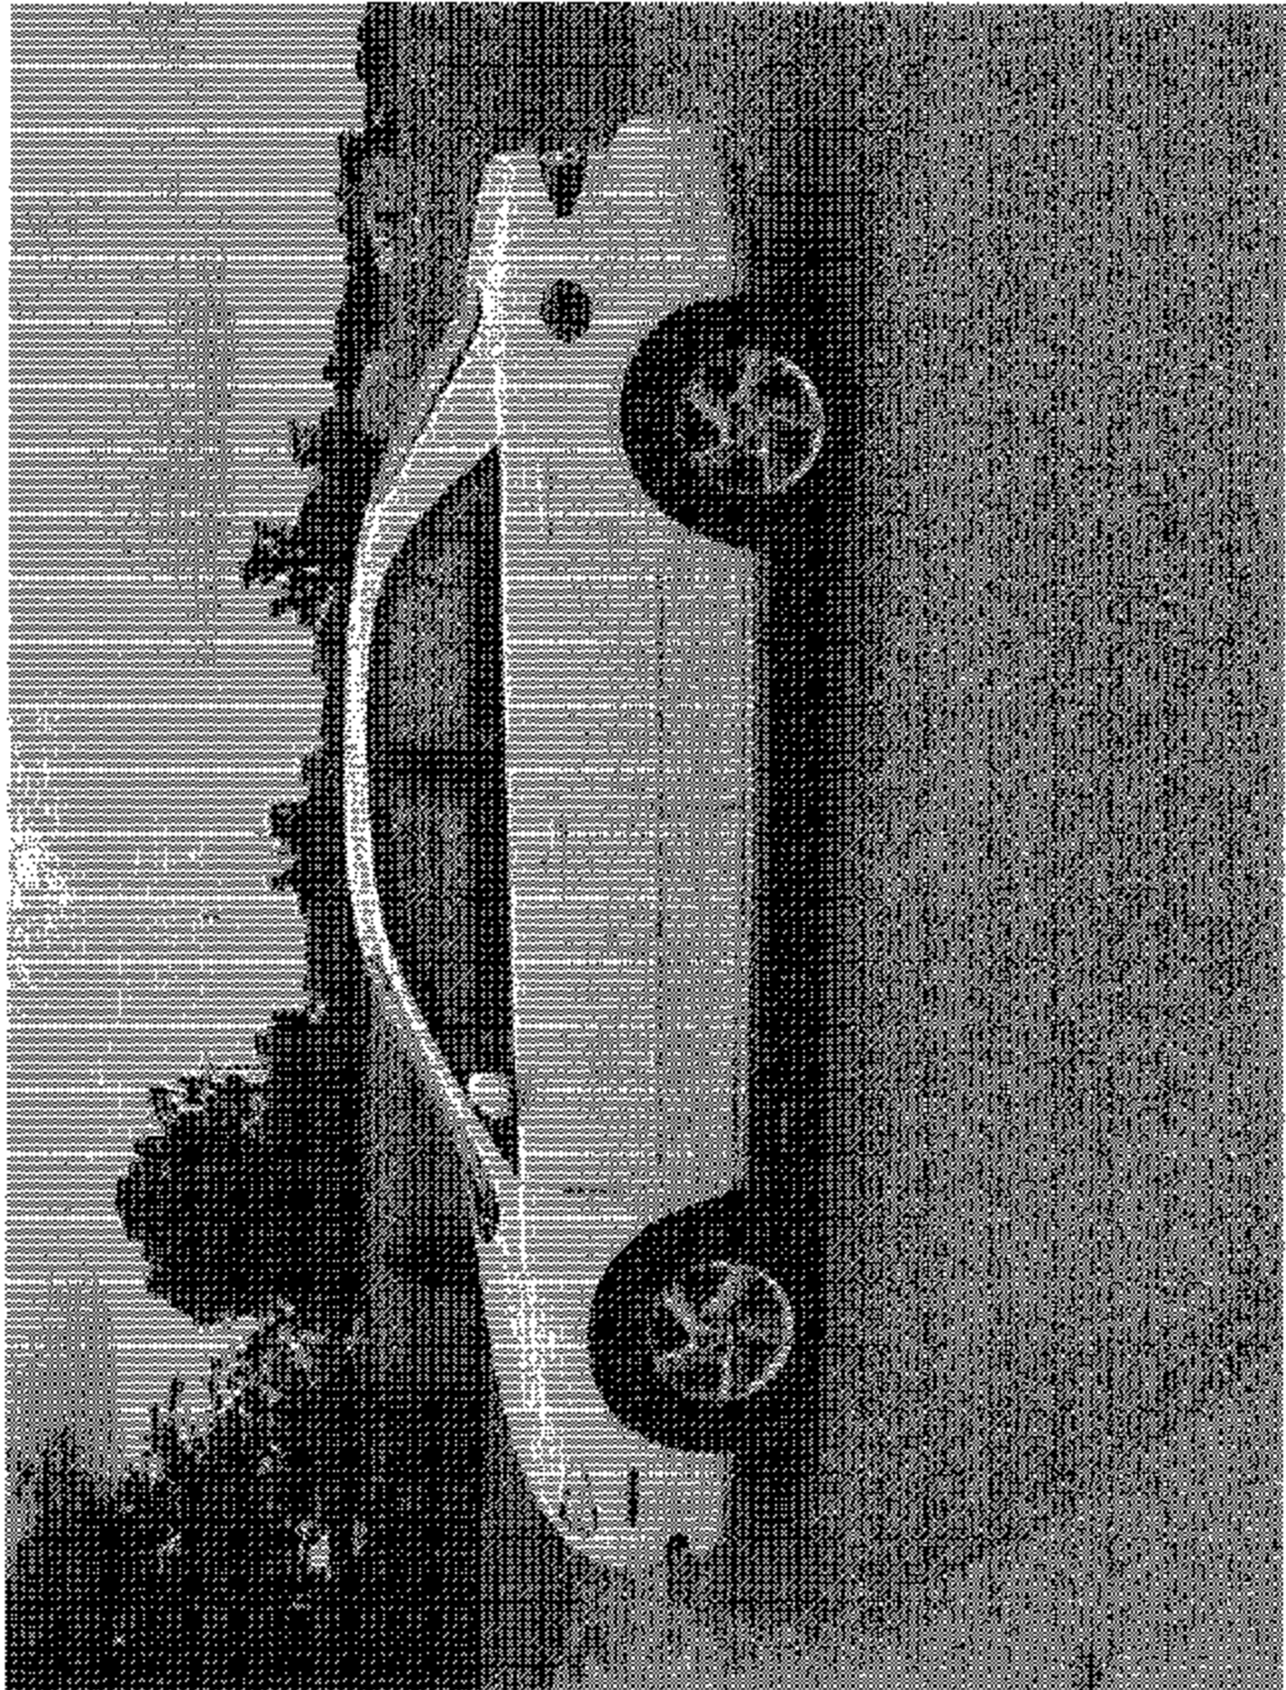
RESULTS: Flattened area above driver's side front door approximately 600mm long x 150 mm wide and pushed down 20 mm. Small dent above driver side rear door approximately 300 mm long x 150 mm wide and pushed down 4 mm. Windshield glass has multiple cracks but is still intact. All doors and side glass windows still operate.

FIGURE 5.23
LEFT SIDE VIEW OF VEHICLE AFTER TESTING
