CALSPAN ON-SITE BACKOVER CRASH INVESTIGATION

SCI CASE NO: CA12011

VEHICLE: 2003 HYUNDAI SANTA FE

CRASH DATE: FEBRUARY 2012

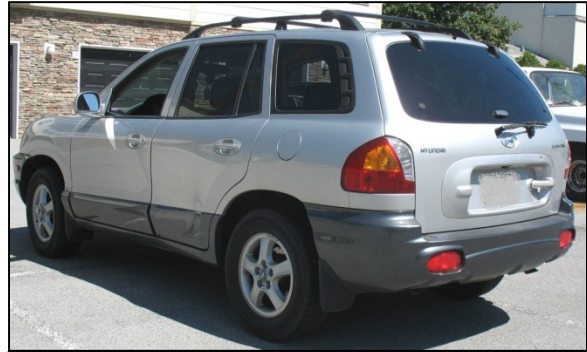
Figure 1: Left rear oblique view of the Hyundai

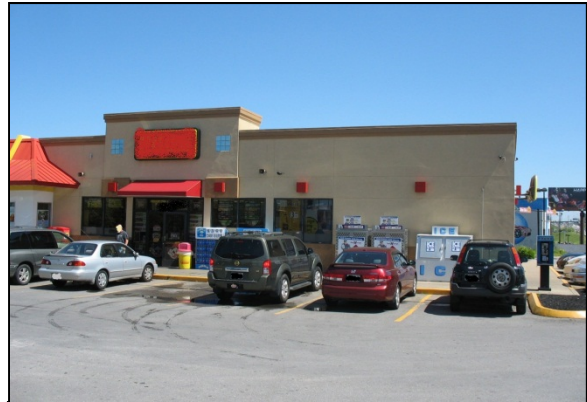
Figure 2 depicts an overall view of the plaza and parking lot. The plaza building itself was 31.5 m (103.3 ft) long. Its interior was divided into a 20 m (65.6 ft) wide convenience store and an 11.5 m (37.7 ft) wide fast-food restaurant.

Figure 2: Overall view of the private parking lot and commercial plaza.

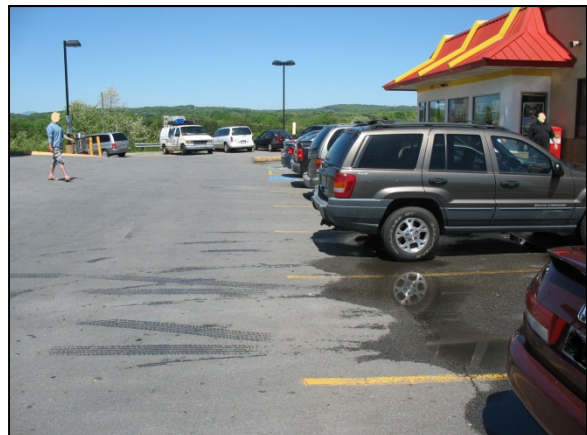
The non-motorist walked in a northerly direction toward the vegetation island at the southwest corner of the building. He discovered that there was no available path to reach the sidewalk, and subsequently elected to continue north toward the front door of the convenience store with the intent of walking between any of the parked vehicles that had sufficient space to allow safe passage. The non-motorist's travel path is depicted in **Figure 3**.

Figure 3: Non-motorist's walking trajectory.

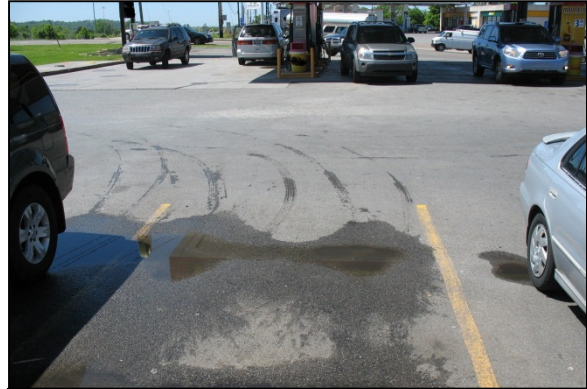
Figure 4: West-facing trajectory view of the Hyundai.

Having not detected any pedestrian or vehicular traffic, the Hyundai driver released the pressure of his foot from the brake pedal and allowed the Hyundai to begin moving in reverse. Vehicles parked adjacent to the Hyundai partially obscured the driver's view of the cross-path behind the parking stalls. **Figure 4** is a west-facing view of the Hyundai's backing trajectory. In this manner, the rear plane of the Hyundai approached the right flank of the non-motorist. The Hyundai moved backward at idle speed over a 0.9 m (3 ft) distance prior to impact.

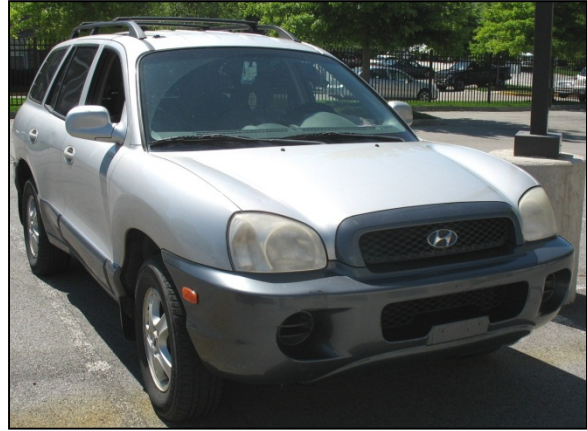
The 2003 Hyundai Santa Fe (**Figure 5**) was identified by the Vehicle Identification Number (VIN): KM8SB12B13Uxxxxxx. The front wheel drive, sport utility vehicle was configured on a 262 cm (103.1 in) wheelbase. Its powertrain consisted of a 2.4 liter, 4-cylinder gasoline internal combustion engine linked to a 4-speed automatic transmission. The Hyundai's service brakes were a four-wheel disc system with ABS. Equivalent in size to the manufacturer's recommendation, the Hyundai was equipped with Firestone Destination tires of size P225/70R16. Inspection of the undercarriage did not yield any evidence of after-market modification (i.e. lift kits or altered suspension). The Hyundai was not equipped with an electronic parking aid (i.e. back-up camera or sensor system).

Figure 5: Front right oblique view of the 2003 Hyundai Santa Fe.

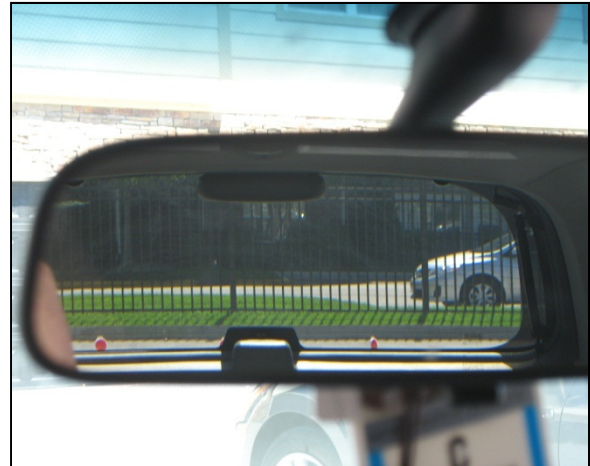
Figure 7: Image through the center mirror to the reference targets positioned aft of the Hyundai.

A 71 cm (28 in) tall red reflective target was placed on the vehicle's centerline and moved rearward to a location where the driver could first see the red target by looking through the rear view mirror (**Figure 7**). The centerline distance measured from the rear bumper to the reflector was 6.1 m (20 ft). The driver's line of sight through the rear view mirror projected to the ground was an additional 10.1 m (33.1 ft) for a total distance of 16.2 m (53.1 ft). Cones of visibility were established using the outside mirrors. These lateral visibility measurements were established at the centerline reference distance of 6.1 m (20 ft). By using the mirrors, the driver located the 71 cm (28 in) targets that were placed laterally relative to the centerline from his normal seated position. The visibility for the left mirror began 0.8 m (2.6 ft) left of center and ended 3.2 m (10.5 ft) left of center. The cone for the right mirror began 1 m (3.3 ft) right of center and ended 5.3 m (17.4 ft) right of center.
