REPORT OF INVESTIGATION: HYBRIDS PLUS PLUG IN HYBRID ELECTRIC VEHICLE

**National Rural Electric Cooperative Association, Inc.
And
U.S. Department of Energy, Idaho National Laboratory**

June 26, 2008

Revision 1

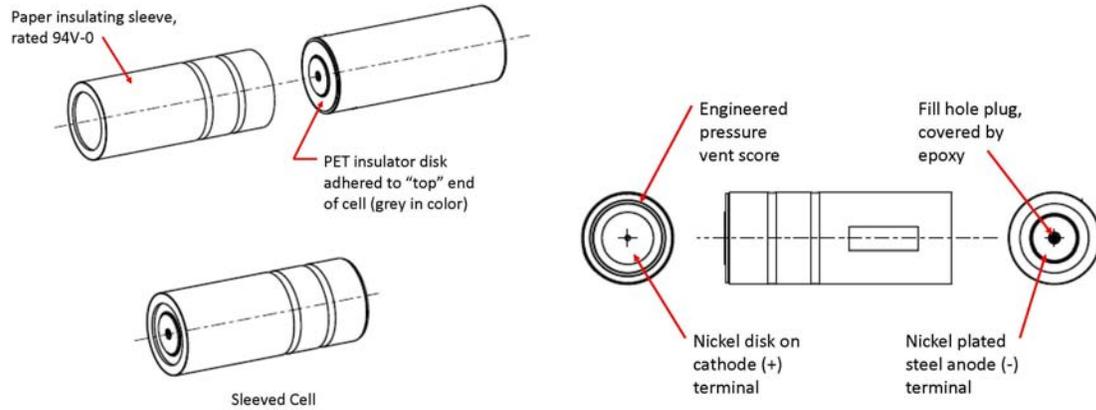
Figure 2--A123 Lithium Ion Cell

The Hybrids-Plus battery pack is based on the A123 Systems Lithium-Ion cell which uses a Nanophosphate¹ technology to limit the reactivity of these cells. The cell uses an aluminum can which contains a roll of copper and aluminum foil onto which the active materials are coated. A flammable, solvent-based electrolyte is used. The cell is sealed with a laser-welded cap which is machined with a relief groove that turns this cap into a rupture disk should internal pressure build beyond a design point (the pressure vent). A fill hole is present on the anode end of the cell through which the electrolyte is loaded into the cell. This hole is sealed with epoxy. As the sides of the cell can are at anode potential, the cell is placed inside a heavy, cardboard sleeve (rated UL 94 V-0, self

extinguishing). With the sleeve in place, only the ends of the can are available to conduct energy. Figure 2 shows the features of the A123 cell.

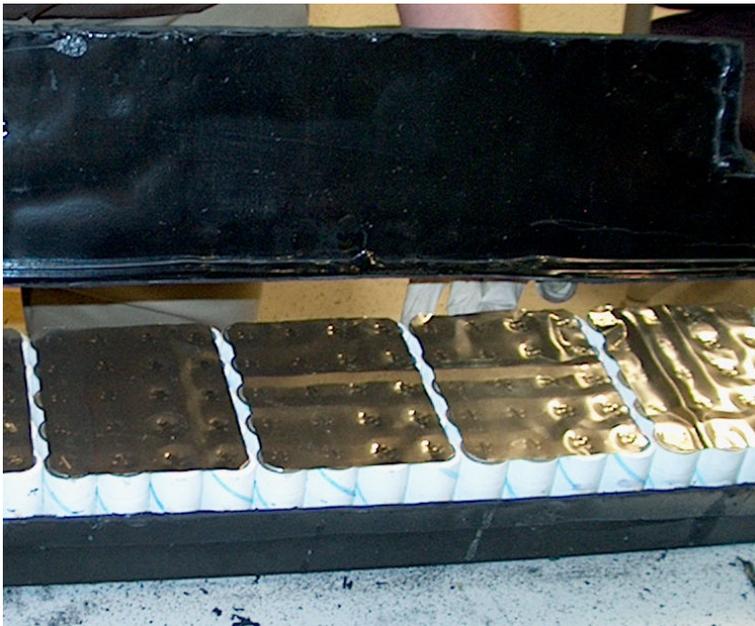
Figure 3--Bus Bar Arrangement

The parallel groups are created by spot welding the poles (all positive or negative) of the cells to a Nickel sheet which acts as the bus bar. Each A123 cell has a Nickel disk (or rivet depending on which pole) attached at the end of the can to facilitate welding to the Nickel bus bar. See Figure 3 for details.

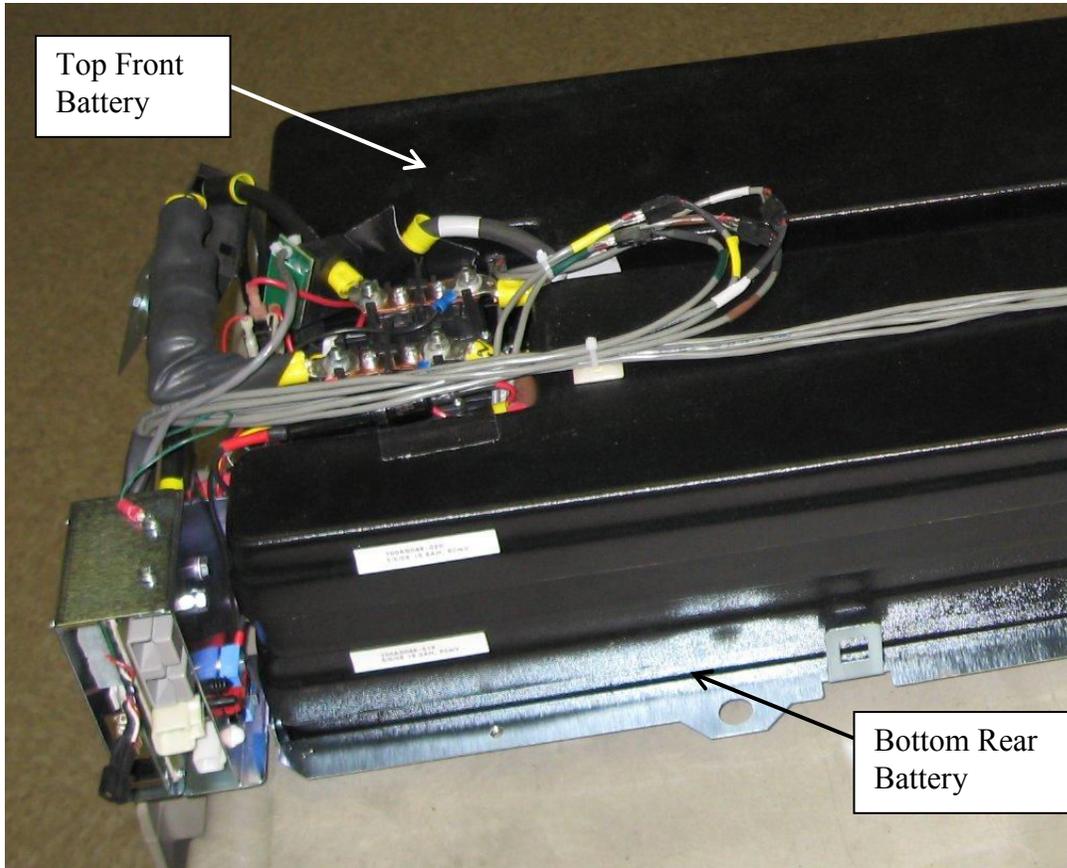
Figure 5--Four-Battery Assembly

Figure 5 shows a close up of the left-hand end of the four-battery assembly.

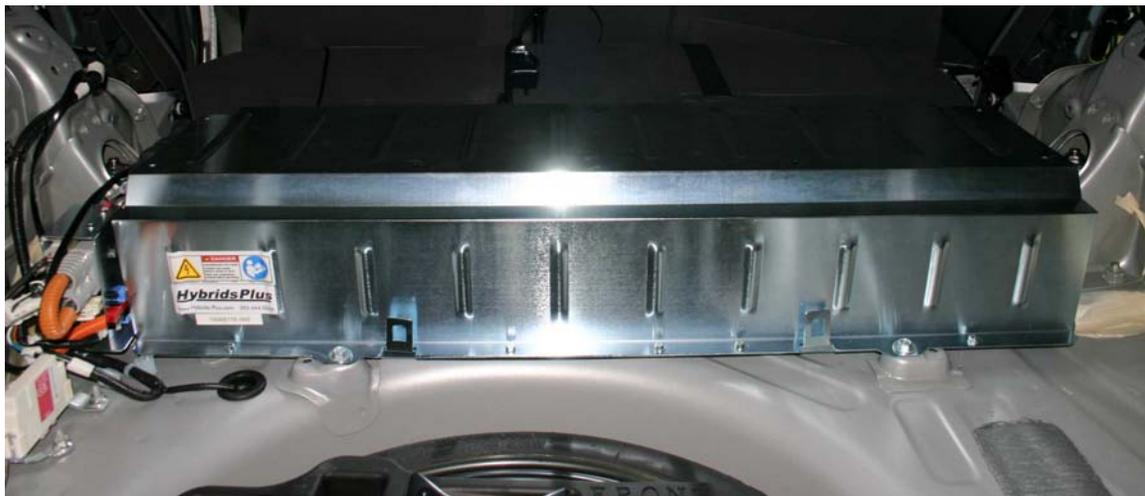
Figure 6--Battery Pack Assembly with Cover

The four batteries are restrained by the top cover which is bolted to the vehicle's chassis in the original battery mounting locations; there is no mechanism for restraining the individual battery assemblies. Figure 6 shows the battery pack with the cover in place.

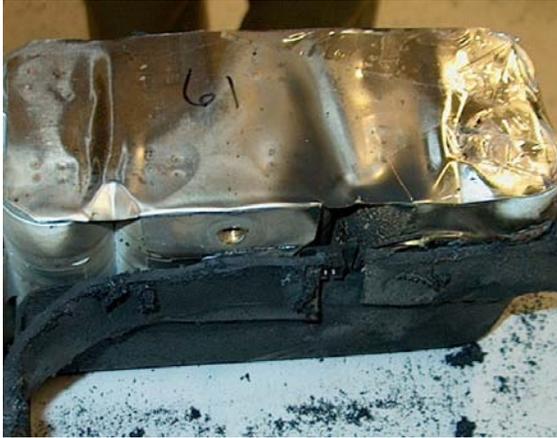
Figure 8--Formed Tab

Although not shown on this diagram, each battery is equipped with a 250A fuse that is connected directly to the Nickel sheet grouping one parallel set of 10 cells via a tab that is formed in the Nickel sheet. A brass nut is soldered to the back of the tab and a brass bolt is run through the blade at one end of the fuse and into the brass nut on the back of the tab (therefore, the fuse blade and Nickel tab are clamped together. The other fuse blade has a brass nut soldered to its back side. The fuse is encased in the plastic clamshell. A small square of open-cell foam is located between the fuse and the cells which is used to push the fuse blade out toward the plastic cover so that the bolt will more easily engage in the threads of the nut on the back of the blade. This foam is known to be flammable from tests conducted at Hybrids Plus and at A123 Systems. A hole is cut in the clamshell so that a lug can be attached to the fuse via another brass bolt. The opposite end of each battery (physically and electrically) uses a brass nut soldered onto the back of the formed tab with a hole cut into the clamshell to allow for the attachment of a lug. See Figures 8 and 9.

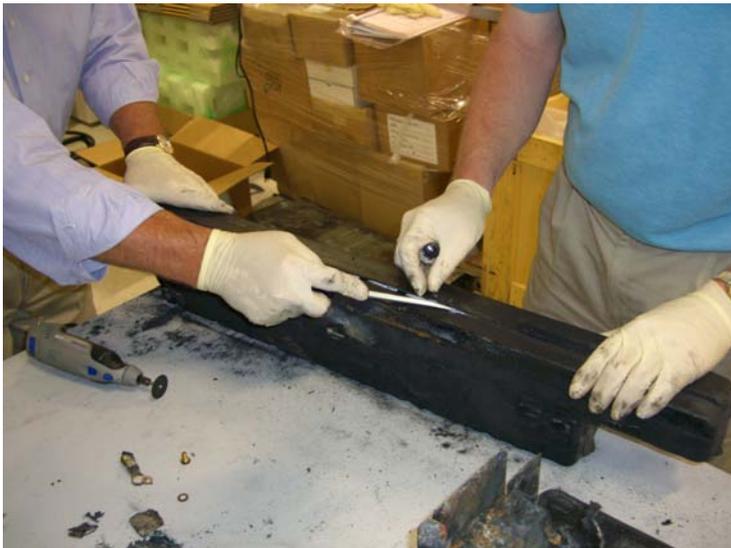
Figure 13--Opening the Clamshell

In order to examine the individual cells and any damage that was present inside the batteries, the Top Front battery was cut apart and removed (Figure 13—the remaining three batteries were shipped to Hybrids Plus for their inspection).
