DOT HS 812 583

# **Special Crash Investigations On-Site Ambulance Crash Investigation**

**Vehicle: 2013 Chevrolet  
Express 3500 Type II  
Ambulance**

**Crash Date: May 2017**

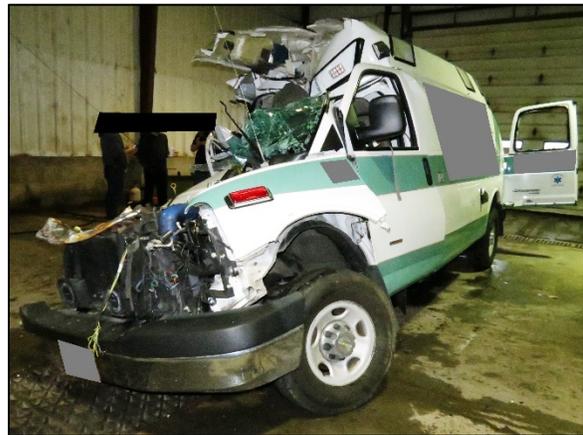
tire pressures of 414 kPa (60 psi) front and 552 kPa (80 psi) rear. At the time of the crash, the Chevrolet was configured with BF Goodrich Commercial T/A tires of the recommended size and mounted on OEM steel wheels. Due to its direct involvement in the impact damage pattern, the right front tire was flat with cuts of the sidewall and tread. There was no damage or restriction to the remaining three tires. All had ample tread and were inflated.

**Figure 7:** Left front oblique view of the 2013 Chevrolet Express 3500 at the time of the SCI inspection.

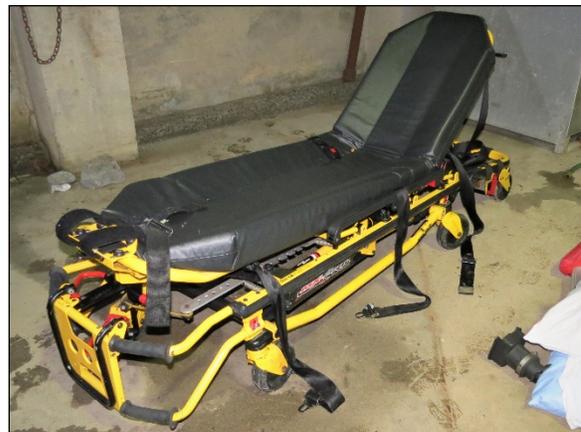
The wheeled ambulance cot (**Figure 16**) installed in the Chevrolet ambulance was an MX-Pro Model 6082, manufactured by Stryker. Its serial number was serial number 03063xxxx, indicative that it was manufactured in June 2003. An additional label affixed by the ambulance agency owner indicated that the cot had been serviced on January 21, 2015. The Stryker cot was constructed of a tubular aluminum frame with circumferential weld joints and steel hardware fasteners. The X-frame supporting the mattress platform featured manual raise/lower capabilities with height positions between a minimum of 34 cm (13.5 in) and a maximum of 95 cm (37.5 in). The mattress platform itself featured positive backrest angular adjustment between 2- and 73-degrees via a manually controlled gas-pressure cylinder. The leg portion featured 14 degrees of positive angular adjustment. Overall dimensions of the cot were 58 cm (23.0 in) wide and 205 cm (80.7 in) long. A placard declared that the load capacity limit of the cot was 295 kg (650 lb).

**Figure 16:** View of the Stryker MX-Pro wheeled ambulance cot at the time of the SCI inspection.
