Identification of Risks of Failure of Pneumatic Tyres of Passenger Vehicles in Ghana

Gabriel S. K. Akakpo¹, Eyram Kwame¹, P. S. A. Gladstone-Bright²,
Christabel S. Ewedji³

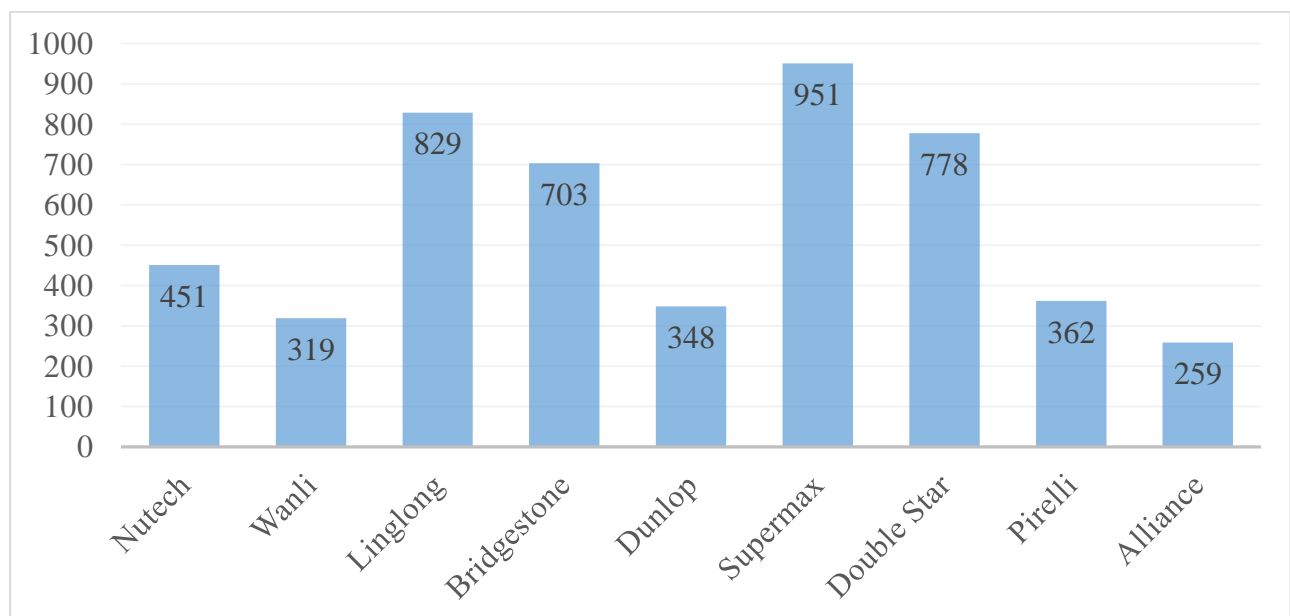
Figure 4: A bar chart showing the distribution of damaged tyre samples by brand

From Figure 4, 601 out of 5000 samples of tyres failed due to road condition. This represents 12% of the sampled tyres. The roads that the Passenger Buses ply in Ghana are relatively flat roads with few hills in the Western and Volta regions respectively, some of which are unpaved or flooded with potholes are present. Normally because of unevenness of the roads and carelessness of drivers, when the buses approach potholes with high speed, breaks are applied abruptly leading to faulty suspension parts. This is because of the sudden vibration that is transmitted to the suspension system which makes the wear pattern of the tyre treads become uneven. Due to the bad conditions of the roads that these Passenger Buses ply, it was noticed that as the tyres enter and leave potholes, cuts are made on the tyre treads, which lead to tyre failure.

As can be seen from Figure 4 above, 302 out of 5000 sample tyres failed due to seldom rotation of tyres. This could be inferred that 6% of the sampled damaged tyres failed due to lack of tyre rotation. Changing the position of tyres at regular intervals is generally favored to compensate for any difference in the working tread pattern wear, or uneven wear due to different working positions; hence to obtain a longer overall tread pattern life, tyre efficiency, and stability in cornering and braking. This was not the case among the selected Passenger Buses. Tyre rotation is hardly done as they see it as not necessary, waste of time and loss of revenue. That is, for them the moment the buses are off the roads it means loss of revenue. Also, in those isolated instances where tyres are rotated, it was observed that the spare tyres were not rotated in accordance with the established measurements.
