TECHNICAL SERVICE BULLETIN

Bulletin Number: V-12-01

SUBJECT: 2012-2013 Victory Motorcycles – Throttle Cable Retention Nut Torque Inspection

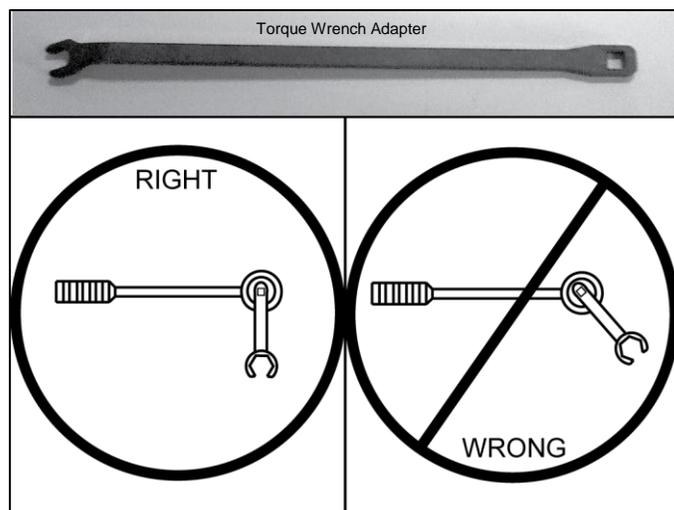
IMPORTANT: The Torque Wrench Adapter shipped to your dealership was specifically designed for use in the application of this service procedure. This tool allows for proper torque to be applied to the 10mm throttle cable retention nuts with limited wrench access. When used at a 90° angle with a torque wrench, no torque multiplier is necessary.

1. Support the motorcycle securely in an upright position with the front wheel clamped in a wheel vise.
2. Working from the right-hand side of the motorcycle, remove the IAC cover (see Figure 1).
