## ON-SITE AIR BAG INVESTIGATION

CASE NUMBER - NASS-2000-49-068A

VEHICLE - 1997 PLYMOUTH GRAND VOYAGER SE

CRASH DATE - April, 2000

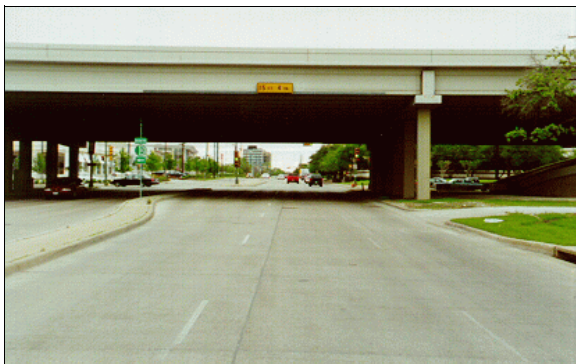
**Figure 1:** Case vehicle's eastward travel path in center through lane of eastbound roadway approaching underpass and four-leg intersection with service road on east side of underpass

The case vehicle was traveling east in the center eastbound through lane (**Figure 1**) of a seven-lane, divided, city trafficway (i.e., both the east and westbound roadways had three through

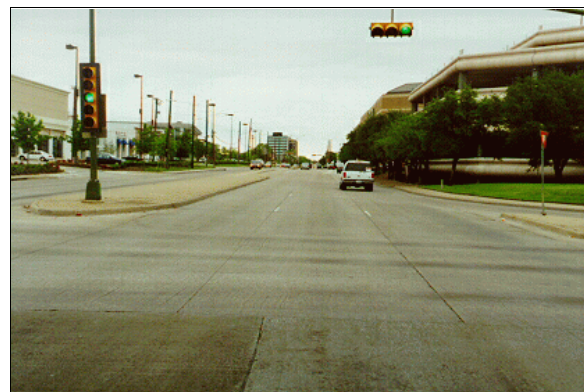
**Figure 2:** Case vehicle's approach to four-leg intersection with service road, just prior to impact; Note: raised paved median and utility pole located therein

lanes while the eastbound roadway had one left-hand turn lane) and was entering a controlled, four-leg intersection (**Figure 2** above) while steering slightly to her left, intending to change into the inside eastbound lane in order to turn left into a shopping center a couple hundred meters (approximately 650 feet) further east of the intersection. The Dodge Dakota was traveling north in the outside through lane (**Figure 3**) of a one-way, four-lane (i.e., three through lanes and one channelized right-hand turn lane), service road, which was adjacent to a divided, state toll

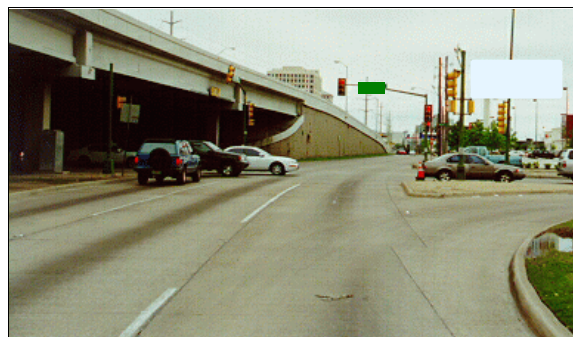
**Figure 3:** Other vehicle's rightward curving travel path in outside through lane of one-way service road, approaching four-leg intersection

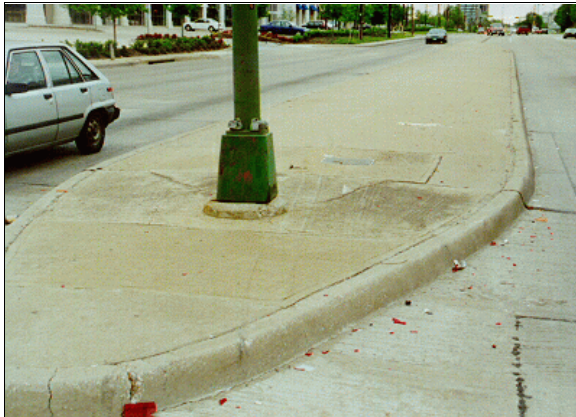
northeasterly direction before striking the curb—*{See End Note A. (3)}*, of the raised median that separated the east and westbound roadways (Figure 10). The case vehicle's left front tire was aired-out while driving onto the raised median (Figure 11). The case vehicle continued driving east-northeast, sideswiped a street light utility pole in the center of the median with its left side (Figure 12), and traveled approximately 35.0 meters (115 feet) prior to coming to rest straddling the median and the inside lane of the westbound roadway heading east (Figure 13 below). The Dodge Dakota was redirected in an easterly direction coming to rest in the inside eastbound lane heading east.

Figure 10: Case vehicle's path of travel into median after initial and side slap impacts with other vehicle; Note: case vehicle impacted the curb and then sideswiped the utility pole

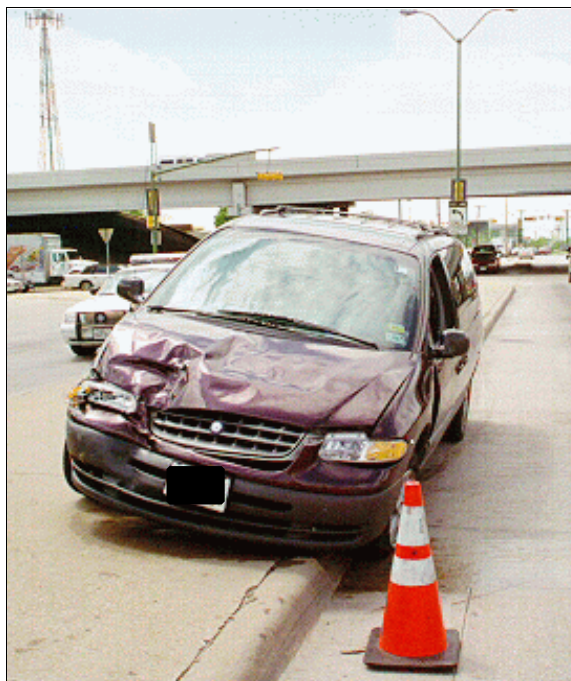
**Figure 13:** On-scene view looking west at case vehicle's final rest position atop median; Note: orange cone is located in inside westbound through lane of divided trafficway

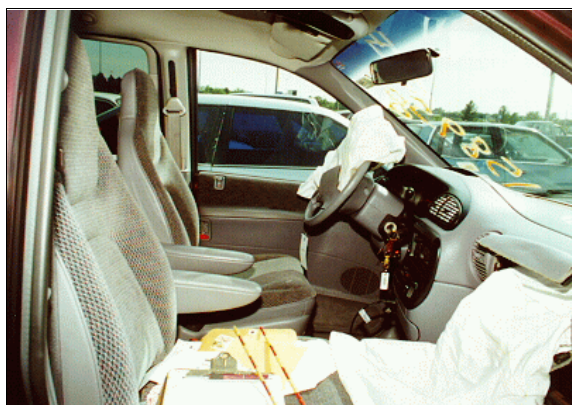
The case vehicle's, short statured driver was restrained by her available, active, three-point, lap-and-shoulder, safety belt system. The upper anchorage for the driver's shoulder belt was adjusted to its down-most position (**Figure 25**). The inspection of the driver's seat belt webbing, "D"-ring, and latch plate showed apparent evidence of loading (i.e., stretching and transfer to "D"-ring). In addition, photographs taken by the this contractor showed plastic residue on the "D"-ring from friction with the seat belt webbing (**Figure 26**).

**Figure 25:** Case vehicle's front seating area showing deployed driver and front right passenger air bags, front bucket seats, and driver's adjustable upper seat belt anchorage, positioned in its down most position

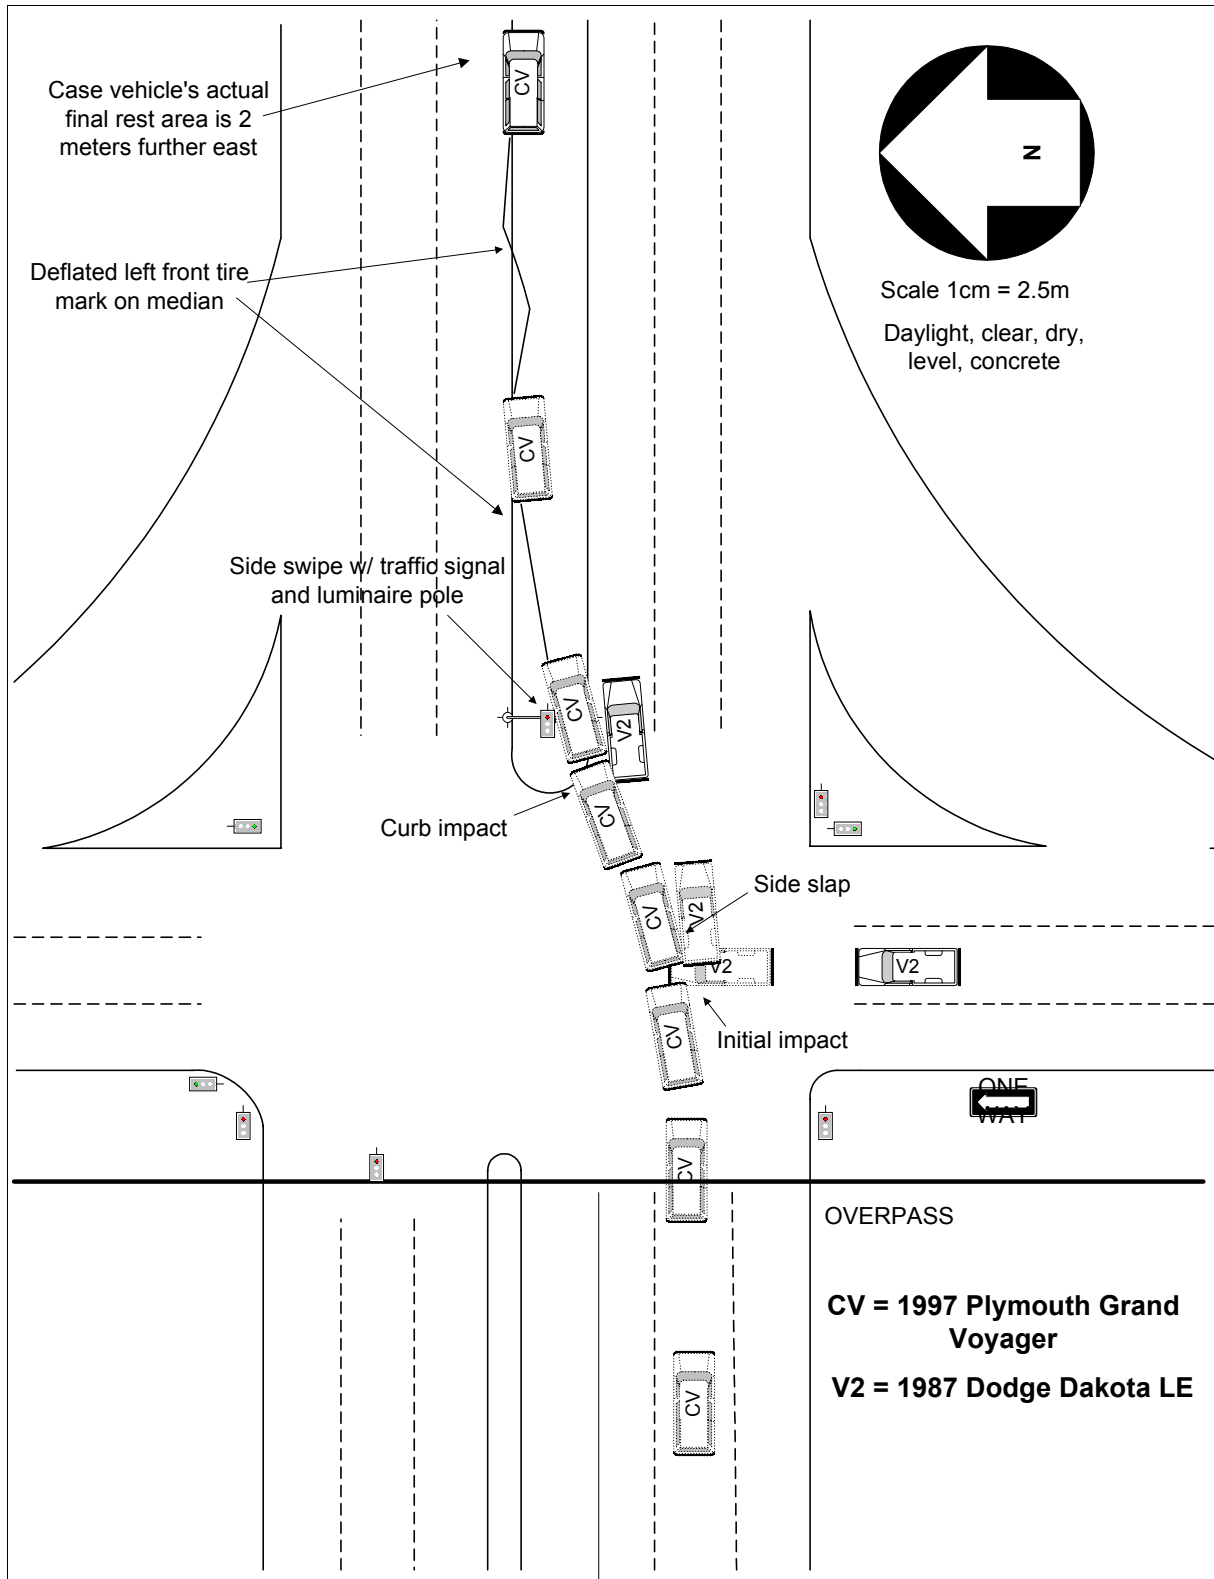
**CRASH DIAGRAM**

- A. (1) NASS scene diagram is a different drawing from the SCI diagram, but there are no substantive differences
- (2) SCI photographs were taken before the case vehicle was repaired. NASS photographs were taken after some repair work had begun. The SCI report includes some of the police photographs; NASS does not acquire police photographs, but some of the police photographs SCI sent to the zone center are included.
