**VERIDIAN ON-SITE REDESIGNED AIR BAG INVESTIGATION
VERIDIAN CASE NO. CA00-004
VEHICLE: 1998 FORD CONTOUR
LOCATION: NORTH CAROLINA
CRASH DATE: JANUARY 2000**

14. <i>Sponsoring Agency Code</i>	
15. <i>Supplementary Notes</i> On-site investigation of a three-vehicle crash that involved a 1998 Ford Contour equipped with redesigned frontal air bags.

VERIDIAN ON-SITE REDESIGNED AIR BAG DEPLOYMENT INVESTIGATION
VERIDIAN CASE NO. CA00-004
VEHICLE: 1998 FORD CONTOUR
LOCATION: NORTH CAROLINA
CRASH DATE: JANUARY 2000

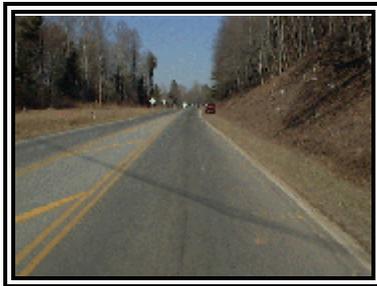
The 1998 Ford Contour was traveling in an easterly direction (**Figure 2**) on the two-lane U.S. route at an estimated speed of 72-80 km/h (45-50 mph). The dark conditions warranted the use of headlights. The 33 year old female driver of the Contour was traveling through the curved segment of roadway as she approached the undivided straight segment. A 1995 Ford Thunderbird was traveling eastbound behind the Ford Contour at a comparable speed. The 1985 Chevrolet Camaro was traveling in a westerly direction (**Figure 3**) at a estimated speed of 80-89 km/h (50-55 mph). The intoxicated driver of the Camaro was operating the vehicle with unsafe tires as the steel belts in the right rear tire were exposed throughout the mid section of the tire. As he descended the negative grade, the Camaro driver lost control of the vehicle and crossed into the eastbound travel lane. There were no skid marks at the scene to support evasive action by the drivers of the Camaro and the Ford Contour. The Crash Schematic is attached as **Figure 16**.

Figure 2. Trajectory of the eastbound Ford Contour and Ford Thunderbird.

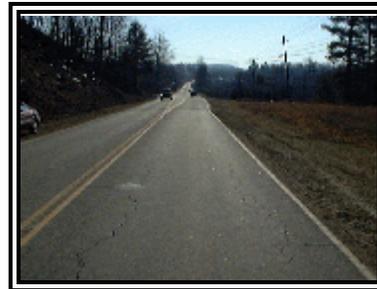
Figure 3. Trajectory of the westbound Chevrolet Camaro.

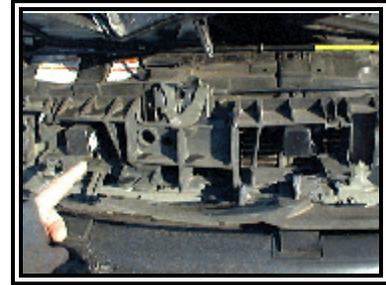
The front crash sensors were mounted to the upper aspect of the radiator support panel, located 17.8 cm (7.0") on each side of the vehicle's center line (**Figure 11**). Both sensors remained intact and were not damaged. The left sensor was identified with Part No. 97BB-14B005-AF and bar coded label number AI27394283. The respective numbers for the right sensor were 97BB-14B004-AF and AH27497688.

Figure 11. Front mounted crash sensors.
