**ADVANCED OCCUPANT PROTECTION SYSTEM STUDY
2000 FORD TAURUS INVESTIGATION**

VERIDIAN CASE NO. CA00-041

LOCATION - MICHIGAN

CRASH DATE - SEPTEMBER 2000

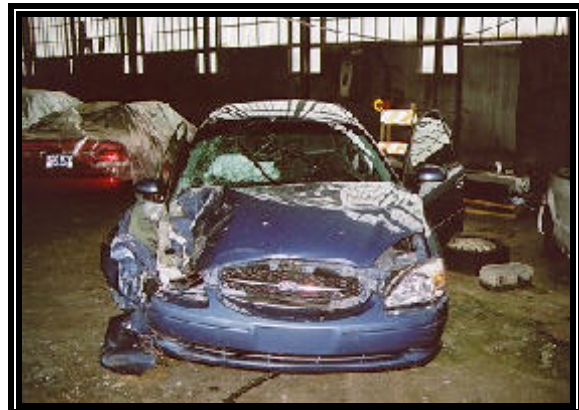
The 2000 Ford Taurus, **Figure 2**, was identified by the Vehicle Identification Number (VIN): 1FAFP55U3YG (production sequence deleted). The vehicle's power train consisted of a 3.0 liter, V-6 engine linked to a 4-speed automatic overdrive transmission. The vehicle had 4-wheel disc brakes. It was not ABS equipped. The cloth trimmed interior was equipped with a power package that included power steering, brakes, windows, door locks, and mirrors. The 4-door sedan was manufactured in

Figure 2: Front view of the Taurus.
