## ON-SITE ADVANCED OCCUPANT PROTECTION SYSTEM INVESTIGATION

CASE NUMBER - IN-02-007  
LOCATION - Texas  
VEHICLE - 2001 FORD CROWN VICTORIA  
CRASH DATE - September 2002

Submitted:  
August 8, 2003  
Revised:  
February 24, 2004

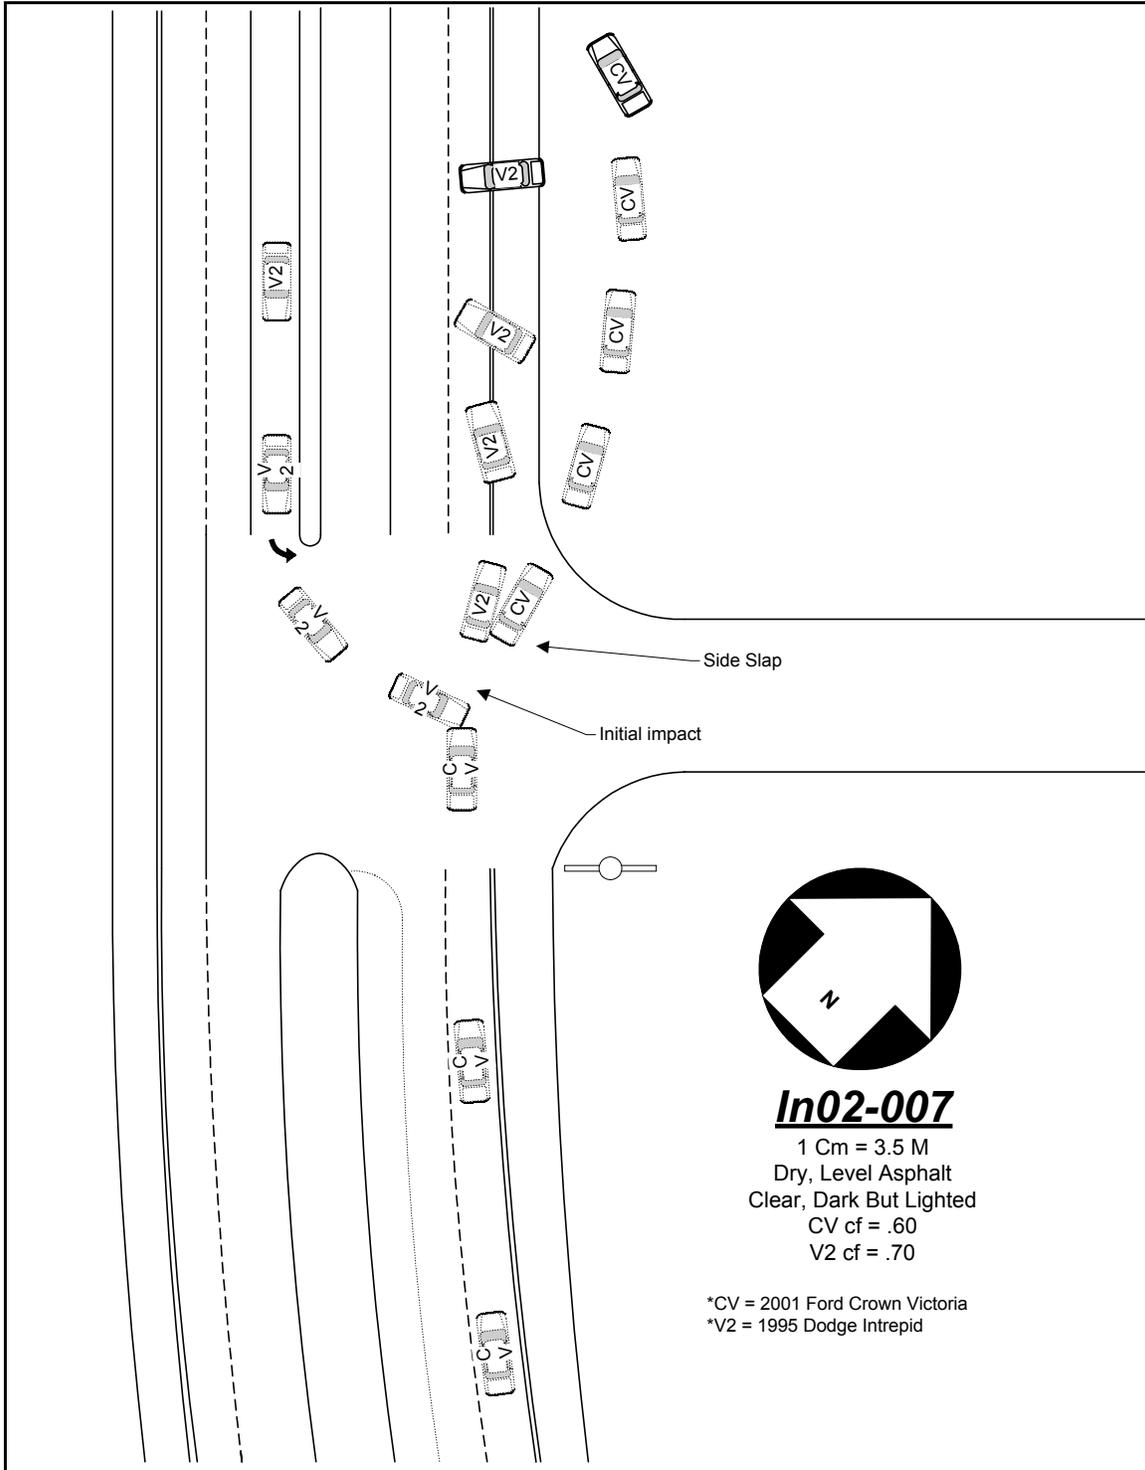
The Dodge also sustained direct contact on its right rear quarter panel from the side slap impact (event #2) with the case vehicle. Because of its high speed and configuration at the first impact, the case vehicle's rear wheels were probably raised up off the ground as the two vehicles pivoted into each other. As a result of the case vehicle being elevated, direct damage on the Dodge was restricted to the upper portion of the quarter panel and trunk lid (**Figure 9**). The CDC for the side slap impact was determined to be **03-RBMW-3 (90)**. The WinSMASH reconstruction for the Dodge's second impact indicated Total, Longitudinal and Lateral Delta-V's, respectively: 10.0 km.p.h. [6.2 m.p.h.], 0 km.p.h. [0 m.p.h.] and -10 km.p.h. [-6.2 m.p.h.].

**Figure 9:** Dodge Intrepid's right rear damage from side slap impact; note, no contact at bumper level (case photo #69)
