**TRANSPORTATION SCIENCES
CRASH DATA RESEARCH CENTER**

SCI TECHNICAL SUMMARY REPORT

NASS/SCI COMBO CASE NO. 03-12-136G

VEHICLE – 2003 CHEVROLET SILVERADO

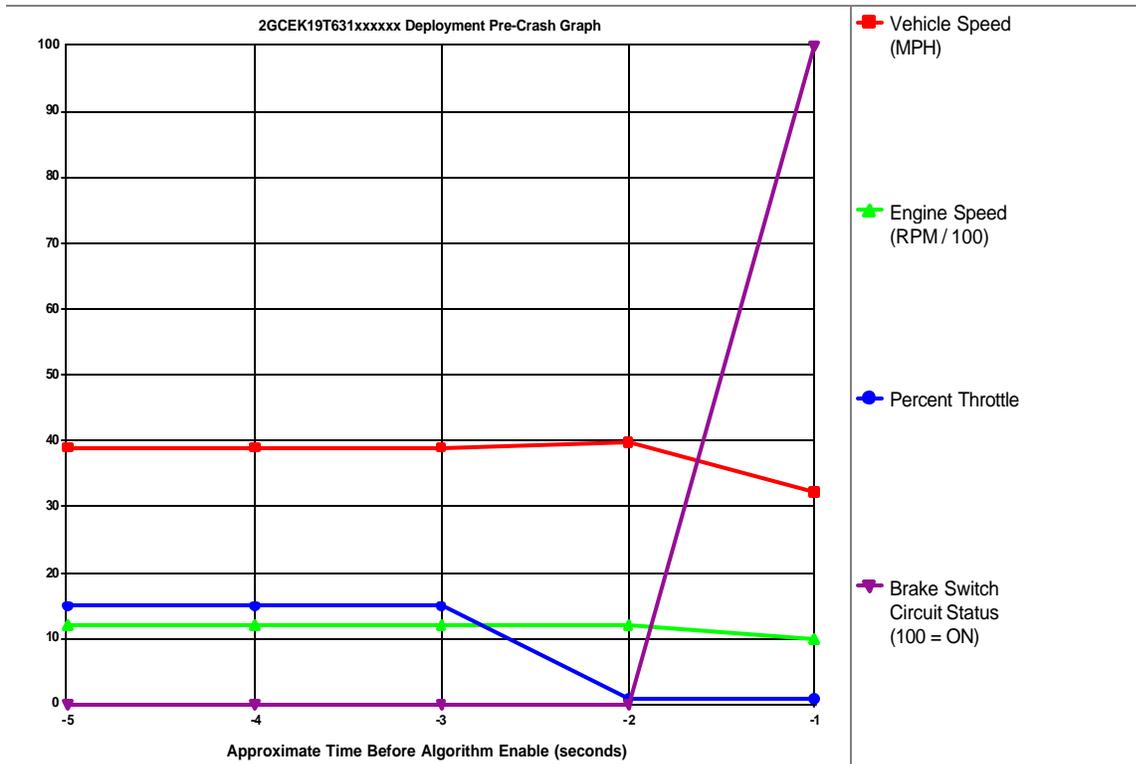
SIR Warning Lamp Status	OFF
Driver's Belt Switch Circuit Status	BUCKLED
Ignition Cycles At Deployment	110
Ignition Cycles At Investigation	113
Maximum SDM Recorded Velocity Change (MPH)	-11.83
Algorithm Enable to Maximum SDM Recorded Velocity Change (msec)	170
Driver First Stage Time Algorithm Enabled to Deployment Command Criteria Met (msec)	20
Driver Second Stage Time Algorithm Enabled to Deployment Command Criteria Met (msec)	N/A
Passenger First Stage Time Algorithm Enabled to Deployment Command Criteria Met (msec)	N/A
Passenger Second Stage Time Algorithm Enabled to Deployment Command Criteria Met (msec)	N/A
Time Between Non-Deployment And Deployment Events (sec)	N/A
Frontal Deployment Level Event Counter	1
Event Recording Complete	Yes
Multiple Events Associated With This Record	No
One Or More Associated Events Not Recorded	No

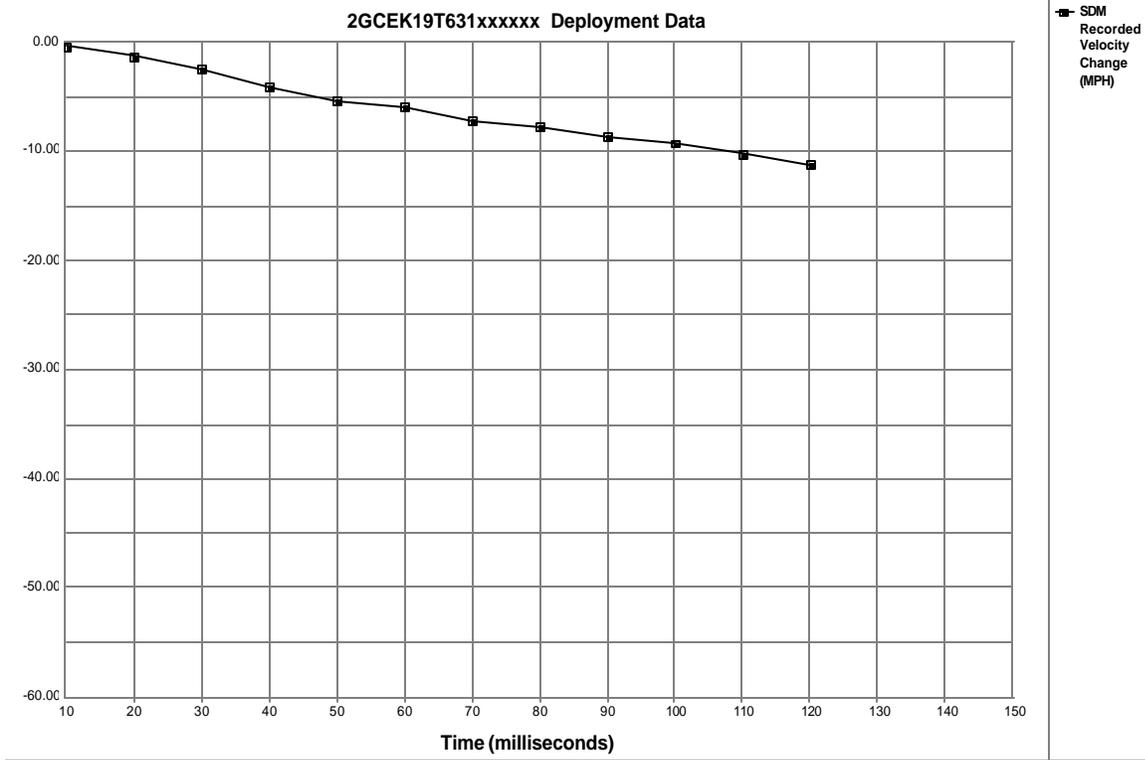
Seconds Before AE	Vehicle Speed (MPH)	Engine Speed (RPM)	Percent Throttle	Brake Switch Circuit Status
-5	39	1152	15	OFF
-4	39	1152	15	OFF
-3	39	1152	15	OFF
-2	40	1152	1	OFF
-1	32	960	1	ON

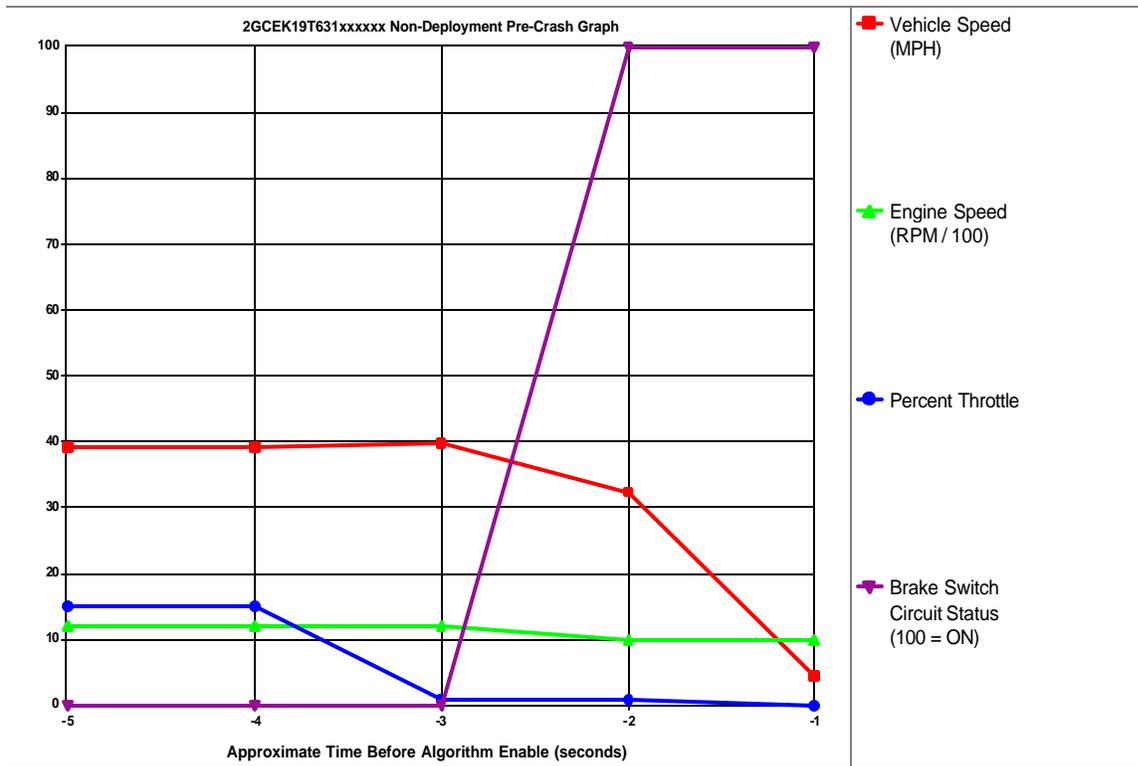
SIR Warning Lamp Status	OFF
Driver's Belt Switch Circuit Status	BUCKLED
Ignition Cycles At Non-Deployment	110
Ignition Cycles At Investigation	113
Maximum SDM Recorded Velocity Change (MPH)	0.00
Algorithm Enable to Maximum SDM Recorded Velocity Change (msec)	175
Event Recording Complete	Yes
Multiple Events Associated With This Record	No
One Or More Associated Events Not Recorded	No

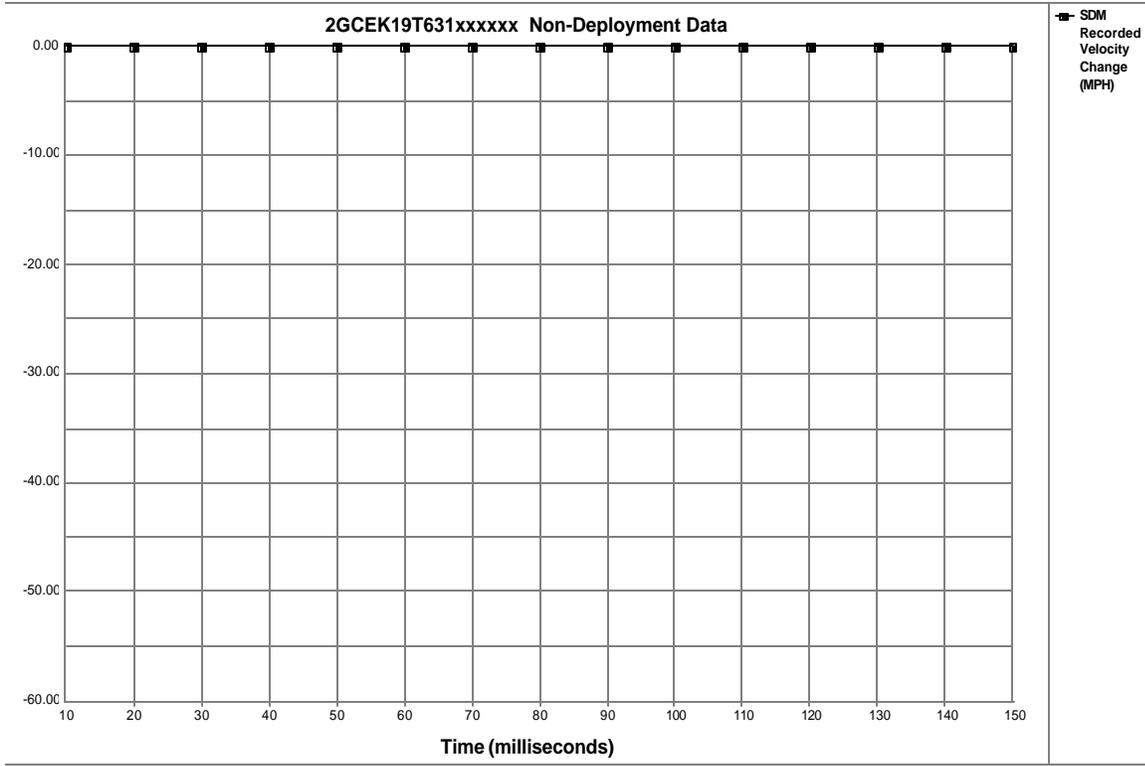
Seconds Before AE	Vehicle Speed (MPH)	Engine Speed (RPM)	Percent Throttle	Brake Switch Circuit Status
-5	39	1152	15	OFF
-4	39	1152	15	OFF
-3	40	1152	1	OFF
-2	32	960	1	ON
-1	4	1024	0	ON
