**GENERAL DYNAMICS ON-SITE CHILD SAFETY SEAT CRASH INVESTIGATION  
SCI TECHNICAL SUMMARY REPORT**

**CASE NO. CA03-007**

**VEHICLES – 1993 DODGE CARAVAN / 1997 FORD F-150 PICKUP TRUCK**

**CRASH DATE – JANUARY 2003**

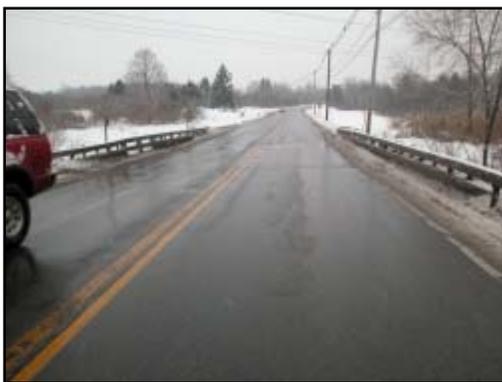
**Figure 2. Southbound approach for the Dodge Caravan**

The 37-year-old female driver was operating the 1993 Dodge Caravan southbound on the two-lane roadway, exiting a left curve into the straight segment of the roadway (**Figure 2**). Witnesses stated that the Caravan was traveling somewhat erratically, and described the pre-crash movement as “fishtailing.” Two non-contact vehicles were stopped in the southbound lane approximately 20 m (66’) south of the point of impact waiting to make left turns into a driveway. As the Caravan entered the sag portion of the roadway, it crossed the centerline in a rapid CCW yaw. It was not known if the driver relinquished control or steered left intentionally. It was possible that she was distracted by the children in the bench seat. The 32-year-old driver of the Ford F-150 was operating the vehicle in a northbound direction on approach to the roadway sag (**Figure 3**). The driver stated that when she detected the Caravan encroaching into the northbound lane she applied the brakes but could not avoid the collision. Police documented a tire mark on the northbound travel lane; however, at the time of the scene inspection, there was no physical evidence present.

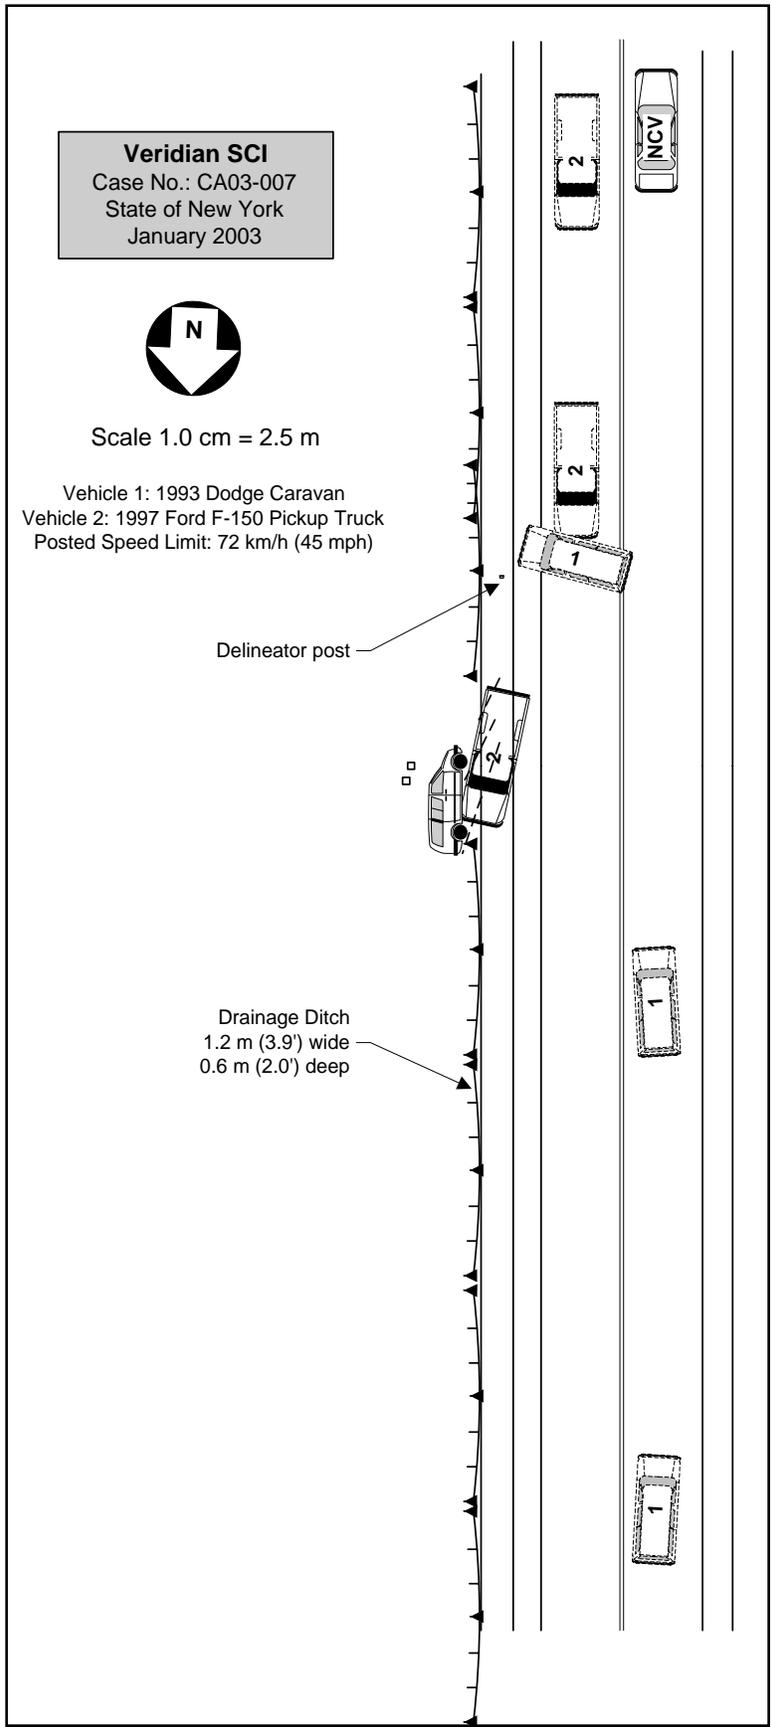
Figure 28. Scene schematic

The roadway was configured with one travel lane in each direction separated by a double-yellow centerline. The crash occurred on a straight segment of the roadway between two opposing curves. A sag was present between the curves and the roadway had an approximate 2 percent positive northbound grade at the crash site. The travel lanes were bordered by asphalt shoulders that measured 1.3m (4.3') in width. A drainage ditch that measured 1.2 m (3.9') in width and 0.6 m (2.0') in depth was located 2.6 m (8.5') from the east roadside and was parallel with the roadway. The roadside environment consisted of snow-covered grassy areas. The posted speed limit for the roadway was 72 km/h (45 mph). There was no traffic control present at the crash site. The scene schematic is included as **Figure 28** at the end of this report.
