INDIANA UNIVERSITY

TRANSPORTATION RESEARCH CENTER

ON-SITE CHILD SAFETY SEAT INVESTIGATION

CASE NUMBER - IN-03-009
LOCATION - MARYLAND
VEHICLE - 2003 FORD EXPLORER EDDIE BAUER
CRASH DATE - January 2003

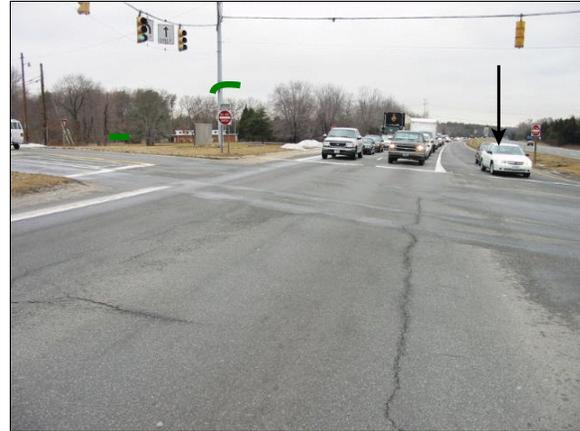
Crash Environment: The trafficway on which both vehicles had been traveling was a five-lane, divided, state highway, traversing in a north-northwesterly and south-southeasterly direction, and both the case vehicle and the Chevrolet were approaching a four-leg intersection (**Figures 1 and 2**). Both the northern (**Figure 1**) and southern (**Figure 2**) roadways were gently curved and had two through lanes and one left-hand turn lane; the northern roadway curved to the right and the southern roadway to the left. Furthermore, and not counted among the lanes, each roadway had a channelized right-hand turn lane (e.g., **Figure 2**). The state highway was curved slightly to the left for southern traffic and level at the area of impact. The pavement was bituminous, but traveled. For the case vehicle's northern roadway the width of the left-hand turn lane for the was 3.4 meters (11.2 feet), the width of the inside northern through lane was 3.4 meters (11.2 feet) and the outside northern through lane was 3.5 meters (11.5 feet). Furthermore, for the Chevrolet's southern roadway, the width of the three travel lanes were: 5.5 meters (18.0 feet) for the left-hand turn lane, and 3.6 meters (11.8 feet) for both the inside and outside through lanes. The shoulders were generally improved (i.e., bituminous). The eastern side of the northern roadway had a 3.4 meter (11.2 foot) paved shoulder and the western side had an minimal dirt shoulder as a part of the 11.8 meter (38.7 feet) wide unprotected grassy median. The western side of the southern roadway had a 2.9 meter (9.5 foot) paved shoulder and the eastern side had an minimal dirt shoulder as a part of the 9.1 meter (29.9 feet) wide unprotected grassy median. The trafficway was not bordered by curbs. Pavement markings for the northern roadway consisted of a solid yellow edge line on the western (left-hand, median) side and a solid white edge line on eastern (right-hand) side. In addition, the through lanes were divided by a dashed white line and the left-hand turn lane was separated from the through lanes by a solid white lane line. Likewise, the pavement markings for the southern roadway consisted of a solid yellow edge line on the eastern (left-hand, median) side and a solid white edge line on western (right-hand) side. Furthermore, the through lanes were divided by a

Figure 1: South-southeasterly view of case vehicle's north-northwesterly travel path (arrow) in left-hand turn lane (case photo #06)

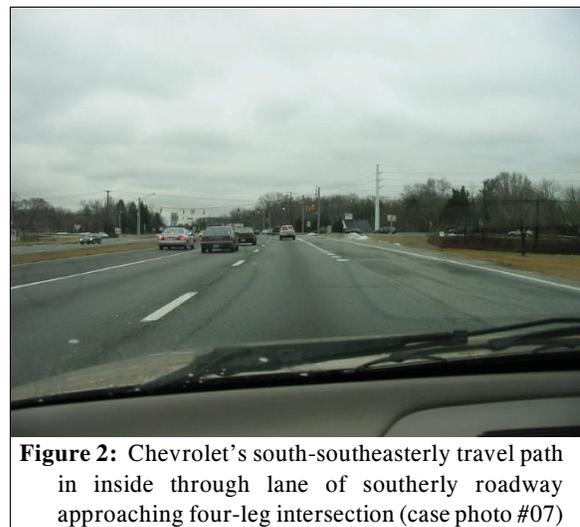
Figure 2: Chevrolet's south-southeasterly travel path in inside through lane of southerly roadway approaching four-leg intersection (case photo #07)

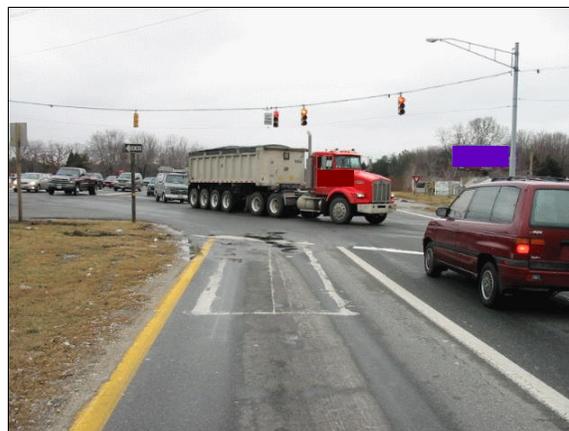
Pre-Crash: The case vehicle had been traveling north-northwestward in the left-hand turn lane (Figure 3) of the northern roadway on the southern leg of the four-leg intersection and had nearly completed making a left-hand turn, intending to travel in a westerly direction on the intersecting trafficway. The Chevrolet was traveling south-southeastward in the outside through lane of the southern roadway on the northern leg of the same intersection and intended to continue straight ahead (Figure 4). According to the case vehicle's driver, she steered to the left, attempting to avoid the crash. The crash occurred in the outside through lane of the southern roadway, within the four-leg intersection of the two trafficways.

Figure 3: North-northwestward travel path of case vehicle's driver in left-hand turn lane (case photo #01)

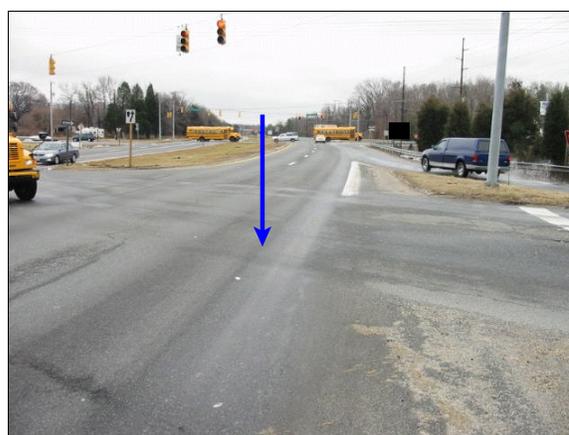
Figure 4: Chevrolet's south-southeastward travel path into four-leg intersection, viewed along edge line of southerly roadway's outside through lane; Note: arrow indicates approximate point of impact (case photo #12)

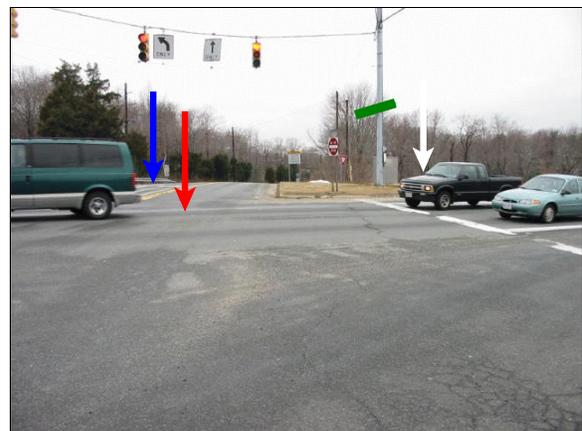
Post-Crash: The Chevrolet's impact with the case vehicle caused the case vehicle to roll about its longitudinal axis, landing on its left side (**Figure 7**) as the case vehicle continued in its westerly travel path. The case vehicle continued to roll, one more quarter turn, landing on its top, across the centerline in the easterly lane, heading in a westerly direction (**Figure 8**).

Figure 8: Westward view of crash scene showing approximate point of impact (red arrow), case vehicle's approximate final rest position on roof (blue arrow), and Chevrolet's (white arrow) converging trajectory (case photo #04)

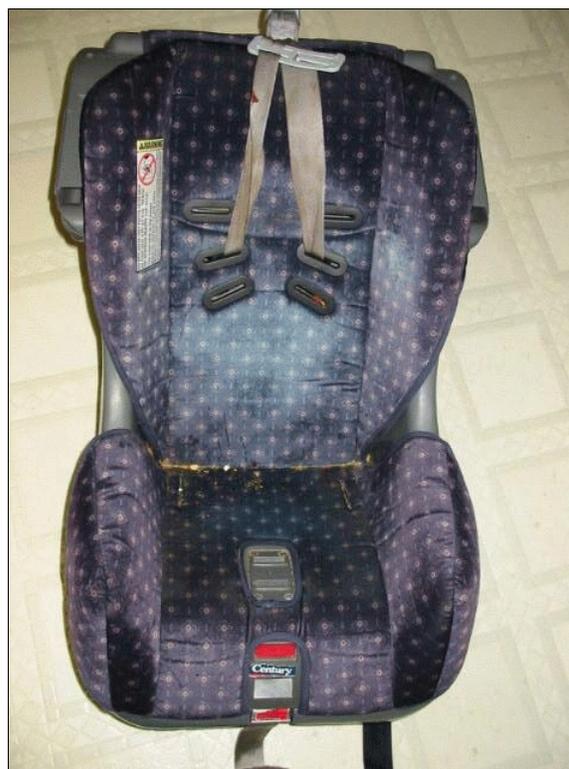
The second seat center passenger was seated in a convertible child safety seat that was used in its forward facing configuration (**Figure 19**). The child safety seat was manufactured by Century but the label containing the date of manufacture was missing. The child seat was identified by Model name "3000 STE" and Model number 44331BEN. The convertible seat was designed with a pullover tray-shield which attached between the child's legs into a recessed buckle. The seat had a top tether (**Figures 20** and **21** below) which was not in use, and there were three sets of slots to thread the harness through. The harness belts were threaded through the middle slots, which according to the manufacturer's instructions should only be used when the seat is in the rear facing configuration. The child seat was used in the forward facing configuration, in the upright position.

Figure 19: Century convertible child safety seat used in forward facing configuration by case vehicle's second seat center passenger (case photo #62)

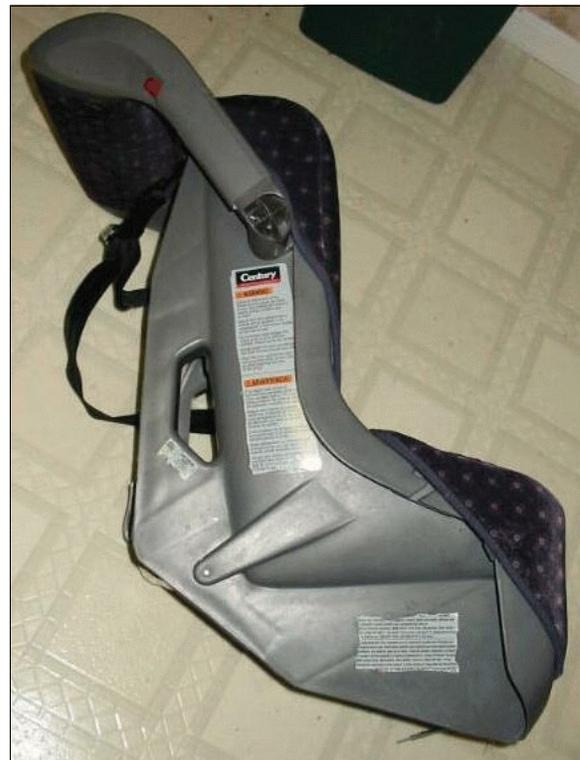
A close inspection of the child safety seat revealed no apparent damage or fractures to the base, shell, or shield (**Figure 20**). In addition, no damage or fractures were noted along the seat's path for the vehicle's safety belt (**Figure 21**). There was a manufacturer's label affixed to the left side (i.e., inboard side when used in the forward facing configuration) giving the child seat's weight limitations [i.e., up to 9-10 kilograms (20-22 pounds) for rear facing and 9-18 kilograms (20-40 pounds) for forward facing].

Figure 21: Case vehicle's Century convertible child safety seat laid on its left side in forward facing configuration showing tray shield, top tether, and warning labels (case photo #65)

Another manufacturer's label was affixed to the right side (i.e., outboard side when used in the forward facing configuration) of the child safety seat which explained the importance of securing the child restraint with a vehicle's safety belt as specified in the vehicle manufacturer's instructions (**Figure 21** above). The manufacturer's instructions for this child safety seat were not available on the back of the seat at the time of this contractor's inspection.

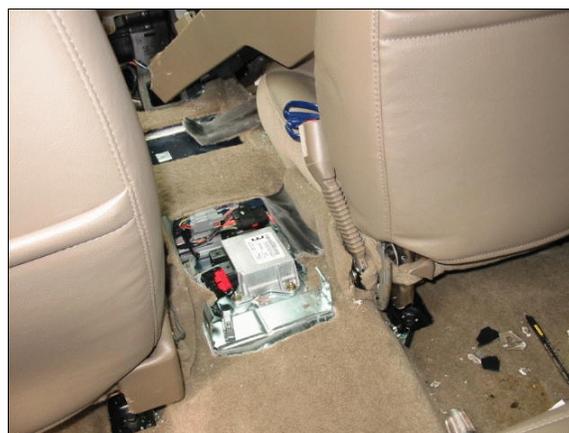
Permission was obtained to download the data from the Restraints Control Module, which houses the **EDR** technology. The RCM was located underneath the center console's carpeting (**Figure 22**). The download was attempted by this contractor's sponsor. Unfortunately, the data was either not able to be downloaded, or there was no data available from the **RCM**.

Figure 22: Case vehicle's Restraints Control Module which was located under the floor, below the center console, and between the front bucket seats—viewed from second seating area (case photo #48)
