Certified Advanced 208 Compliant Investigation / Vehicle to Object
Dynamic Science, Inc. / Case Number: DS03020
2003 GMC Yukon K1500
Texas
April, 2003

Dynamic Science, Inc.
Crash Investigation
Case Number: DS03020

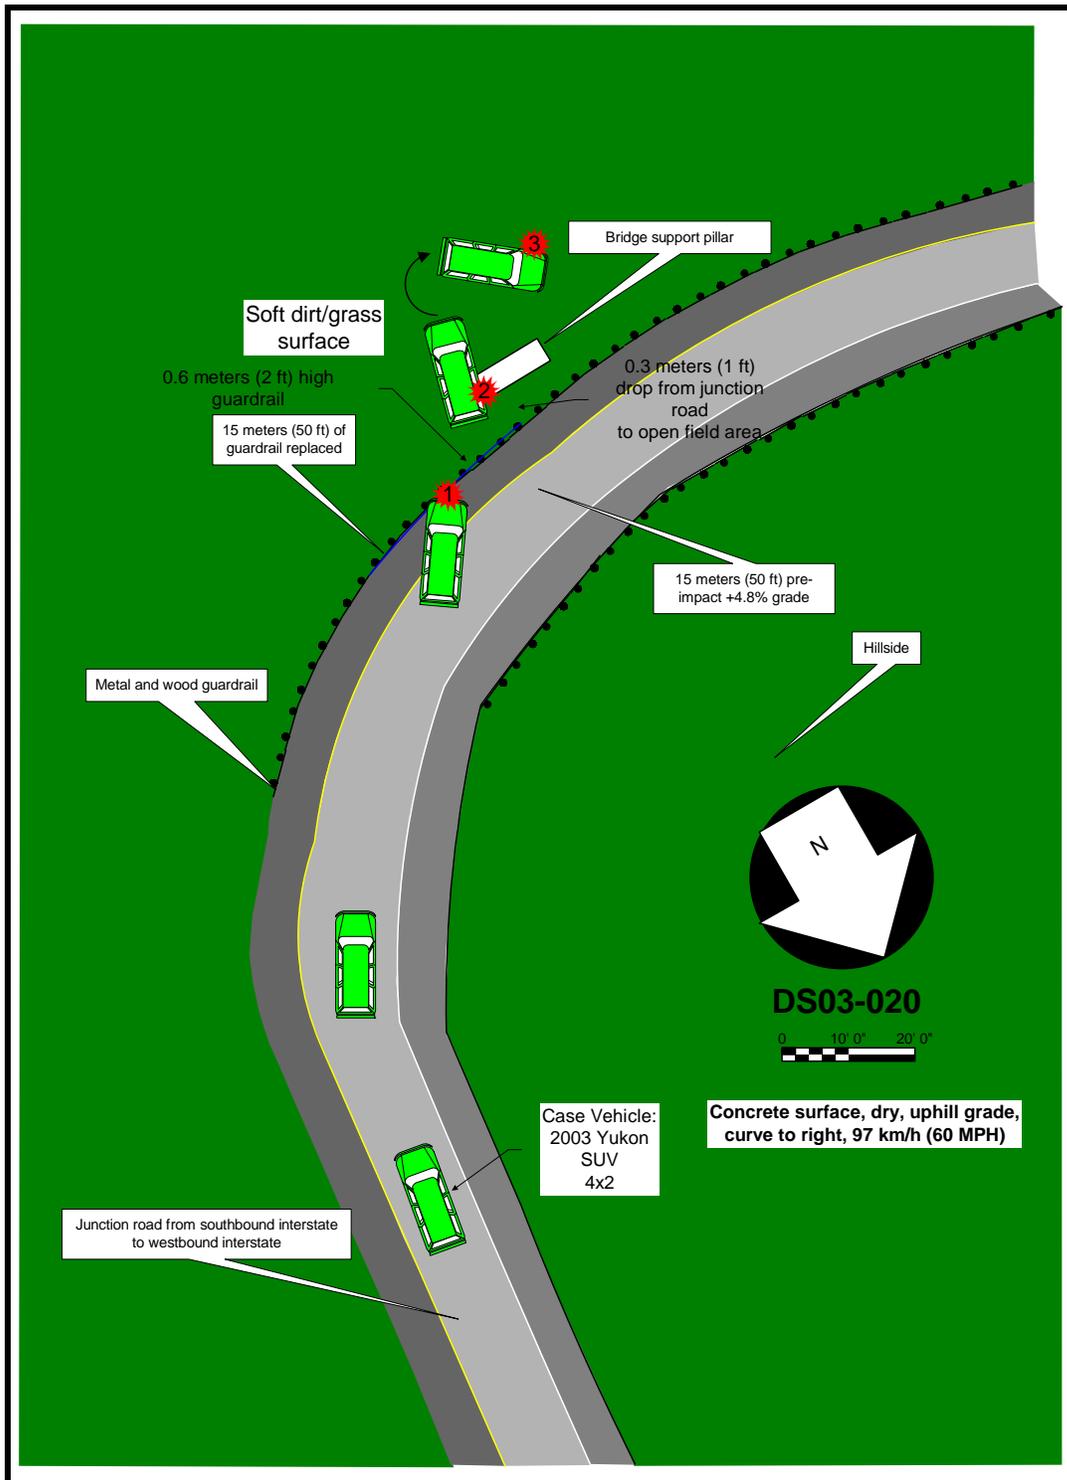
Attachment 1. Scene Diagram

The case vehicle crashed into the metal/wood guardrail (approximately 15.0 meters [50.0 ft] of the guardrail was newly replaced) on the left shoulder area with its lower front end and undercarriage areas (12FDLW1). The total velocity change for the case vehicle as calculated by the Barrier algorithm of the WinSmash collision model was 13.0 km/h (8.1 mph)¹. The longitudinal and lateral delta V components were -13.0 km/h (-8.1 mph) and 0 km/h (0 mph), respectively. This is a borderline reconstruction given the yielding object-guardrail.

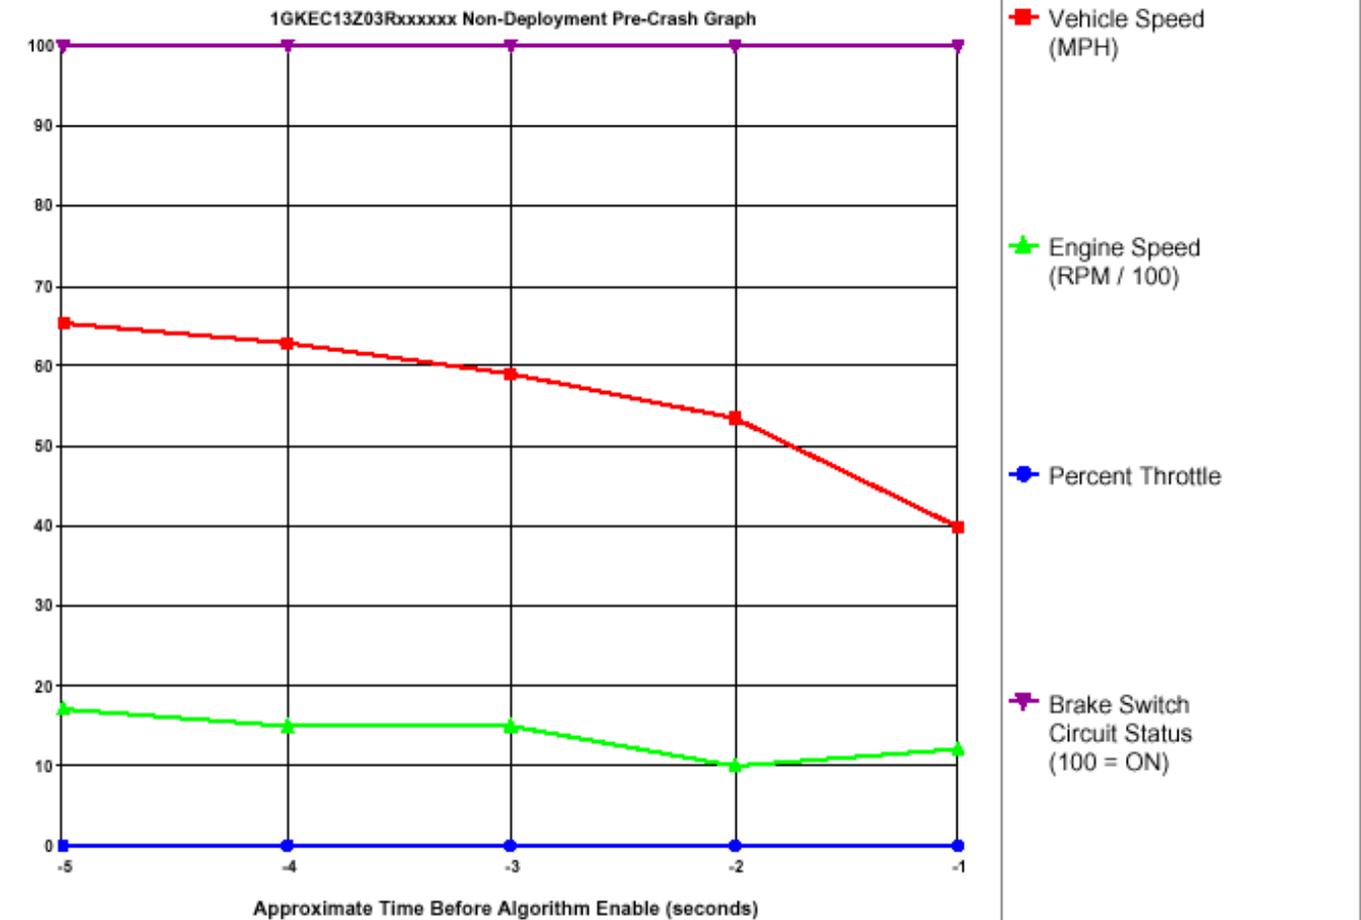
| Seconds Before AE | Vehicle Speed (MPH) | Engine Speed (RPM) | Percent Throttle | Brake Switch Circuit Status |
| -5 | 65 | 1728 | 0 | ON |
| -4 | 63 | 1472 | 0 | ON |
| -3 | 59 | 1472 | 0 | ON |
| -2 | 53 | 1024 | 0 | ON |
| -1 | 40 | 1216 | 0 | ON |

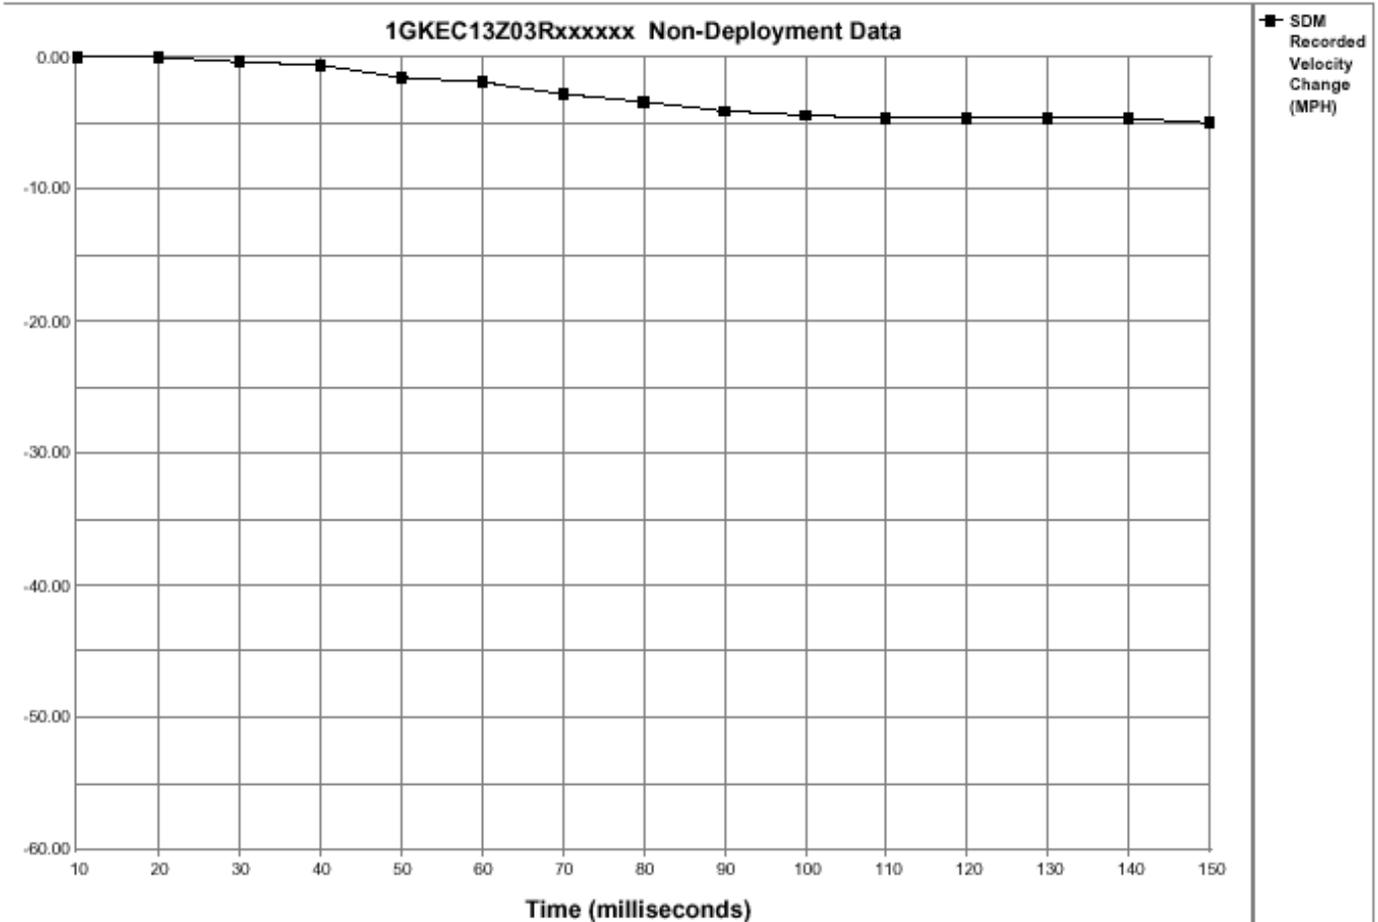
| Time (milliseconds) | 10 | 20 | 30 | 40 | 50 | 60 | 70 | 80 | 90 | 100 | 110 | 120 | 130 | 140 | 150 |
| Recorded Velocity Change (MPH) | 0.00 | 0.00 | -0.31 | -0.62 | -1.55 | -1.86 | -2.79 | -3.41 | -4.03 | -4.34 | -4.65 | -4.65 | -4.65 | -4.65 | -4.96 |
