Certified Advanced 208 Compliant Investigation/ Vehicle to Vehicle  
Dynamic Science, Inc. / Case Number: DS03021  
2003 Chevrolet Silverado pickup  
Texas  
May, 2003

| 4. Title and Subtitle<br><br>On Site Certified Advanced 208 Compliant Investigation | | 5. Report Date<br>March 7, 2006 | |

**Dynamic Science, Inc.  
Crash Investigation  
Case Number:DS03021**

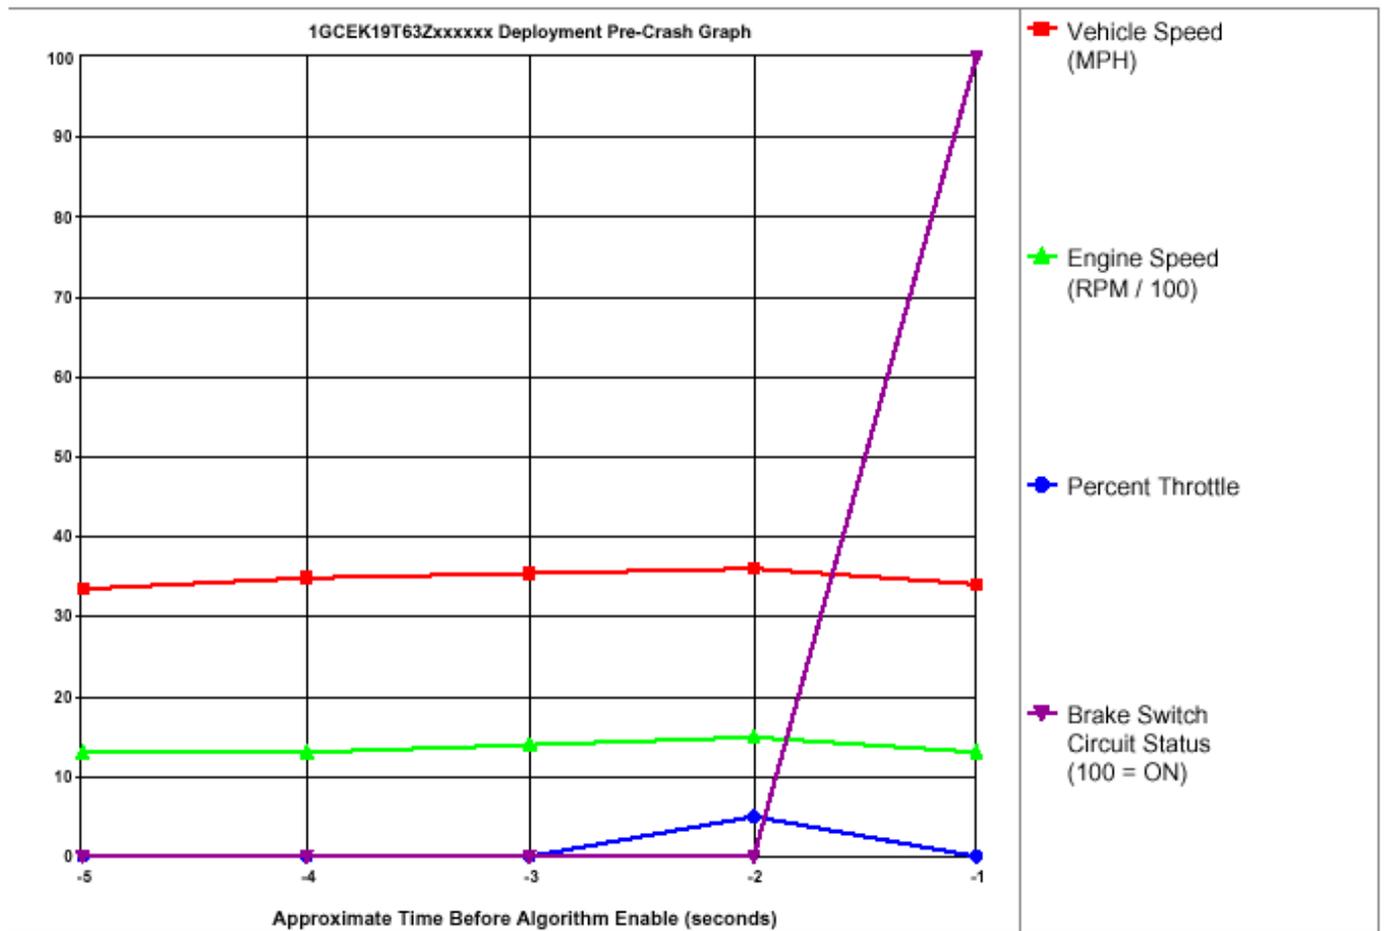
| Seconds Before AE | Vehicle Speed (MPH) | Engine Speed (RPM) | Percent Throttle | Brake Switch Circuit Status |
| -5 | 34 | 1344 | 0 | OFF |
| -4 | 35 | 1344 | 0 | OFF |
| -3 | 35 | 1408 | 0 | OFF |
| -2 | 36 | 1472 | 5 | OFF |
| -1 | 34 | 1344 | 0 | ON |

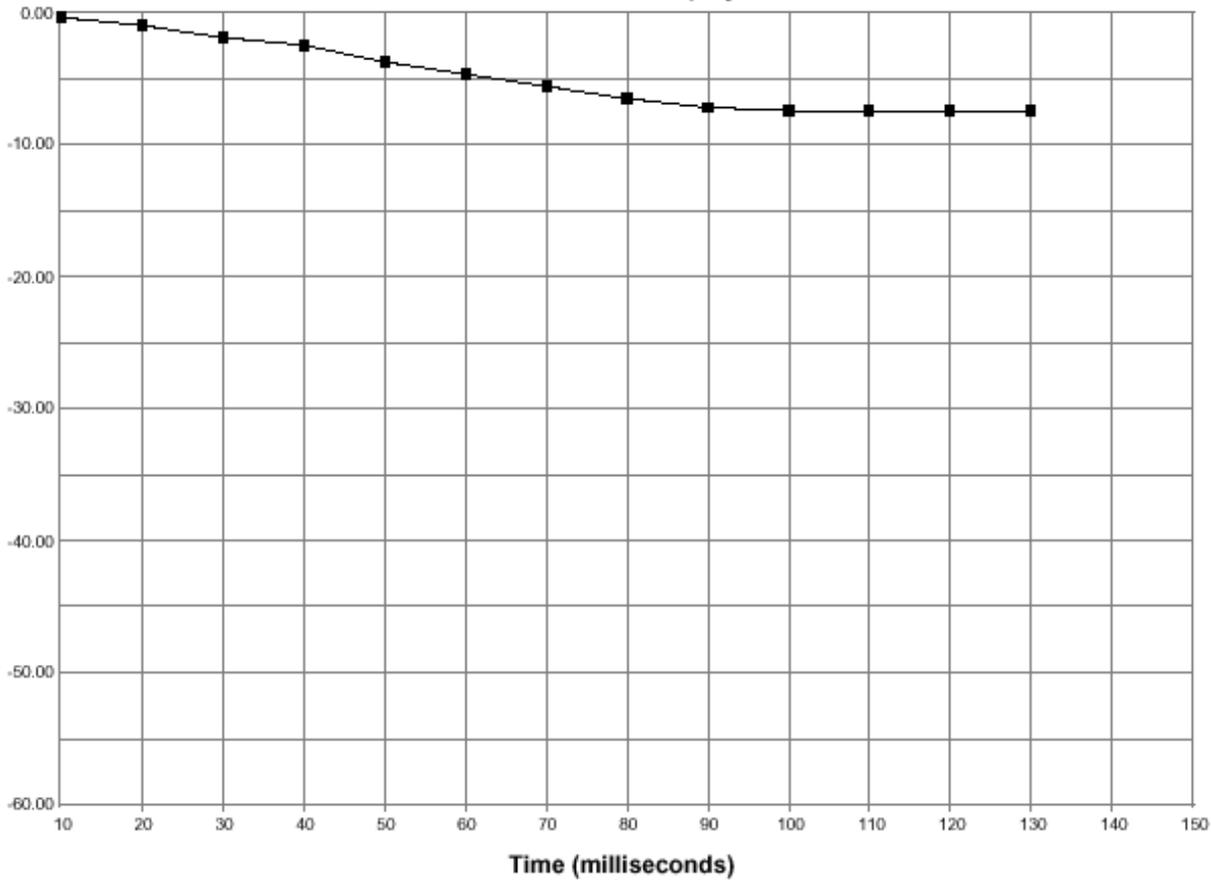
1GCEK19T63Zxxxxxx Deployment Data

■ SDM  
Recorded  
Velocity  
Change  
(MPH)

| Time (milliseconds) | 10 | 20 | 30 | 40 | 50 | 60 | 70 | 80 | 90 | 100 | 110 | 120 | 130 | 140 | 150 |
| Recorded Velocity Change (MPH) | -0.31 | -0.93 | -1.86 | -2.48 | -3.72 | -4.65 | -5.58 | -6.51 | -7.13 | -7.44 | -7.44 | -7.44 | -7.44 | N/A | N/A |

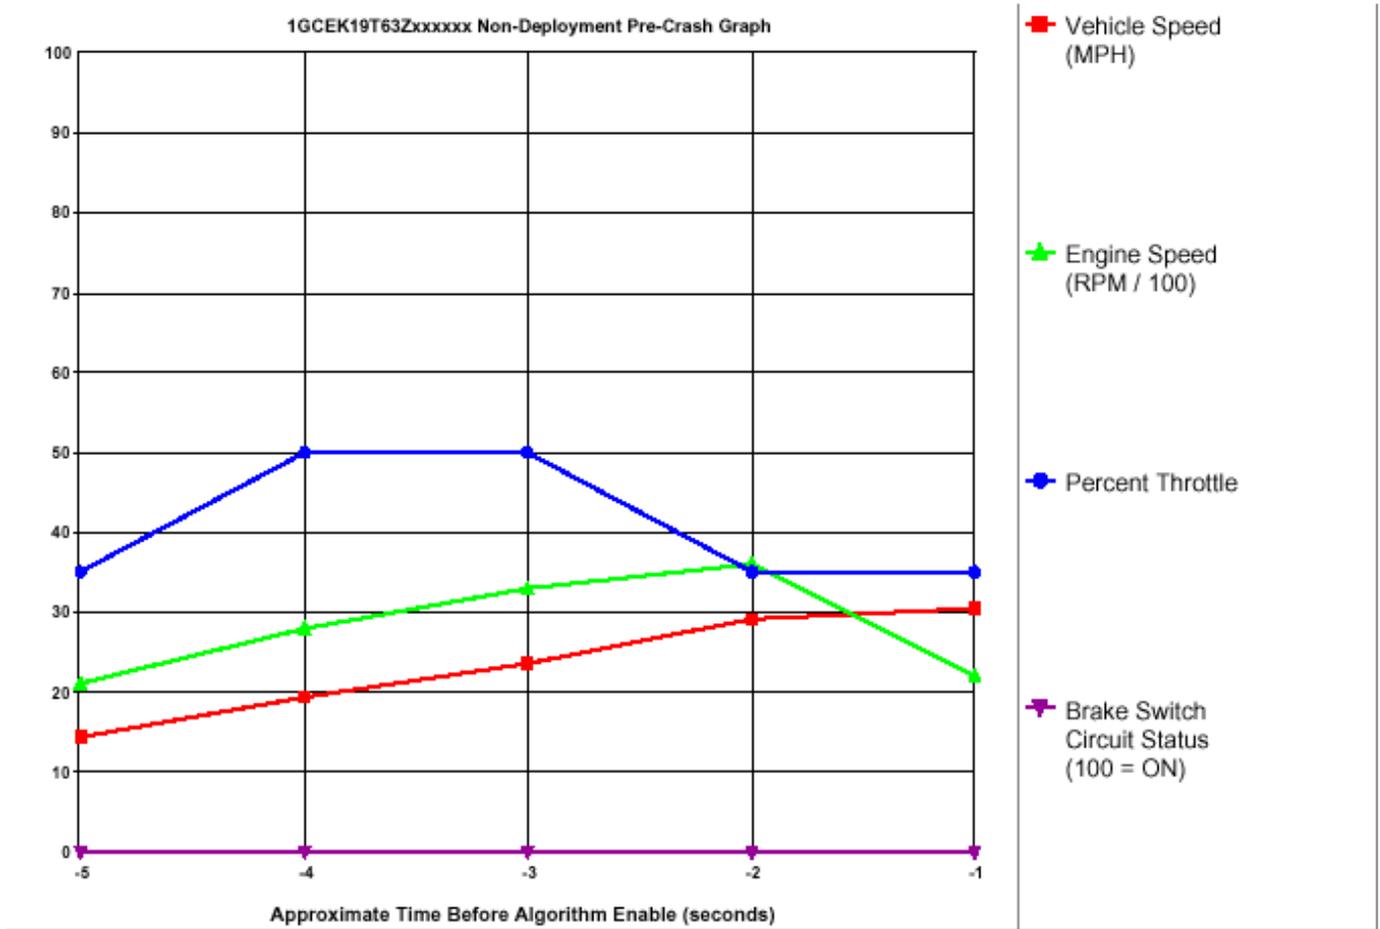
| Seconds Before AE | Vehicle Speed (MPH) | Engine Speed (RPM) | Percent Throttle | Brake Switch Circuit Status |
| -5 | 14 | 2112 | 35 | OFF |
| -4 | 19 | 2752 | 50 | OFF |
| -3 | 24 | 3328 | 50 | OFF |
| -2 | 29 | 3584 | 35 | OFF |
| -1 | 30 | 2240 | 35 | OFF |

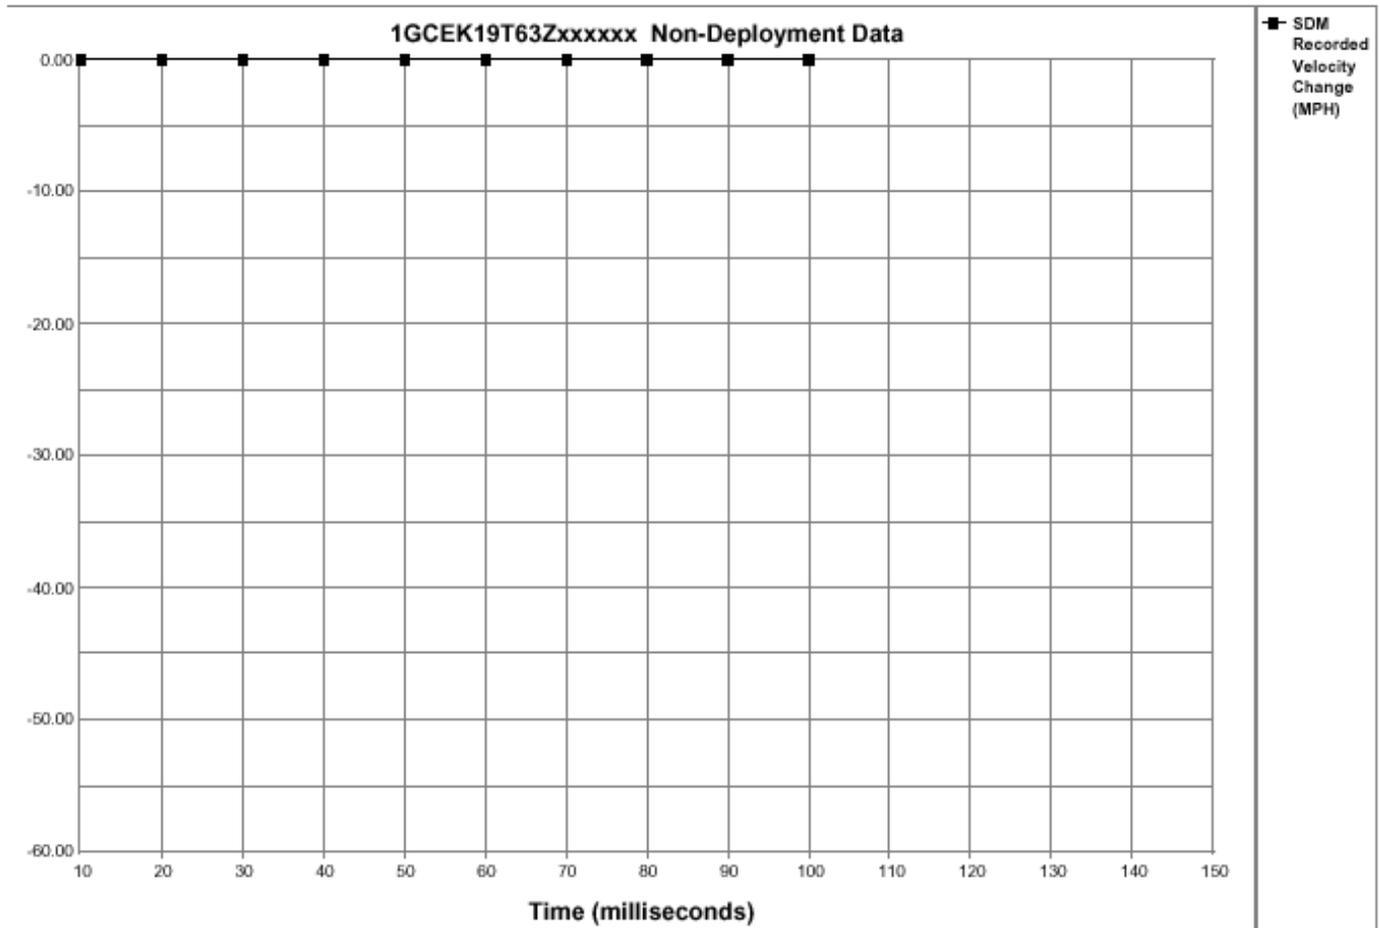
| Time (milliseconds) | 10 | 20 | 30 | 40 | 50 | 60 | 70 | 80 | 90 | 100 | 110 | 120 | 130 | 140 | 150 |
| Recorded Velocity Change (MPH) | 0.00 | 0.00 | 0.00 | 0.00 | 0.00 | 0.00 | 0.00 | 0.00 | 0.00 | 0.00 | N/A | N/A | N/A | N/A | N/A |
