**GENERAL DYNAMICS ON-SITE CHILD SAFETY SEAT INVESTIGATION
SCI TECHNICAL SUMMARY REPORT**

CASE NO. CA03-036

VEHICLE – 1994 DODGE GRAND CARAVAN

CRASH DATE – JUNE 2003

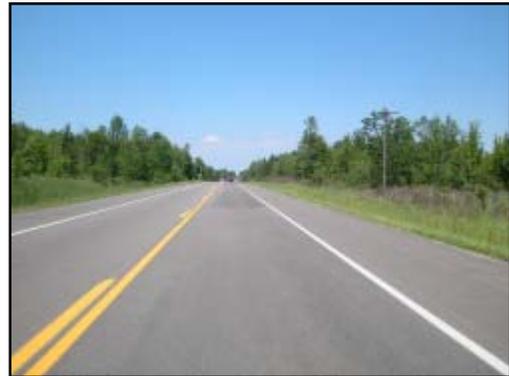
The 62-year-old male driver of the Dodge Grand Caravan was operating the vehicle eastbound on the two-lane roadway (**Figure 2**). A 19-year-old female driver was operating the Pontiac 6000 westbound on the same roadway (**Figure 3**). The driver of the Pontiac 6000 drifted over the centerline in a tracking mode into the path of the oncoming Grand Caravan. The cause of the 19-year-old driver's inattention was not known. The driver of the Grand Caravan detected the Pontiac encroaching into the eastbound lane and attempted to avoid the collision by steering right onto the asphalt shoulder. The Pontiac continued across the eastbound lane onto the asphalt shoulder into the path of the Grand Caravan. Based on the damage patterns and post-impact trajectories, it appeared that one or both of the drivers attempted to steer back onto the roadway prior to the impact, however, this could not be confirmed.

Figure 2. Eastbound approach for the Grand Caravan

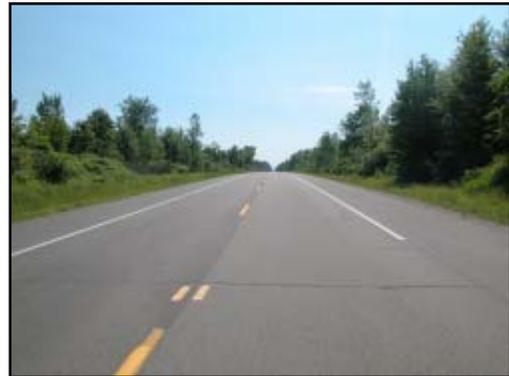
Figure 3. Westbound approach for the Pontiac 6000

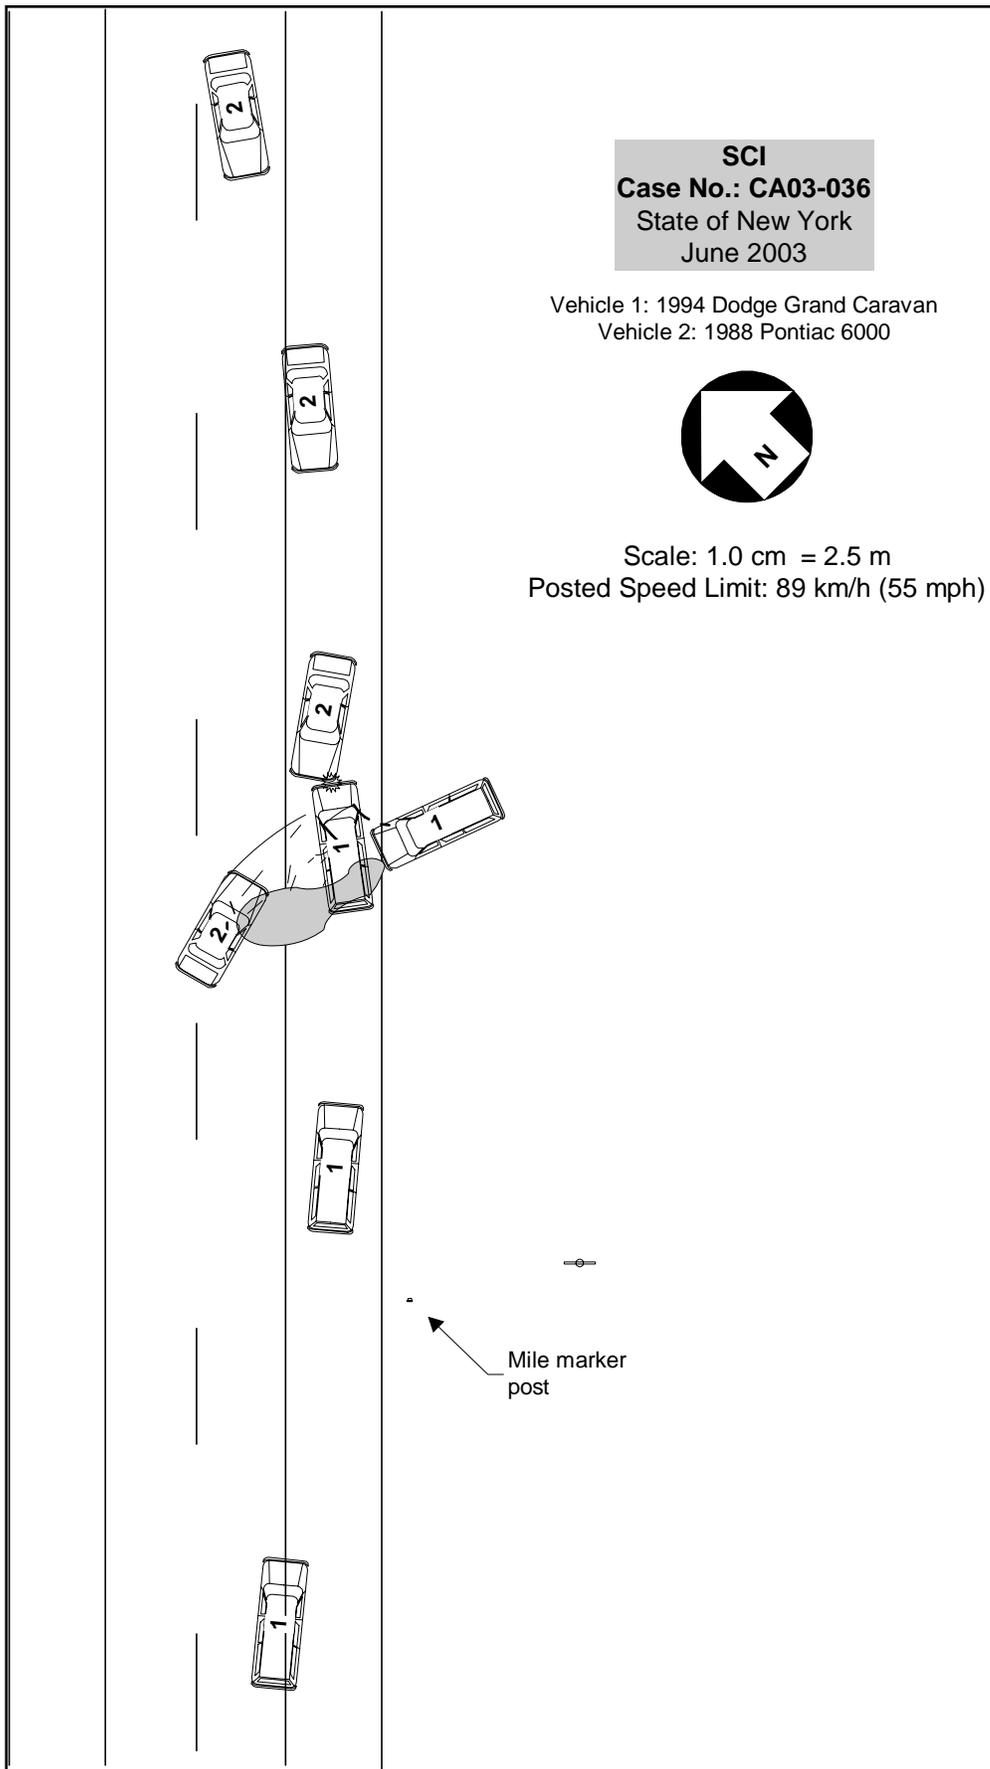
Figure 18. Scene schematic

This two-vehicle crash occurred during the daylight hours of June 2003 in the state of New York. At the time of the crash, the weather was clear and the asphalt roadway surface was dry. The crash occurred on a two-lane east/west state roadway. The roadway was configured with one travel lane in each direction separated by a broken yellow centerline, and bordered by asphalt shoulders. The roadway exhibited a slight positive westbound grade at the crash site and a hillcrest was located 70.6 m (231.6’) west of the crash site. The roadside environment consisted of wooded areas and grassy drainage ditches. The posted speed limit was 89 km/h (55 mph). The scene schematic is included as **Figure 18** of this report.
