**GENERAL DYNAMICS ON-SITE ADVANCED OCCUPANT PROTECTION SYSTEM
(AOPS) INVESTIGATION
SCI TECHNICAL SUMMARY REPORT**

CASE NO. CA03-039

VEHICLE – 2001 HYUNDAI ELANTRA

CRASH DATE – JULY 2003

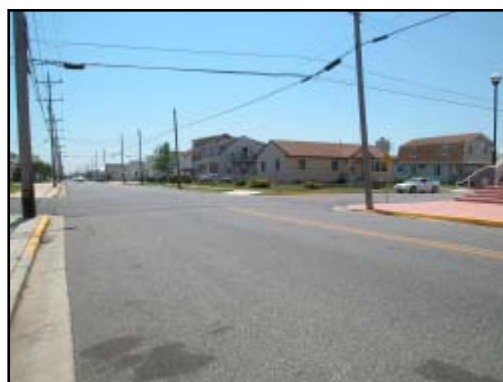
This two-vehicle crash occurred during the daylight hours of July 2003 in the state of New Jersey. At the time of the crash, the weather was clear and the asphalt roadway surface was dry. The crash occurred at a four-leg intersection of a two-lane arterial roadway and a two-lane local roadway (**Figure 2**). The north/south arterial roadway was configured with one travel lane in each direction separated by a double-yellow centerline

Figure 2. Overall view of the intersection - lookback view from the location of the parked Blazer

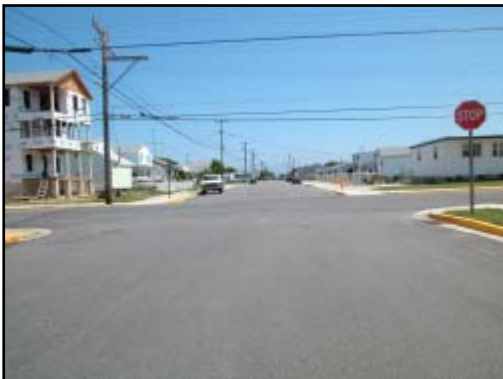
The 18-year-old female driver of the Elantra was operating the vehicle in an eastbound direction on the two-lane roadway on approach to the four-leg intersection (**Figure 3**). The driver brought the Elantra to a controlled stop at the stop sign with the intent to initiate a left turn onto the northbound travel lane. The police reported that as the Elantra proceeded into the intersection (**Figure 4**), the female driver detected a non-contact vehicle approaching at a high rate of speed in the northbound lane. She stated to police that the driver of the northbound vehicle sounded the horn as the Elantra was in the intersection. The driver of the Elantra steered right toward the curb in an attempt to clear the travel lane as the non-contact vehicle approached. She did not detect the 1993 Chevrolet S-10 Blazer that was parked parallel to the right curb of the northbound lane.

Figure 3. Eastbound approach to the intersection for the Elantra

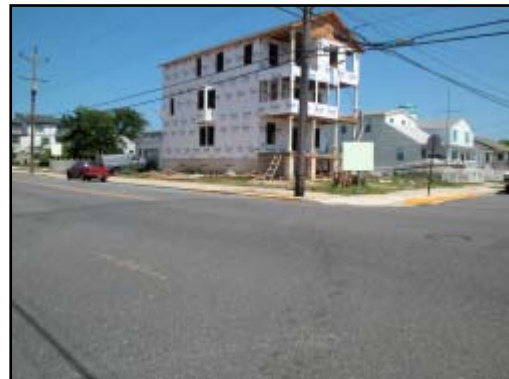
Figure 4. Approach view for the Elantra as it entered the intersection

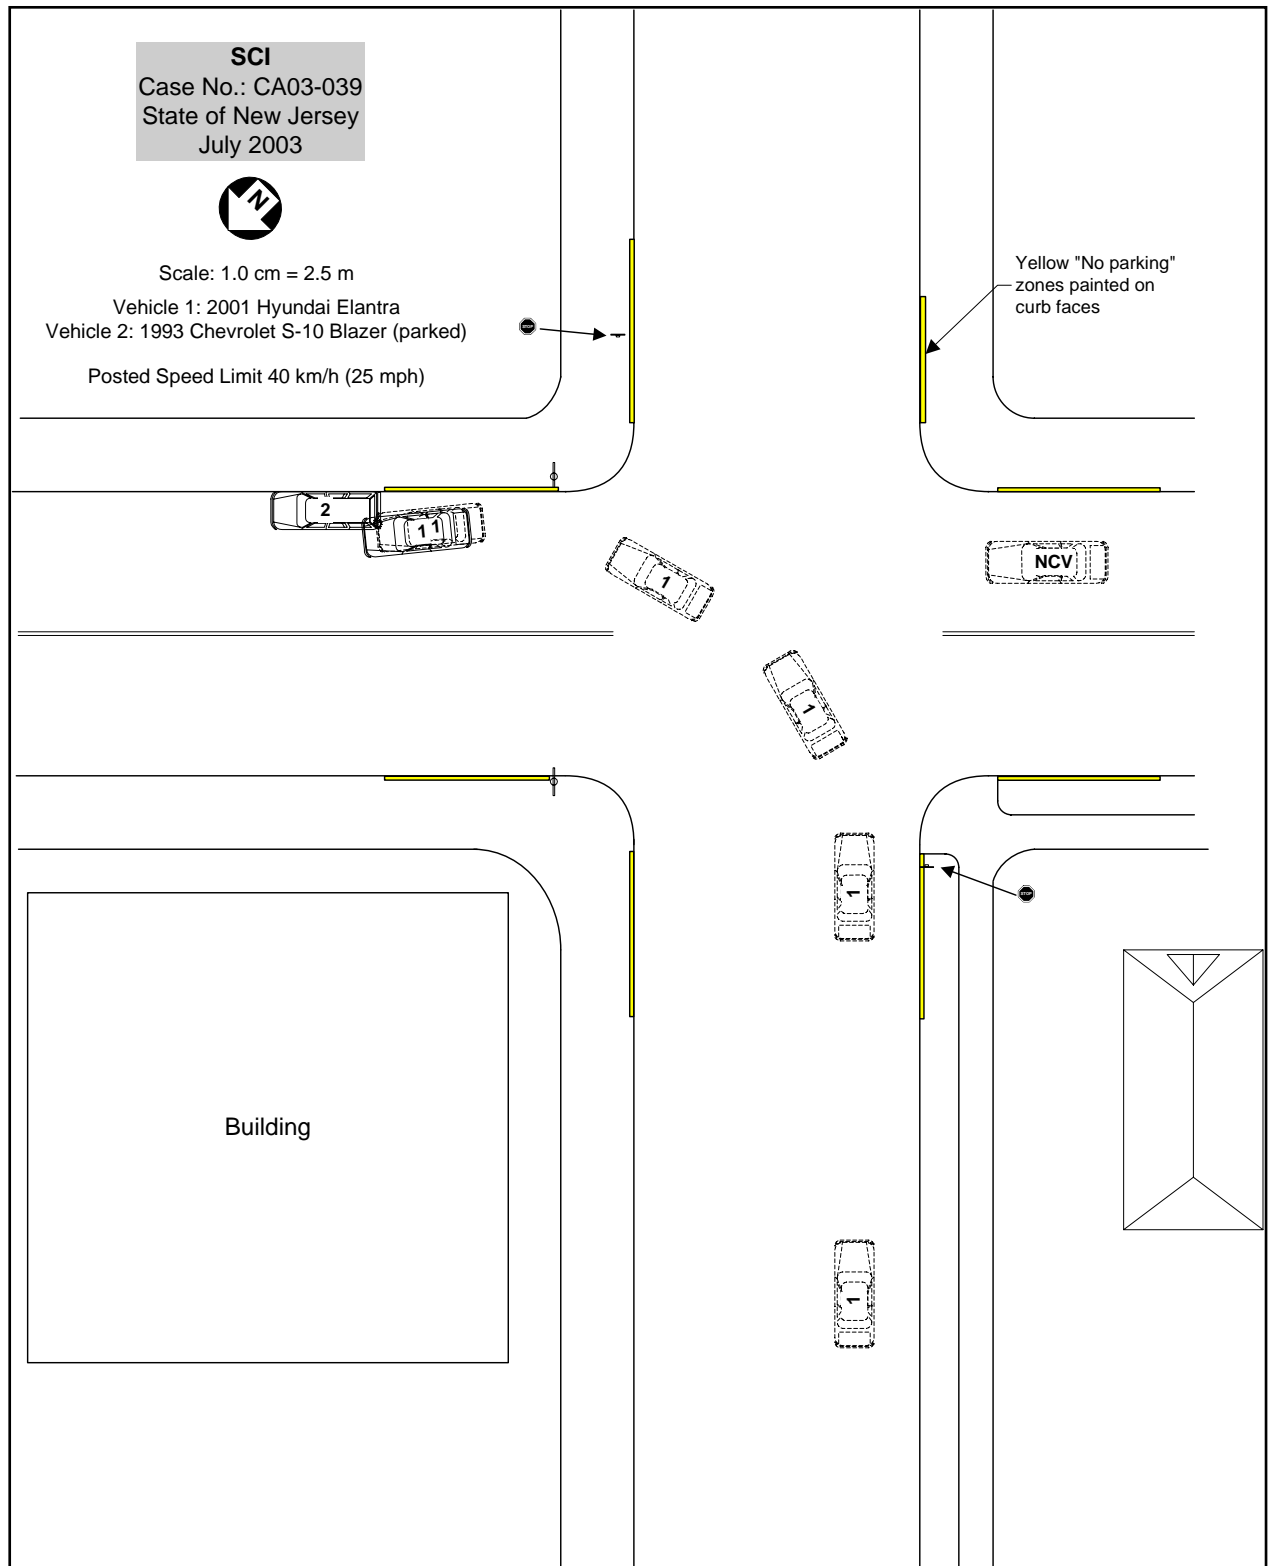
Figure 12. Scene schematic

and bordered by concrete curbs. The travel lanes measured 6.2 m (20.3') in width and were wide enough to accommodate parallel curbside parking. The two-lane east/west roadway consisted of one travel lane in each direction and was bordered by concrete curbs. The concrete curbs exhibited yellow paint on the curb faces adjacent to the intersection corners, which identified 'no parking' zones. Both roadways were bordered by concrete sidewalks and residential properties. Traffic flow through the intersection was controlled by stop signs for east and westbound traffic. The posted speed limit for both roadways was 40 km/h (25 mph). The scene schematic is included as **Figure 12** at the end of this report.
