**GENERAL DYNAMICS ON-SITE CERTIFIED ADVANCED 208-COMPLIANT  
VEHICLE CRASH INVESTIGATION  
SCI TECHNICAL SUMMARY REPORT**

**CASE NO. CA03-043**

**VEHICLE – 2003 CADILLAC ESCALADE EXT**

**CRASH DATE – JULY 2003**

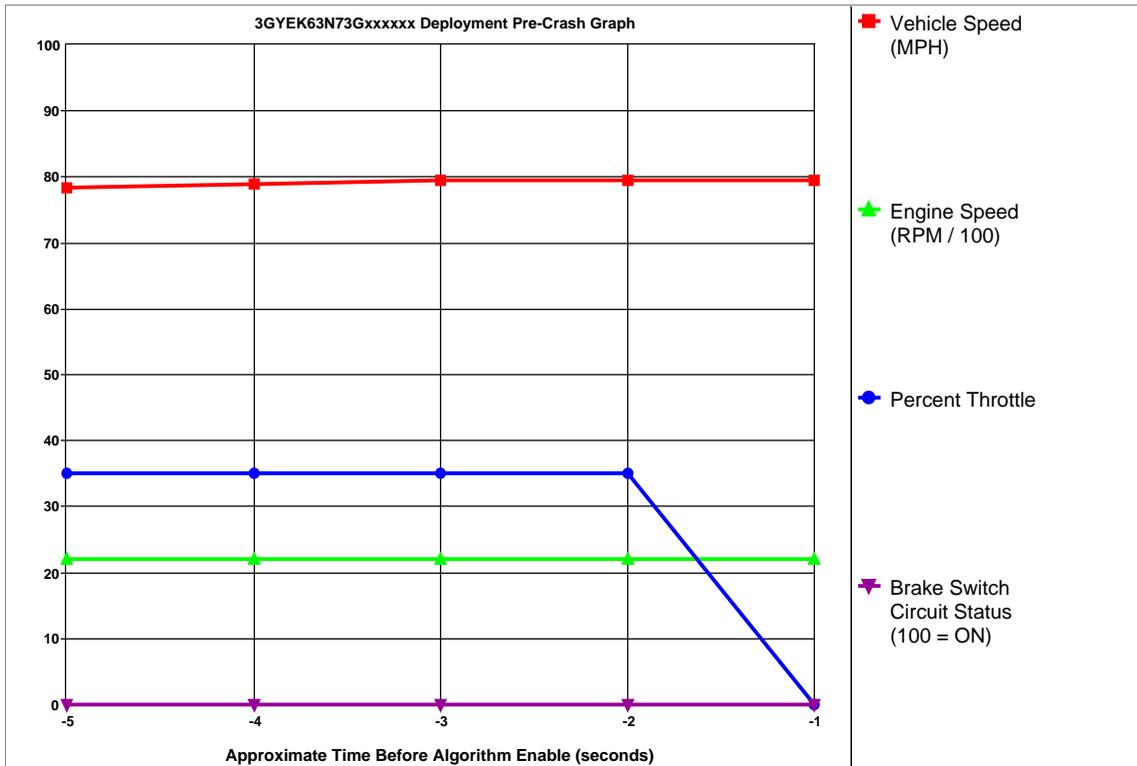
### System Status At Deployment

SIR Warning Lamp Status	OFF
Driver's Belt Switch Circuit Status	BUCKLED
Ignition Cycles At Deployment	828
Ignition Cycles At Investigation	832
Maximum SDM Recorded Velocity Change (MPH)	-9.43
Algorithm Enable to Maximum SDM Recorded Velocity Change (msec)	110
Driver First Stage Time Algorithm Enabled to Deployment Command Criteria Met (msec)	35
Driver Second Stage Time Algorithm Enabled to Deployment Command Criteria Met (msec)	35
Passenger First Stage Time Algorithm Enabled to Deployment Command Criteria Met (msec)	35
Passenger Second Stage Time Algorithm Enabled to Deployment Command Criteria Met (msec)	35
Time Between Non-Deployment And Deployment Events (sec)	N/A
Frontal Deployment Level Event Counter	1
Event Recording Complete	Yes
Multiple Events Associated With This Record	No
One Or More Associated Events Not Recorded	No

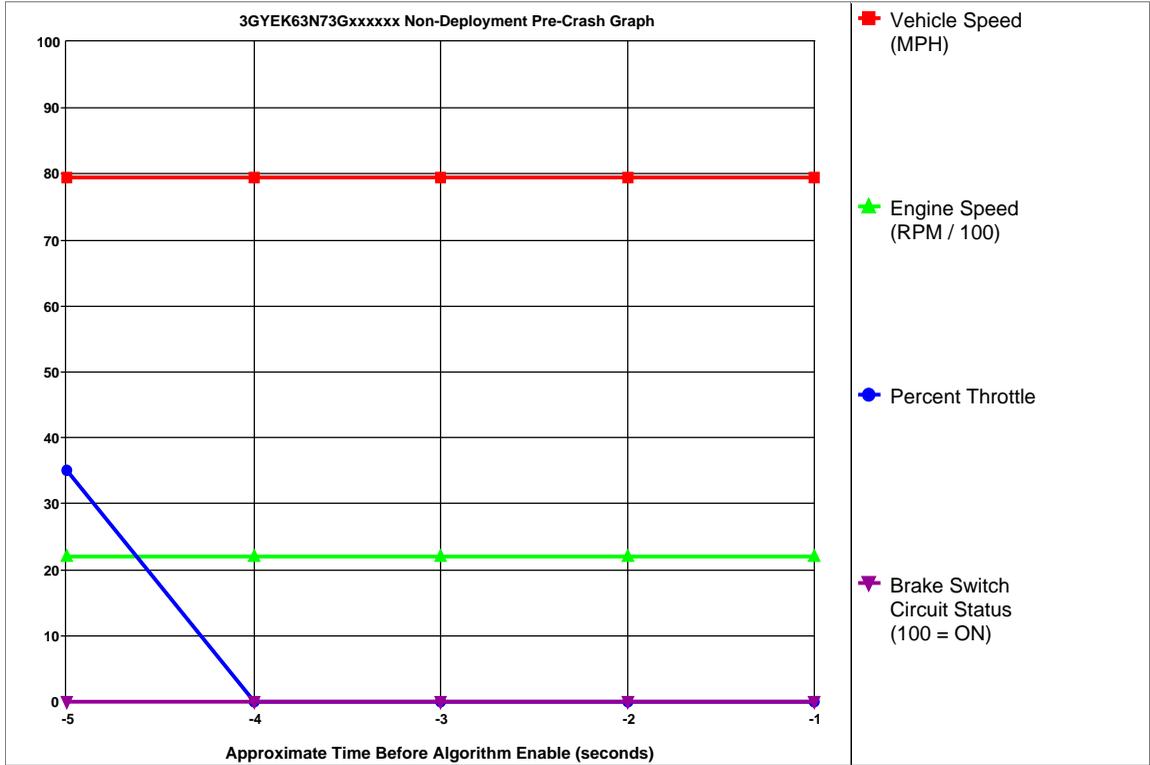
### System Status At Non-Deployment

SIR Warning Lamp Status	OFF
Driver's Belt Switch Circuit Status	BUCKLED
Ignition Cycles At Non-Deployment	828
Ignition Cycles At Investigation	832
Maximum SDM Recorded Velocity Change (MPH)	-0.27
Algorithm Enable to Maximum SDM Recorded Velocity Change (msec)	60
Event Recording Complete	Yes
Multiple Events Associated With This Record	Yes
One Or More Associated Events Not Recorded	Yes
