ON-SITE CHILD SAFETY SEAT INVESTIGATION

CASE NUMBER - IN-03-047

VEHICLE - 1996 TOYOTA CAMRY

CRASH DATE - November 2003

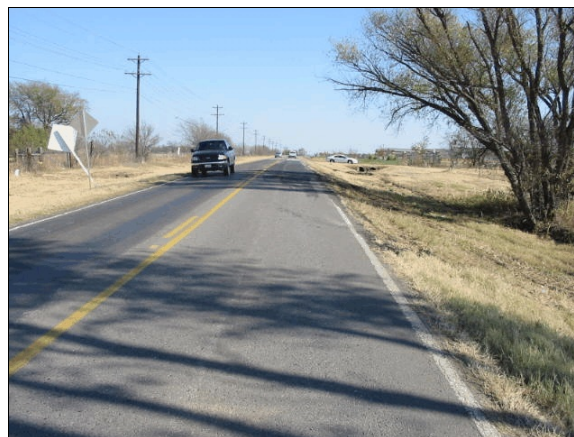
Figure 1: Case vehicle's eastward travel path in eastbound lane; Note: level roadway with slight perceptible upgrade (case photo #01)

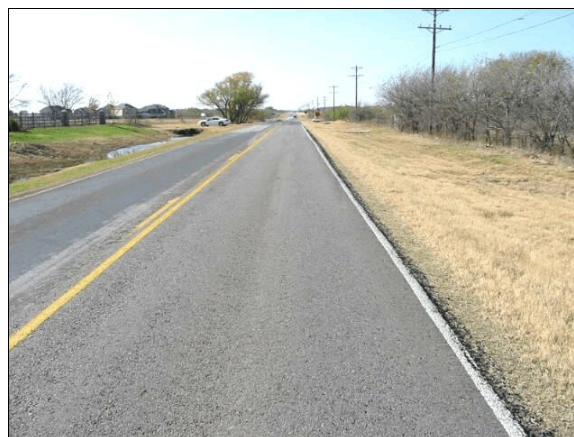
Figure 2: Mack truck's westward travel path in westbound lane; Note: truck's right tires went onto the north shoulder and level roadway with slight perceptible upgrade in westbound direction (case photo #12)

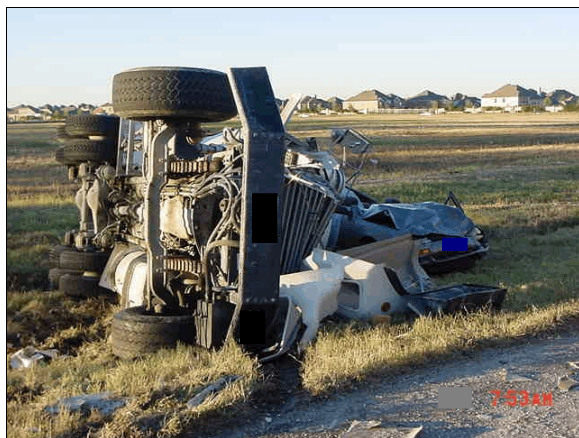
Post-Crash: As a result of the impact, the case vehicle was immediately driven rearward (**Figure 5** and **Figure 8**), in a west-southwesterly direction, off the south edge of the roadway, and into a shallow ditch on the south roadside (**Figure 9** below). The case vehicle also rotated approximately 90 degrees counterclockwise as it was redirected along its westerly path. At some time during its post-crash movement, the right rear of the case vehicle was impacted by the left and/or top sides of the Mack truck. The case vehicle came to rest in the ditch on the south roadside, heading in a northerly direction (**Figures 10** and **11** below). The Mack truck continued in a west-southwesterly direction, on its left side, after impacting the case vehicle. The Mack truck continued to rotate clockwise as it traveled westward (**Figure 12** below). This degree of

rotation was almost certainly increased by the negative slope of the roadside ditch into which it moved. An unknown part of the Mack truck impacted the right rear of the case vehicle during its westerly movement. The Mack truck came to rest on its left side in the southerly ditch (**Figure 13** below), also heading in a north-northeasterly direction at final rest (**Figure 9**).

Figure 9: On-scene southwesterly view of final rest positions of Mack truck (on left side) and case vehicle on south roadside (case photo #06a)

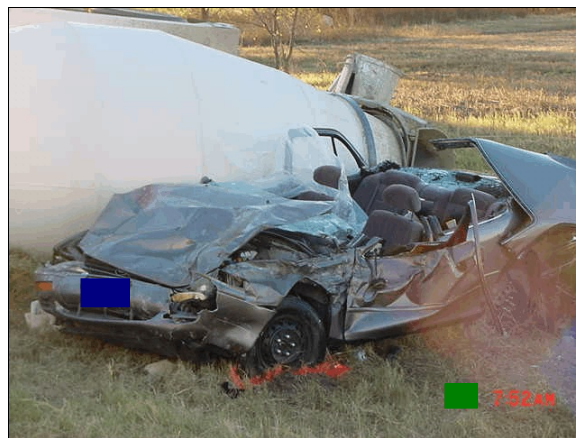
Figure 10: On-scene southeasterly view of final rest positions of Mack truck (background) and case vehicle (foreground); Note: case vehicle's roof and been removed for extrication purposes (case photo #07)

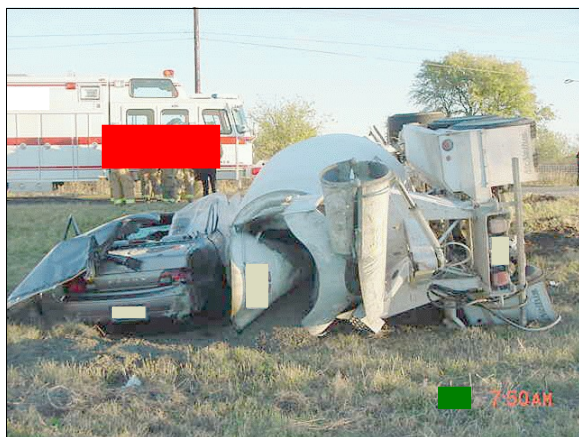
Figure 11: On-scene northern view of final rest positions of case vehicle (left) and Mack truck (right); Note: case vehicle's roof removed for extrication purposes (case photo #08)

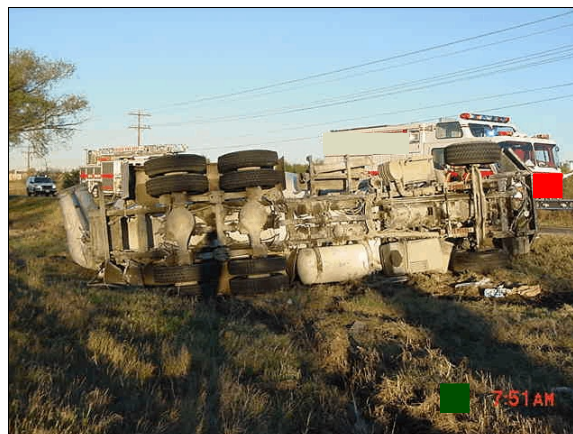
Figure 13: On-scene northwesterly view of Mack truck's final rest position on south roadside (case photo #19)

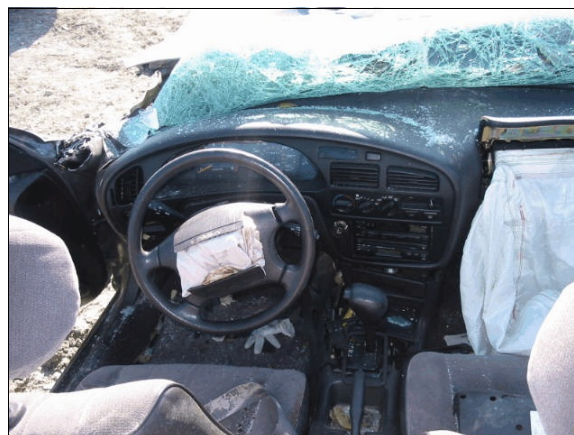
The case vehicle was equipped with a Supplemental Restraint System (SRS) that contained frontal air bags at the driver and front right passenger positions. Both frontal air bags deployed as a result of the frontal impact with the Mack truck (**Figures 23** and **24**). The case vehicle's driver air bag was located in the steering wheel hub. The module cover consisted of asymmetrical "H"-configuration cover flaps made of thick vinyl with overall dimensions of 15 centimeters (5.9 inches) at the horizontal seam and 6 centimeters (2.4 inches) vertically for the upper flap and 7 centimeters (2.8 inches) vertically for the lower flap. An inspection of the air bag module's cover flaps and the air bag's fabric revealed that the cover flaps opened at the designated tear points, and there was no evidence of damage during the deployment to the air bag or the cover flaps. The driver's air bag was designed with four tethers, each approximately 6.5 centimeters (2.6 inches) in width. The driver's air bag had two vent ports, approximately 3 centimeters (1.2 inches) in diameter, located at the 1:30 and 10:30 clock positions. The deployed driver's air bag was round with a diameter of 66 centimeters (26.0 inches). The distance between the mid-center of the driver's seat back, as positioned at the time of the vehicle inspection, and the front surface of the air bag's fabric at full excursion was 25 centimeters (9.8 inches). An inspection of the driver's air bag fabric revealed a large amount of blood on the front surface of the air bag's fabric (**Figure 25**), most notably in the upper left and lower right quadrants. In addition, blood also liberally covered the lower half of the air bag's back surface (**Figure 26** below). The blood most likely came from an avulsion/laceration on the left posterior surface of the driver's scalp.

Figure 23: Elevated view of case vehicle's driver seating area showing deployed driver air bag (case photo #43)

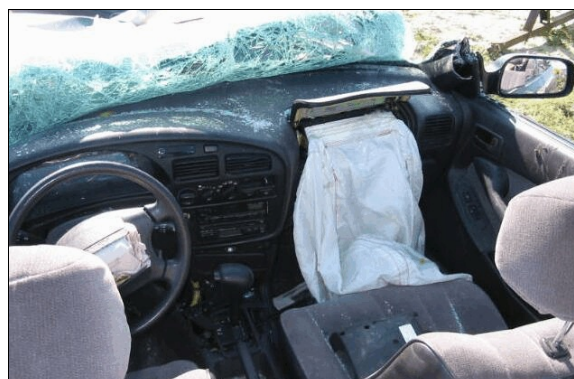
Figure 24: Elevated view of case vehicle's front right seating area showing deployed front right air bag (case photo #45)

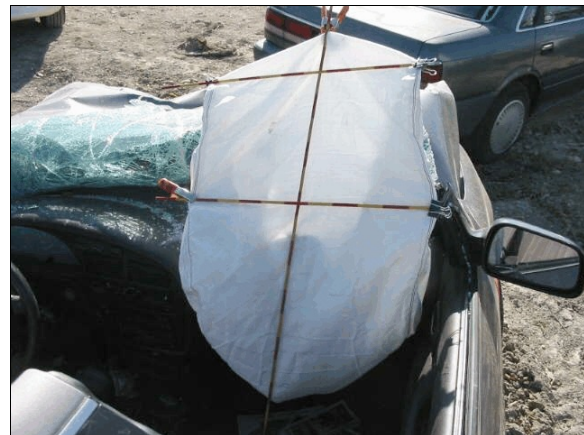
driver's module. The flap's dimensions were 36 centimeters (14.2 inches) at the lower horizontal seam and 17 centimeters (6.7 inches) along both vertical seams. The profile of the case vehicle's instrument panel was flush with the leading edge of the cover flap. An inspection of the front right air bag module's cover flap and the air bag's fabric revealed that the cover flap opened at the designated tear points, and there was no evidence of damage during the deployment to the air bag or the cover flap. The front right passenger's air bag was designed without any tethers. The front right air bag had two vent ports, approximately 4 centimeters (1.6 inches) in diameter, located at the 3 and 9 o'clock positions. The deployed front right air bag was rectangular with a height of approximately 80 centimeters (31.5 inches) and a width of approximately 53 centimeters (20.9 inches). There was no distance (i.e., touched seat back) between the mid-center of the front right seat back, as positioned at the time of the vehicle inspection, and the front surface of the air bag's fabric at full excursion. An inspection of the front right passenger's air bag fabric revealed no contact evidence readily apparent on the front surface of the front right air bag's fabric (**Figure 27**). However, there was a blood spot on the left side surface (**Figure 28**), most likely a splatter spot from the case vehicle's driver.

Figure 27: Elevated view of front surface of case vehicle's deployed front right air bag showing no evidence of occupant contact (case photo #65)

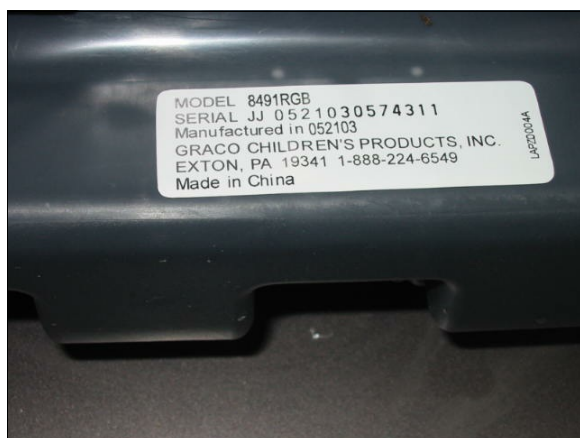
Figure 30: Label containing model and serial number for Graco child booster seat used by case vehicle’s back left passenger (case photo #105)

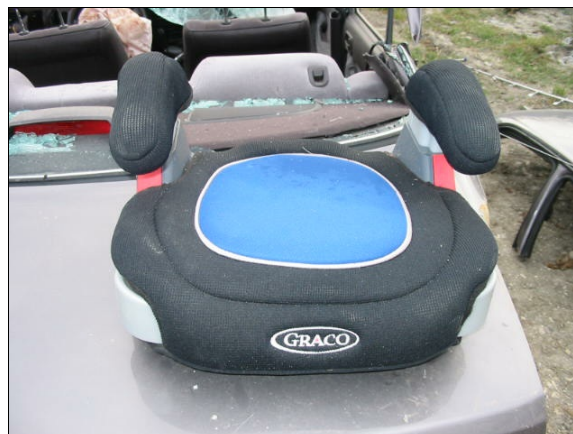
The booster child safety seat was made of hard plastic, covered with soft, removable, padding. Based on inspection and the statement of the case vehicle’s driver, booster child safety seat did not show any areas of stress to the plastic seat, arm rest, or belt positioning areas (e.g., scuff marks and stress fractures) and very little wear and tear to the cloth cover or padding. There was a large manufacturer’s label affixed to the bottom of the seat (**Figure 31**) giving the child seat’s height and weight limitations [i.e., with back support—approximately 96 to 145 centimeters and 13.6 to 45 kilograms (38 and 57 inches and 30 and 100 pounds); without back support—approximately 101 to 145 centimeters and 18 to 45 kilograms (40 and 57 inches and 30 and 100 pounds)]. This label was not dated. Other warning labels were

Figure 29: Front of Graco child booster seat used by case vehicle’s back left passenger; Note: seat cushion (i.e., blue on black) folds upward providing “limited” back support for specific children (case photo #99)

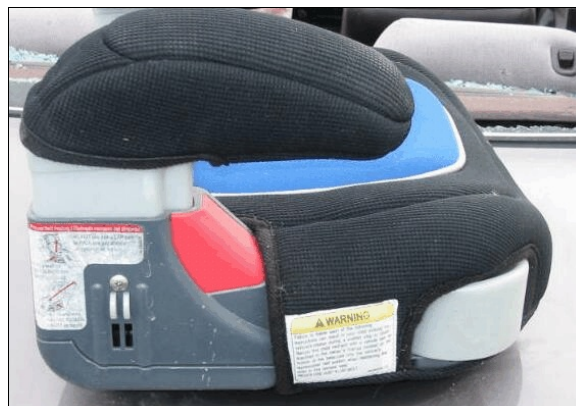
sewn onto the base, one in English and one in Spanish, advising against use in the front seat. A final manufacturer's label was affixed to the right rear side of the base, with schematics depicting where the vehicle's belt should be placed (**Figure 32**).

Figure 32: Right side of Graco child booster seat used by case vehicle's back left passenger showing warning label, instructions for securing seat with vehicle's safety belts, and red positioning device for placement of actual seat belt (case photo #102)

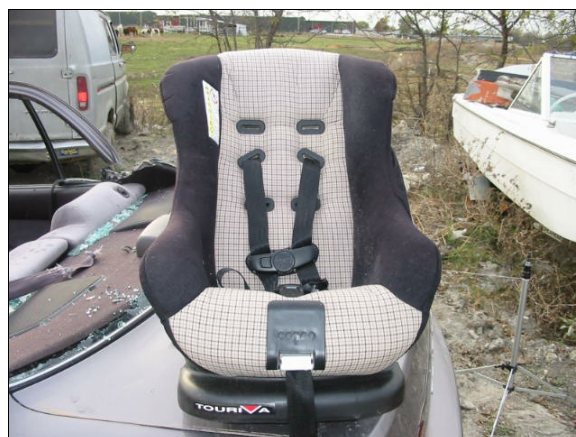
The back right passenger was seated in a convertible child safety seat that was used in its rear-facing configuration at the time of the crash (**Figure 33**). The child safety seat was manufactured by Dorel on September 7, 2003 and was identified by model name "*Touriva*" and model number **22-110-WAL** (**Figure 34**). The convertible seat was designed with a five-point harness, with two straps located above the shoulders, two at the hips, and one between the child's legs. The straps were clipped into the non-recessed buckle at the top of the crotch strap (**Figure 35**). The seat was also equipped with a top tether and lower anchor attachments for use with a LATCH system (**Figures 36 and 37** below). There were three sets of slots to thread the two shoulder harness straps through. The harness straps were threaded through the middle slots (**Figure 33**), which according to the manufacturer's instructions should only be used

Figure 33: Front of Dorel Touriva convertible child seat used in rear-facing configuration by case vehicle's back right passenger (case photo #80)

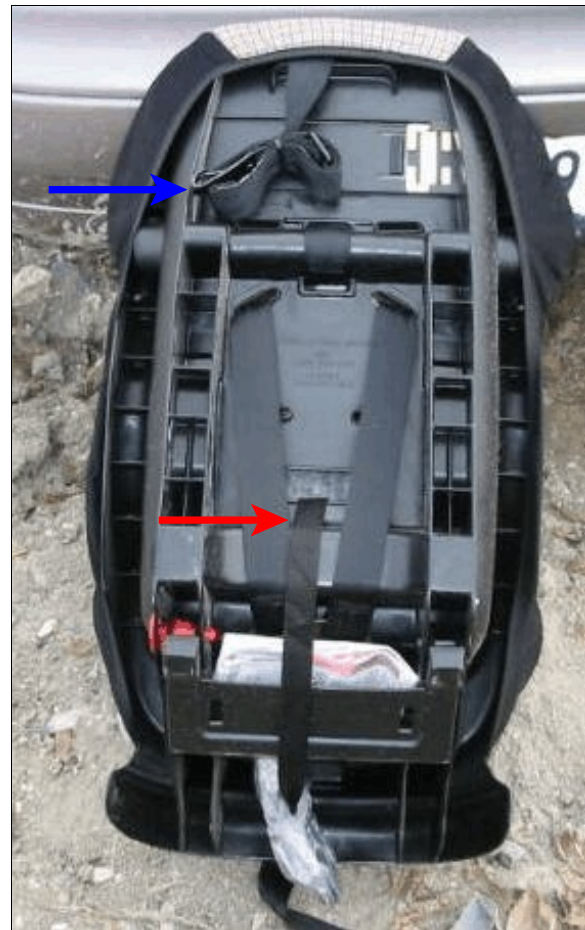
Figure 36: Back surface of case vehicle's Dorel Touriva convertible child safety seat, used in its rear-facing configuration by back right passenger, showing both upper (forward-facing-blue arrow) and lower (rear-facing-red arrow) LATCH attachments and location of instruction booklet (case photo #86)

A close inspection of the child safety seat revealed no apparent damage or fractures to the base or shell (**Figure 36** above and **Figure 38**). There were manufacturer's warning and instruction labels on the left side (i.e., outboard side when used in the rear-facing configuration), warning the user/parent not to place this child seat in a vehicle's front right seat when the vehicle is equipped with a front right passenger air bag and where to position the vehicle's seat belts for the rear-facing configuration (**Figure 39**). There was

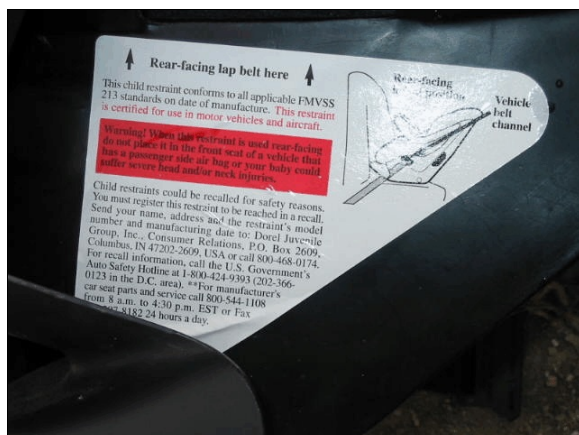
Figure 39: Close-up of manufacturer's label on left side of case vehicle's convertible child safety seat used by back right passenger showing location for correct placement of vehicle's safety belts when seat used in rear-facing configuration and warning (red background) against use of seat in front right position (case photo #91)

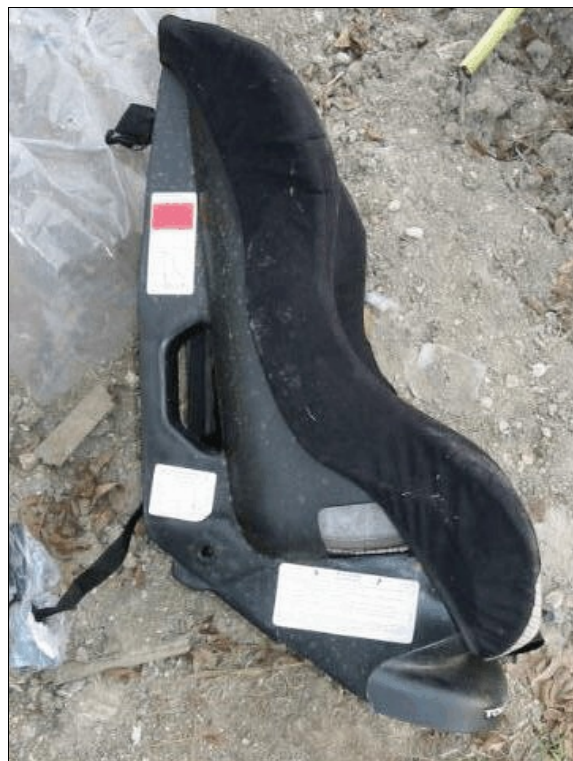
Figure 38: Right side of case vehicle's convertible child safety seat used by back right passenger in rear-facing configuration showing applicable manufacturer's labels (case photo #90)

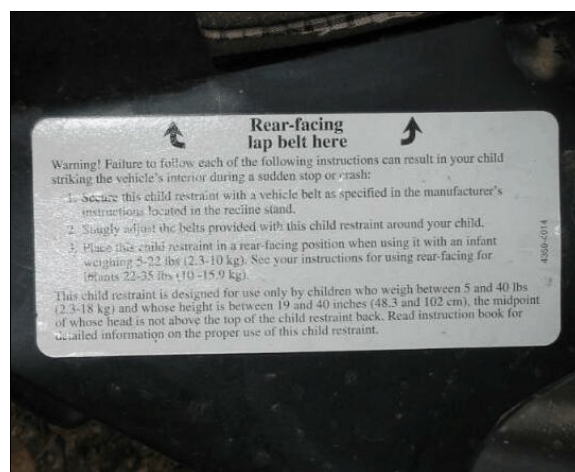
Figure 40: Close-up of manufacturer's label on right side of case vehicle's convertible child safety seat used in rear-facing configuration by back right passenger showing proper location for securing vehicle's safety belts and applicable height and weight limitations for both rear-facing and forward-facing configurations (case photo #97)

a manufacturer's label affixed to the right side (i.e., inboard side when used in the rear-facing configuration) giving the child seat's weight limitations (**Figure 40** above) for both the rear-facing configuration [i.e., for both smaller infants–2.3 to 10 kilograms (5 to 22 pounds) and larger infants–10 to 15.9 kilograms (22 to 35 pounds)] **and** the forward-facing configuration [i.e., 10-18 kilograms (22-40 pounds)]. Furthermore, this label provided the overall height limitations for the seat [i.e., 48.3 to 102 centimeters (19 to 40 inches)]. In addition, this label (**Figure 40** above) explained the importance of securing the child restraint with a vehicle's safety belt as specified in the vehicle manufacturer's instructions. The manufacturer's instructions for this child safety seat were available on the back of the seat at the time of this contractor's inspection (**Figure 36** above).
