**ON-SITE PASSENGER AIR BAG RELATED FATALITY INVESTIGATION
GENERAL DYNAMICS CASE NO: CA03-049**

**SUBJECT VEHICLE – 1998 DODGE NEON
LOCATION - PENNSYLVANIA
CRASH DATE – AUGUST 2003**

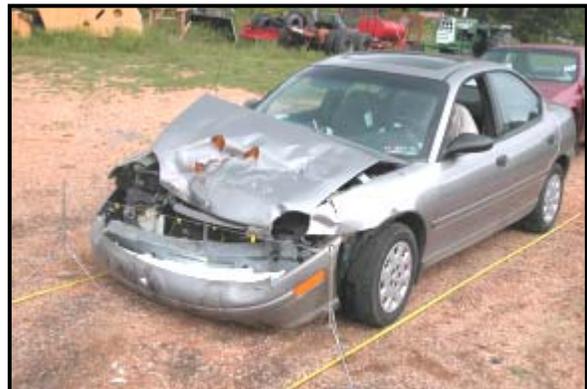
This on-site investigation focused on the injury mechanisms and the cause of death for an 85-year old female front right passenger in a 1998 Dodge Neon (**Figure 1**). The Dodge was equipped with a redesigned frontal air bag system for the driver and front right passenger positions that deployed as result of the crash. The Dodge was involved in an intersection-type crash with a 1994 Ford Taurus. The Ford was occupied by an 81-year-old male driver and three other passengers. The Ford was equipped with frontal air bags that also deployed as result of the impact. The driver of the Dodge was traveling in westerly direction on a two-lane residential

Figure 1: 1998 Dodge Neon.

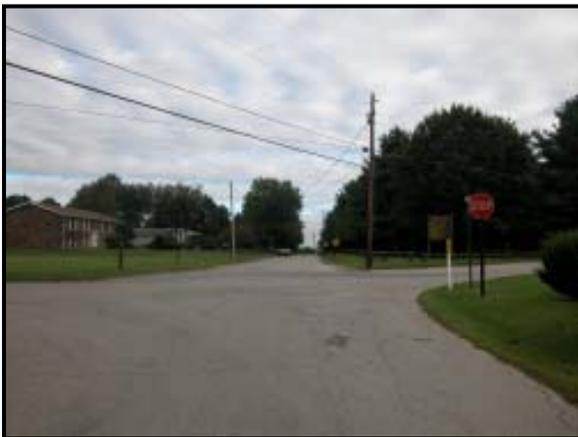
The 1994 Ford Taurus was northbound (**Figure 2**) driven by an 81-year old male and occupied by three adult passengers. A witness reported that the driver of the Ford stopped at the stop sign and then proceeded into the intersection directly into the path of the Dodge. The 1998 Dodge Neon was westbound driven by a 57-year old female driver, **Figure 3**. The front right and rear right passengers were an 85-year old female and a 51-year old male, respectively. All the occupants of the Dodge were unrestrained. Reportedly, the Dodge had just exited a county park located 79.2 meters (260.0 ft) east of the intersection. The female driver of the Dodge reportedly recognized the impending crash and applied the brakes. The estimated travel speed of the Dodge was 32 – 40 km/h (20 - 25 mph). No pre-crash skid marks were identified during the SCI scene inspection or documented by the police investigators.

Figure 2: Northward trajectory view at the intersection.

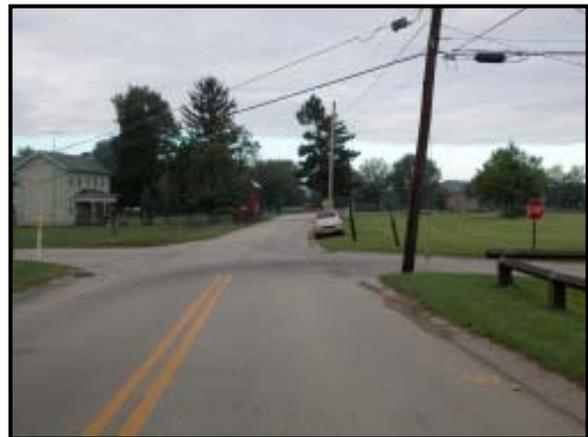
Figure 3: Westward trajectory view.
