**GENERAL DYNAMICS ON-SITE CHILD SAFETY SEAT CRASH INVESTIGATION
SCI TECHNICAL SUMMARY REPORT**

CASE NO. CA03-051

VEHICLE – 1994 PLYMOUTH VOYAGER

CRASH DATE – JULY 2003

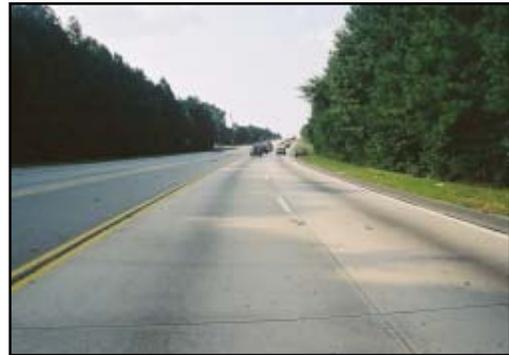
The 44-year-old female driver was operating the Plymouth Voyager on the inboard westbound lane and entered the slight right curve (**Figure 2**). Her pre-crash travel speed was unknown. The 34-year-old male driver of the 1994 Cadillac DeVille was operating the vehicle at a high rate of speed in the inboard eastbound lane (**Figure 3**). As the DeVille descended the slight downgrade and entered the left curve on approach to the crash site, the vehicle began to hydroplane on the wet roadway surface. The driver lost control of the vehicle and the DeVille initiated a CCW yaw. The Cadillac departed the travel lane and crossed the paved median while it continued to rotate. The DeVille had rotated a total of approximately 110 degrees in a CCW direction, exposing its right side, when it encroached into the inboard westbound lane into the path of the oncoming Plymouth Voyager. It was unknown if the driver of the Voyager attempted any avoidance maneuvers prior to the crash. The 1994 Ford Ranger was traveling behind the Voyager in the outboard lane.

Figure 2. Westbound approach for the Plymouth Voyager and Ford Ranger

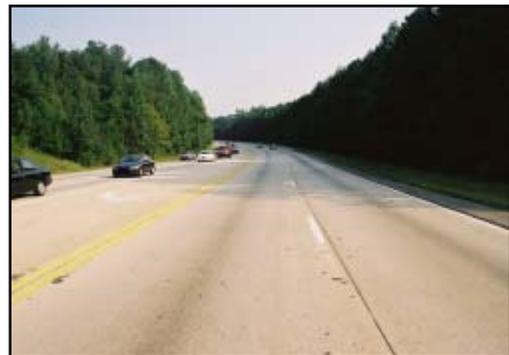
Figure 3. Eastbound approach for the Cadillac DeVille

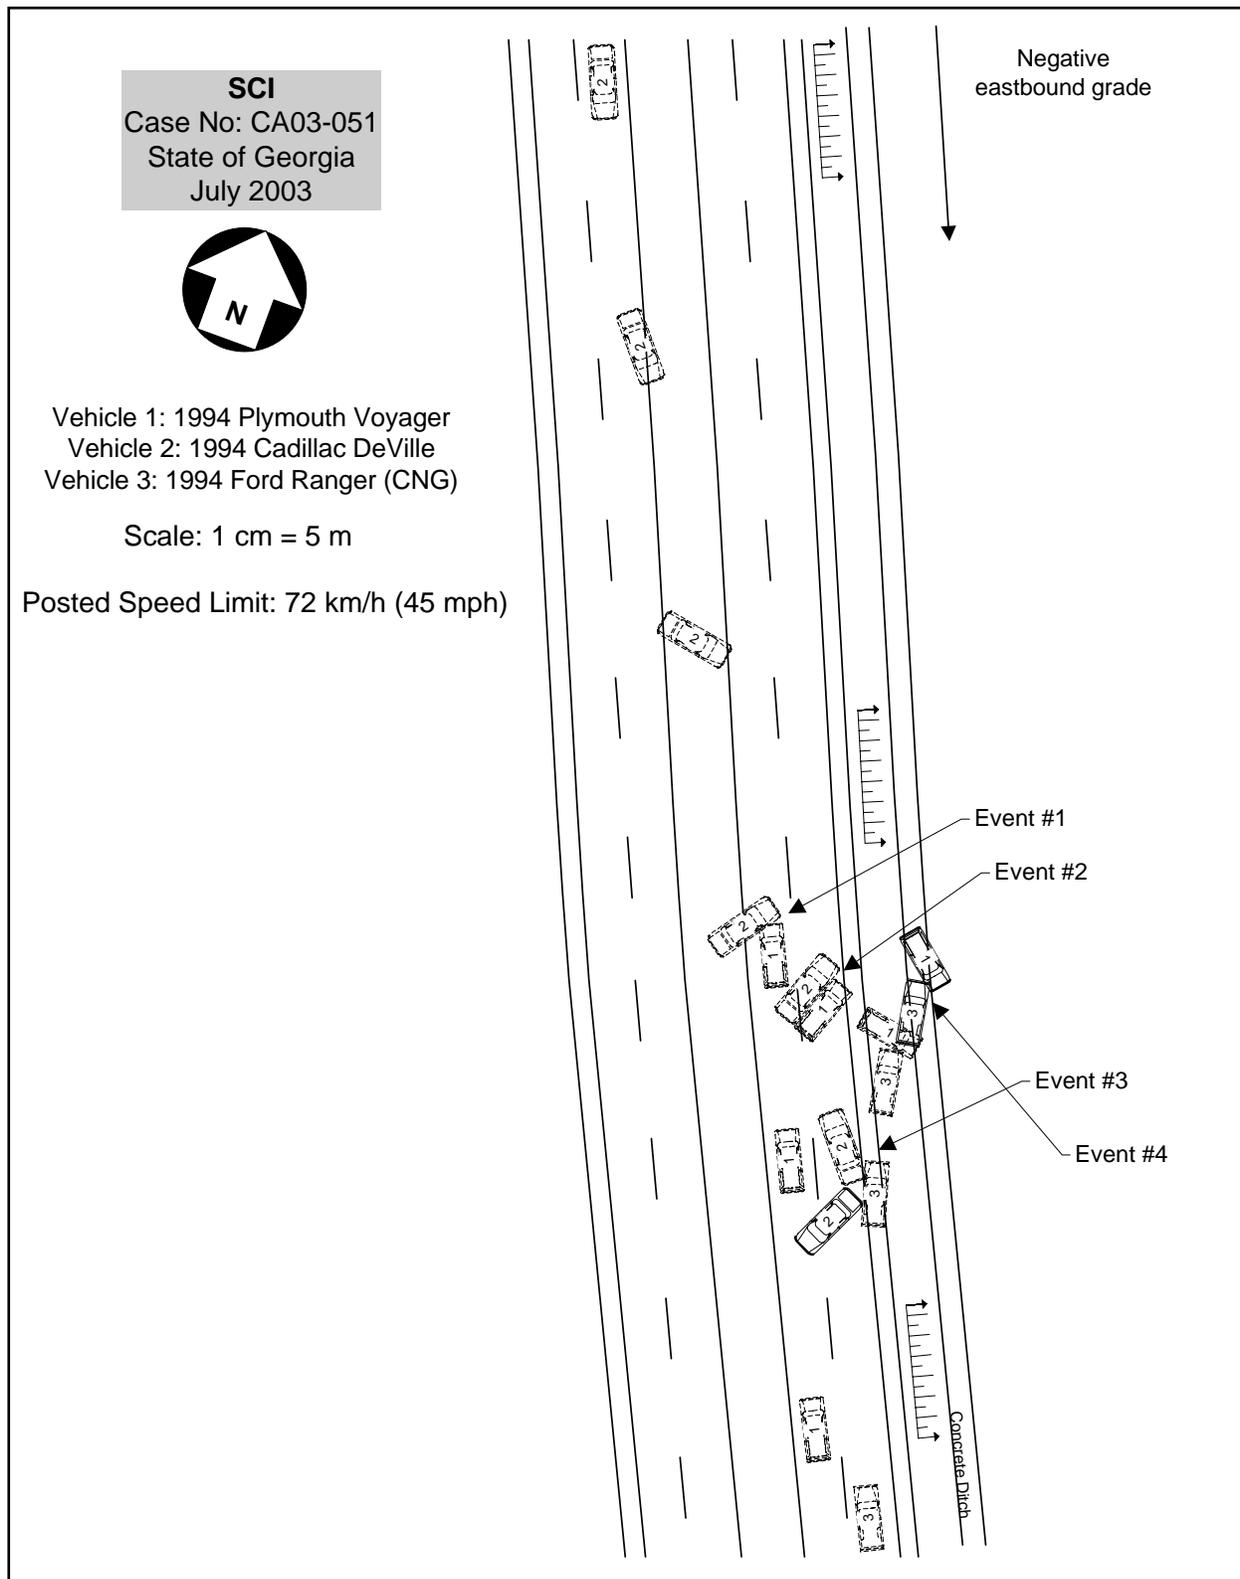
Figure 19. Scene schematic

measured 4.7 m (15.4') in width. West of the crash site, the painted median formed a center left turn lane. The roadway exhibited a gradual westbound right curve through the crash site and exhibited a slight positive westbound grade that began west of the crash site. The roadway was bordered by concrete shoulders that were configured with Continuous Shoulder Rumble Strips (CSRS). The roadside environment consisted of grassy and wooded areas. The westbound roadside had a negative embankment that led to a concrete drainage ditch, which measured 1.5 m (5.0') in width and was located 3.3 m (10.8') north of the westbound road edge. The posted speed limit for the roadway was 72 km/h (45 mph). There were no traffic control devices present at the crash site. The scene schematic is included as **Figure 19** of this narrative report.
