**GENERAL DYNAMICS ON-SITE ALLEGED SEAT FAILURE INVESTIGATION  
SCI TECHNICAL SUMMARY REPORT**

**CASE NO. CA03-054**

**VEHICLE – 2003 JEEP GRAND CHEROKEE**

**CRASH DATE – JULY 2003**

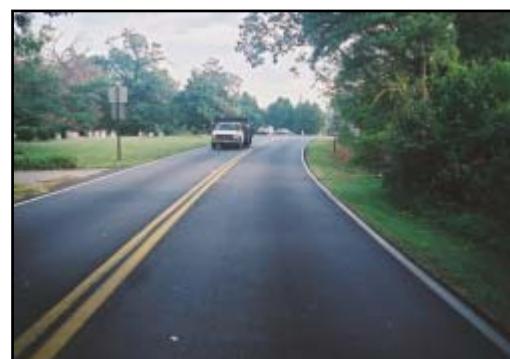
The 42-year-old male driver of the Jeep Grand Cherokee was operating the vehicle in a northbound direction (**Figure 3**) on the straight aspect of the two-lane roadway on approach to the right curve and hillcrest. The driver stated that his travel speed was approximately 64 km/h (40 mph) and that the occupants were conversing, however, there were no additional distractions within the vehicle. The 36-year-old female driver of the Grand Am was operating the vehicle in a southbound direction on the two-lane

**Figure 3. Northbound approach for the Grand Cherokee**

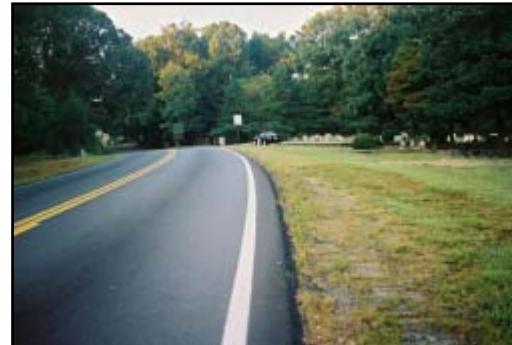
roadway. The vehicle entered the left curve on approach to the hillcrest (**Figure 4**). The driver failed to negotiate the left curve and the Grand Am departed the right roadside. The driver of the Grand Am steered left in an attempt to re-enter the roadway. The Grand Am initiated a slight counterclockwise (CCW) yaw and re-entered the roadway south of the apex of the curve. The Grand Am continued the CCW yaw across the southbound travel lane, across the centerline, and into the path of the Grand Cherokee. The driver of the Cherokee stated that he observed the Grand Am depart the roadway and thought that the Grand Am might come to a controlled stop or continue to rotate on the roadside. He further stated that he attempted to apply the brakes immediately prior to the impact. Police documented the yaw marks from the Grand Am post-crash. Although the yaw marks were not visible at the time of the SCI inspection, paint marks present on the roadway from the police documentation (**Figure 5**) were documented and plotted on the scene schematic. The pre-crash speed of the Grand Am was not known.

**Figure 4. Southbound approach for the Grand Am**

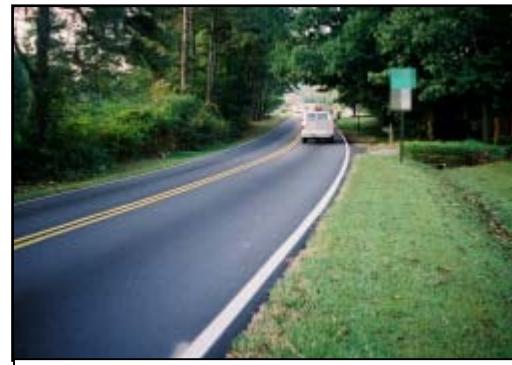
**Figure 5. View of police paint marks and the Grand Am's trajectory across the travel lanes**

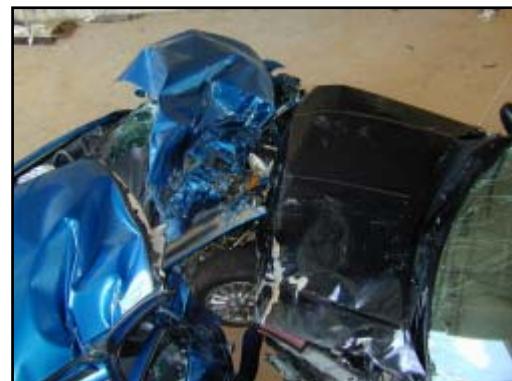
The front aspect of the Jeep Grand Cherokee struck the front right corner aspect of the Grand Am in an angular configuration (**Figure 6**) as the Grand Am encroached into the northbound lane. The impact resulted in severe damage to both vehicles and was sufficient to deploy the frontal air bags and safety belt pretensioners in the Grand Cherokee and the frontal air bags in the Grand Am. The directions of force were in the 12 o'clock and the 1 o'clock sectors for the Grand Cherokee and the Grand Am, respectively. The damage algorithm of the WinSMASH program computed a total delta-V of 33.0 km/h (20.5 mph) for the Grand Cherokee and a total delta-V of 47.0 km/h (29.2 mph) for the Grand Am. The delta-V results for both vehicles appeared low based on the visual damage comparisons of NHTSA New Car Assessment Program (NCAP) test results. Visual comparisons between the damaged Grand Cherokee and damage patterns of similar NCAP test vehicles, suggested that the total delta-V for the Grand Cherokee may have been closer to 56 km/h (35 mph). The Grand Cherokee rotated 100 degrees in a CW direction and came to rest facing east on the east roadside. The Grand Am rotated 90 degrees in a CCW direction and came to rest facing northeast on the northbound lane.

**Figure 6. Post-crash police photograph depicting impact configuration**

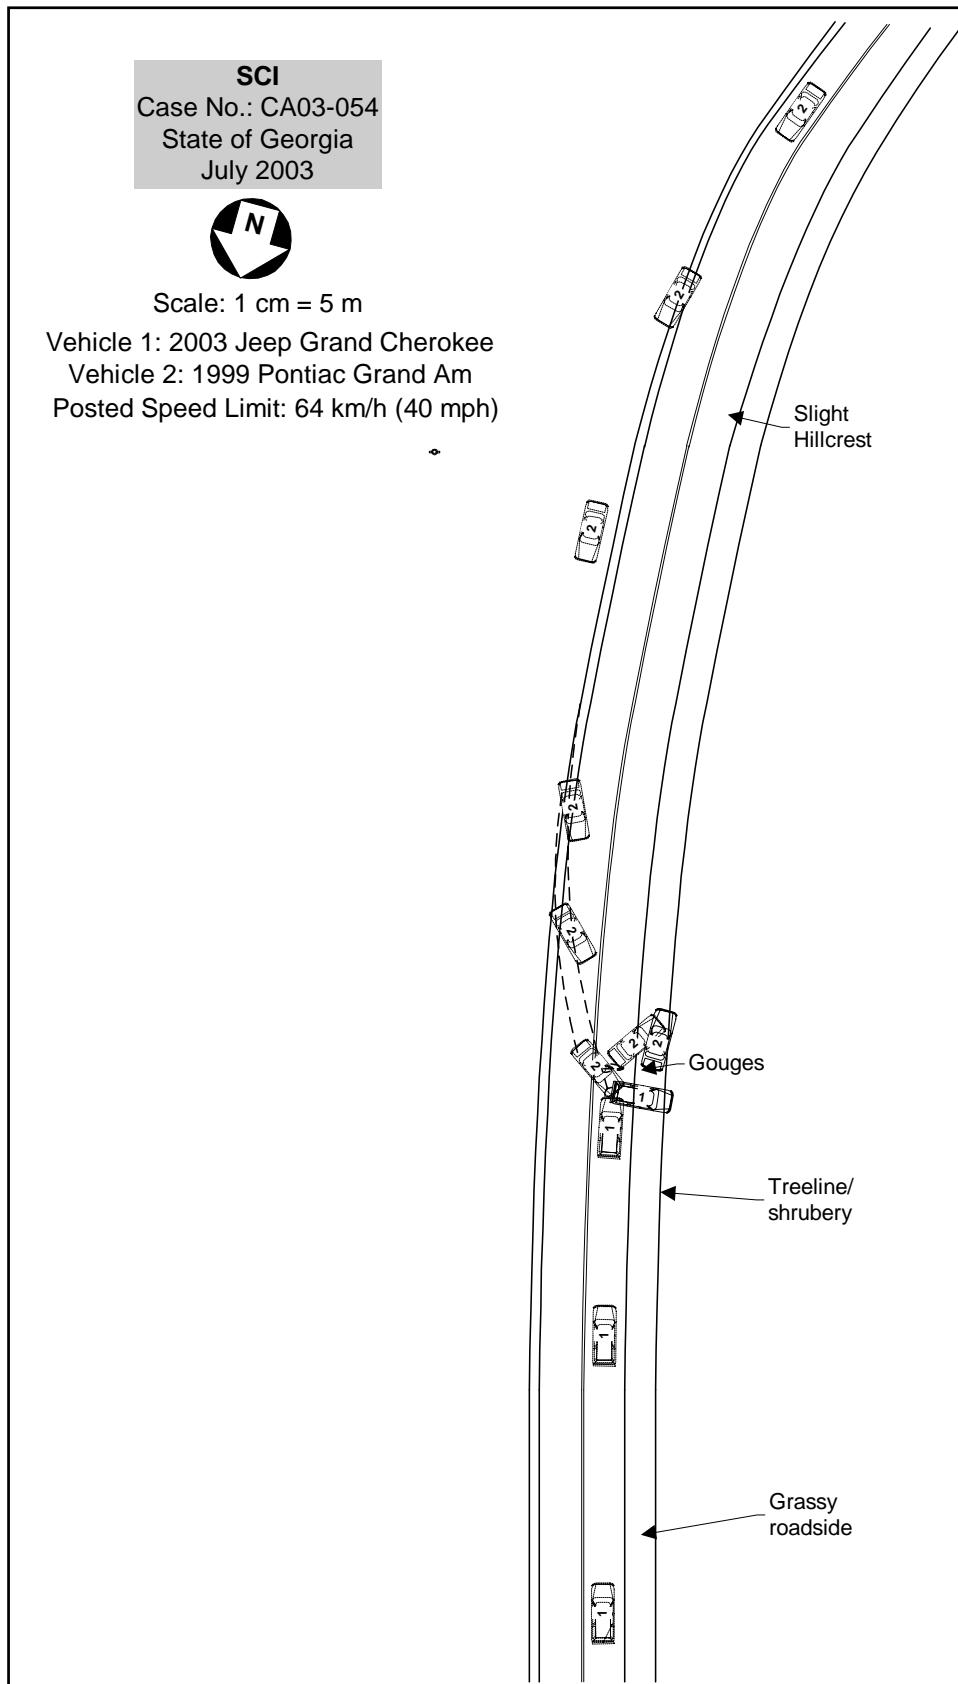
**Figure 23. Scene schematic**
