**GENERAL DYNAMICS ON-SITE AIR BAG NON-DEPLOYMENT  
INVESTIGATION**

**GENERAL DYNAMICS CASE NO. – CA03-057**

**SUBJECT VEHICLE – 1995 PONTIAC GRAND PRIX**

**CRASH DATE – OCTOBER 2003**

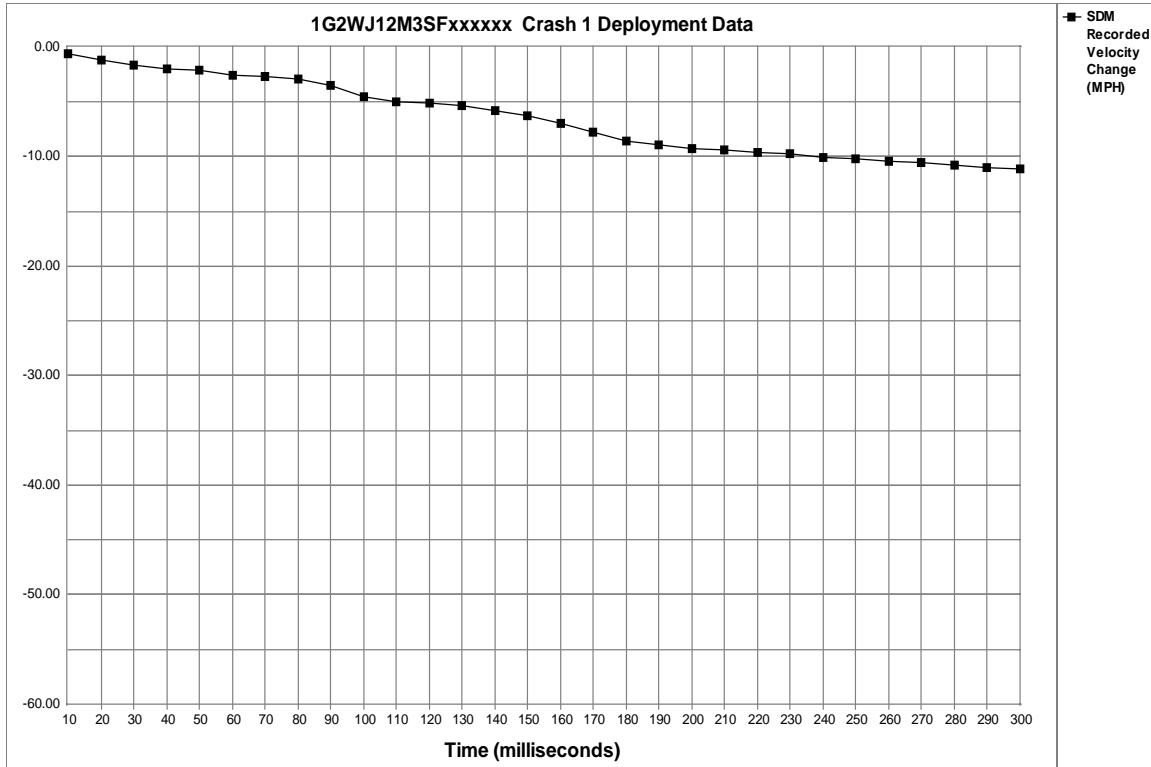
## System Status At Crash 1

SIR Warning Lamp Status	OFF
Driver's Belt Switch Circuit Status	UNBUCKLED
Ignition Cycles At Deployment	10026
Ignition Cycles At Investigation	10029
Time From Algorithm Enable to Deployment Command Criteria Met (msec)	162.5
Time Between Non-Deployment And Deployment Events (sec)	.21

Time (milliseconds)	10	20	30	40	50	60	70	80	90	100	110	120	130	140	150
Recorded Velocity Change (MPH)	-0.55	-1.21	-1.65	-1.97	-2.08	-2.52	-2.63	-2.85	-3.51	-4.50	-4.94	-5.05	-5.38	-5.81	-6.25
Time (milliseconds)	160	170	180	190	200	210	220	230	240	250	260	270	280	290	300
Recorded Velocity Change (MPH)	-6.91	-7.79	-8.56	-8.89	-9.21	-9.32	-9.54	-9.76	-10.09	-10.20	-10.42	-10.53	-10.75	-10.97	-11.08

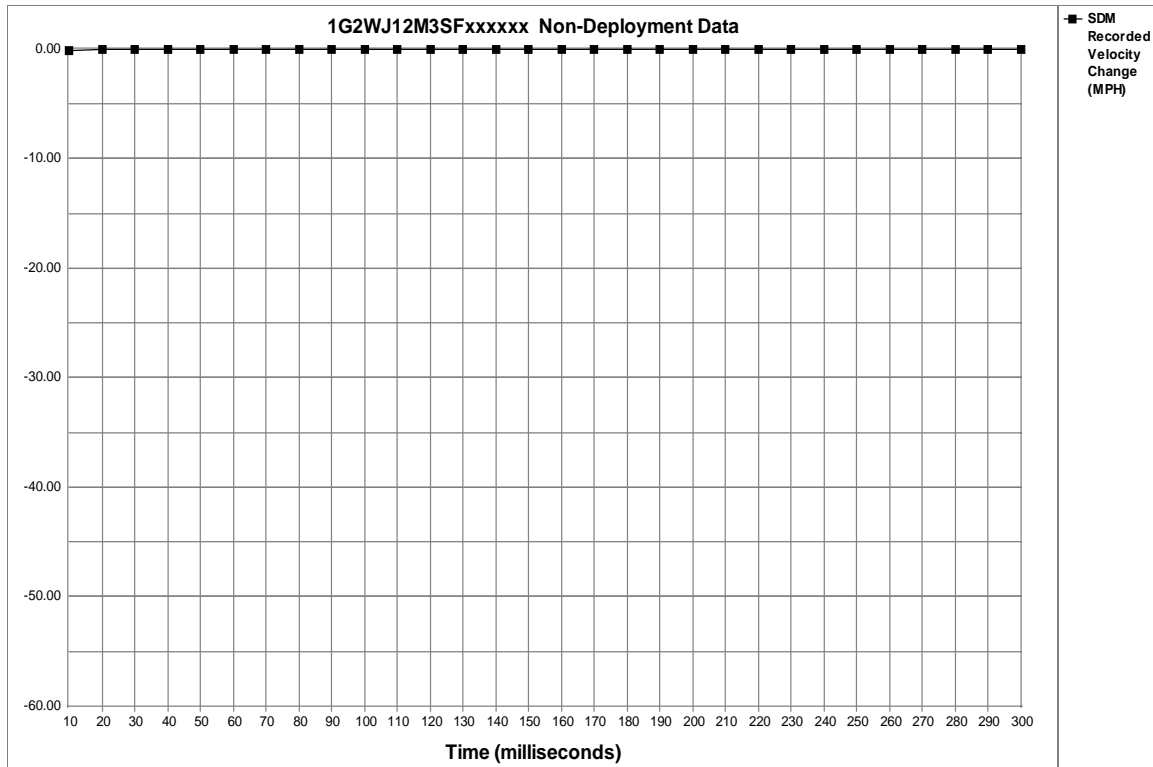
## System Status At Non-Deployment

SIR Warning Lamp Status	OFF
Driver's Belt Switch Circuit Status	UNBUCKLED
Ignition Cycles At Non-Deployment	10026
Ignition Cycles At Investigation	10029
Algorithm Enable to Maximum SDM Recorded Velocity Change (msec)	2.5
Maximum SDM Recorded Velocity Change (MPH)	-0.22
A Deployment was Commanded Prior to this Event	No

Time (milliseconds)	10	20	30	40	50	60	70	80	90	100	110	120	130	140	150
Recorded Velocity Change (MPH)	-0.11	0.00	0.00	0.00	0.00	0.00	0.00	0.00	0.00	0.00	0.00	0.00	0.00	0.00	0.00
Time (milliseconds)	160	170	180	190	200	210	220	230	240	250	260	270	280	290	300
Recorded Velocity Change (MPH)	0.00	0.00	0.00	0.00	0.00	0.00	0.00	0.00	0.00	0.00	0.00	0.00	0.00	0.00	0.00
