Certified Advanced 208 Compliant Vehicle Investigation/ Vehicle to Vehicle
Dynamic Science, Inc. / Case Number: 2004-75-153E
2004 Chevrolet Silverado
Colorado
October, 2004

1. Report No. 2004-75-153E		2. Government Accession No.		3. Recipient Catalog No.	
4. Title and Subtitle Certified Advanced 208 Compliant Vehicle Investigation				5. Report Date February 1, 2006

Dynamic Science, Inc.
Crash Investigation
Case Number:2004-75-153E

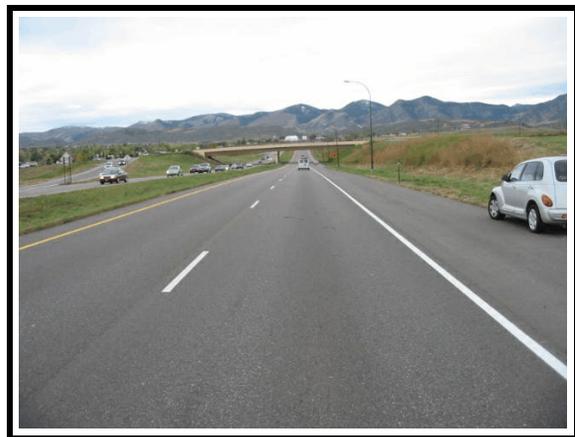
Figure 2. Approach to area of impact (west)

This two vehicle crash occurred in Colorado in 2004, at 1307 hours. Both vehicles were traveling westbound on a divided, two lane interstate. The westbound lanes were separated from the eastbound lanes by a grassy, depressed center median. The posted speed limit was 105 km/h (65 mph). At the time of the crash the atmospheric conditions were conducive for travel. The asphalt pavement was dry and defect free. The roadway in the crash vicinity was straight, and free of any traffic control devices. There was a downhill negative grade of more than 2% noted at the crash location. The location of the crash was not a junction; there were no ramps within the area of the crash location for westbound vehicles operating on this side of the center median.

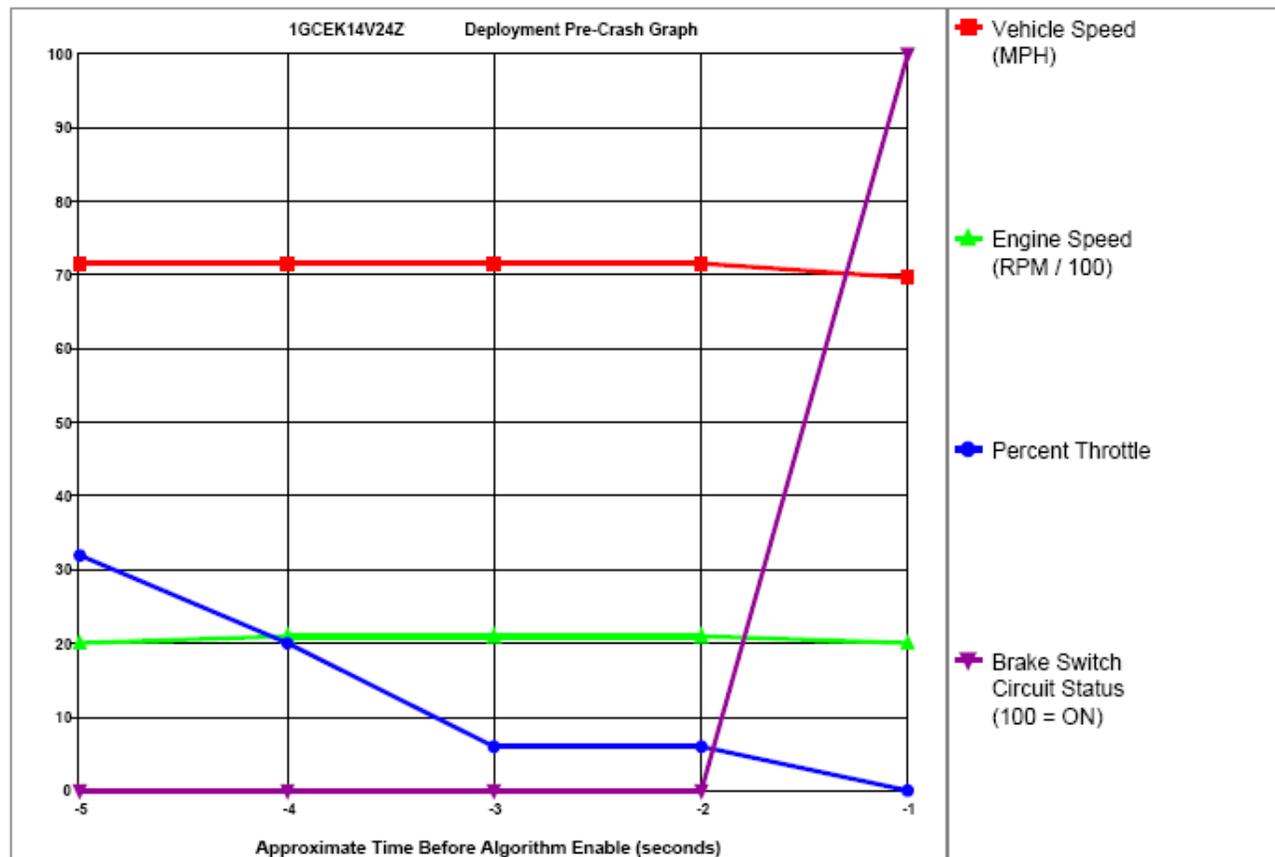
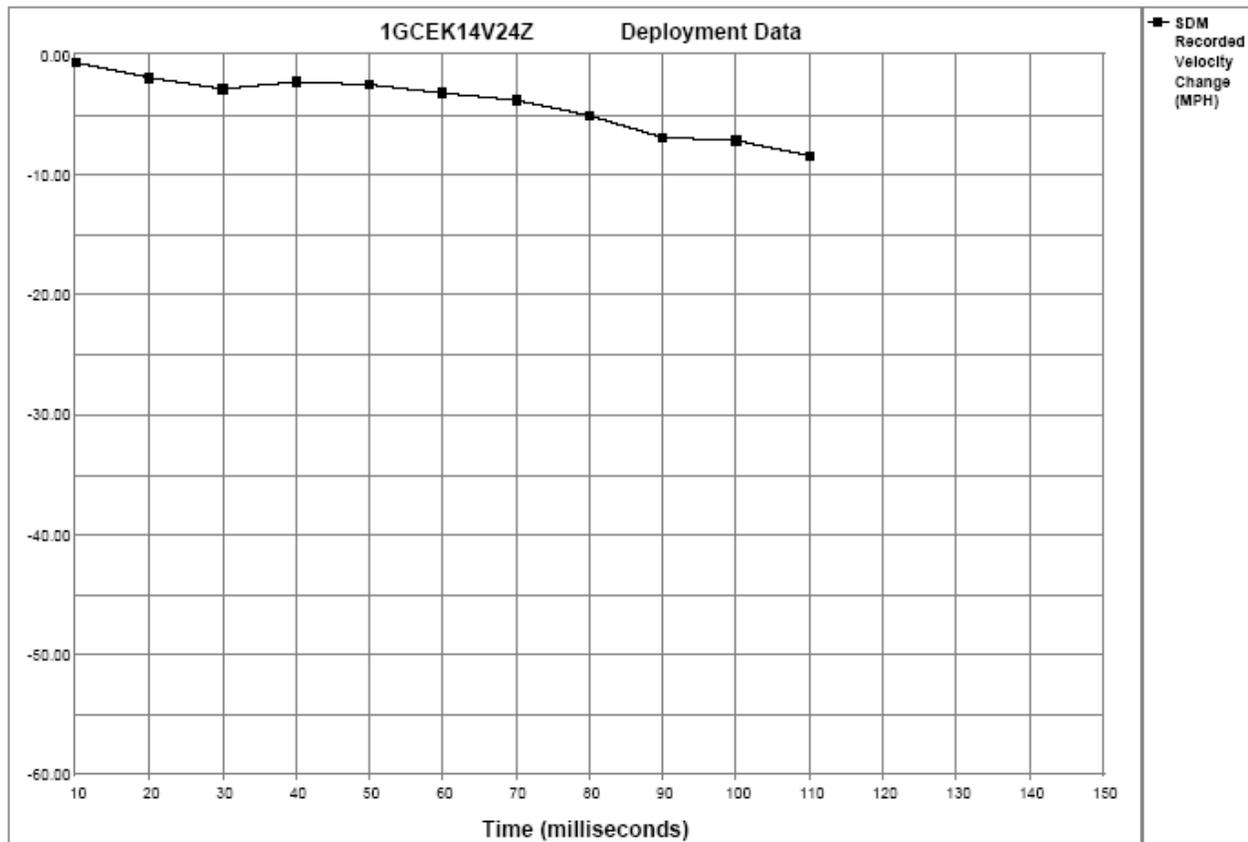
SIR Warning Lamp Status	OFF
Driver's Belt Switch Circuit Status	BUCKLED
Ignition Cycles At Deployment	3186
Ignition Cycles At Investigation	3187
Maximum SDM Recorded Velocity Change (MPH)	-15.02
Algorithm Enable to Maximum SDM Recorded Velocity Change (msec)	215
Driver First Stage Time Algorithm Enabled to Deployment Command Criteria Met (msec)	12.5
Driver Second Stage Time Algorithm Enabled to Deployment Command Criteria Met (msec)	N/A
Passenger First Stage Time Algorithm Enabled to Deployment Command Criteria Met (msec)	Suppressed
Passenger Second Stage Time Algorithm Enabled to Deployment Command Criteria Met (msec)	N/A
Time Between Non-Deployment And Deployment Events (sec)	N/A
Frontal Deployment Level Event Counter	1
Event Recording Complete	Yes
Multiple Events Associated With This Record	No
One Or More Associated Events Not Recorded	No

Seconds Before AE	Vehicle Speed (MPH)	Engine Speed (RPM)	Percent Throttle	Brake Switch Circuit Status
-5	71	2048	32	OFF
-4	71	2112	20	OFF
-3	71	2112	6	OFF
-2	71	2112	6	OFF
-1	70	1984	0	ON

Time (milliseconds)	10	20	30	40	50	60	70	80	90	100	110	120	130	140	150
Recorded Velocity Change (MPH)	-0.62	-1.86	-2.79	-2.17	-2.48	-3.10	-3.72	-4.96	-6.82	-7.13	-8.37	N/A	N/A	N/A	N/A

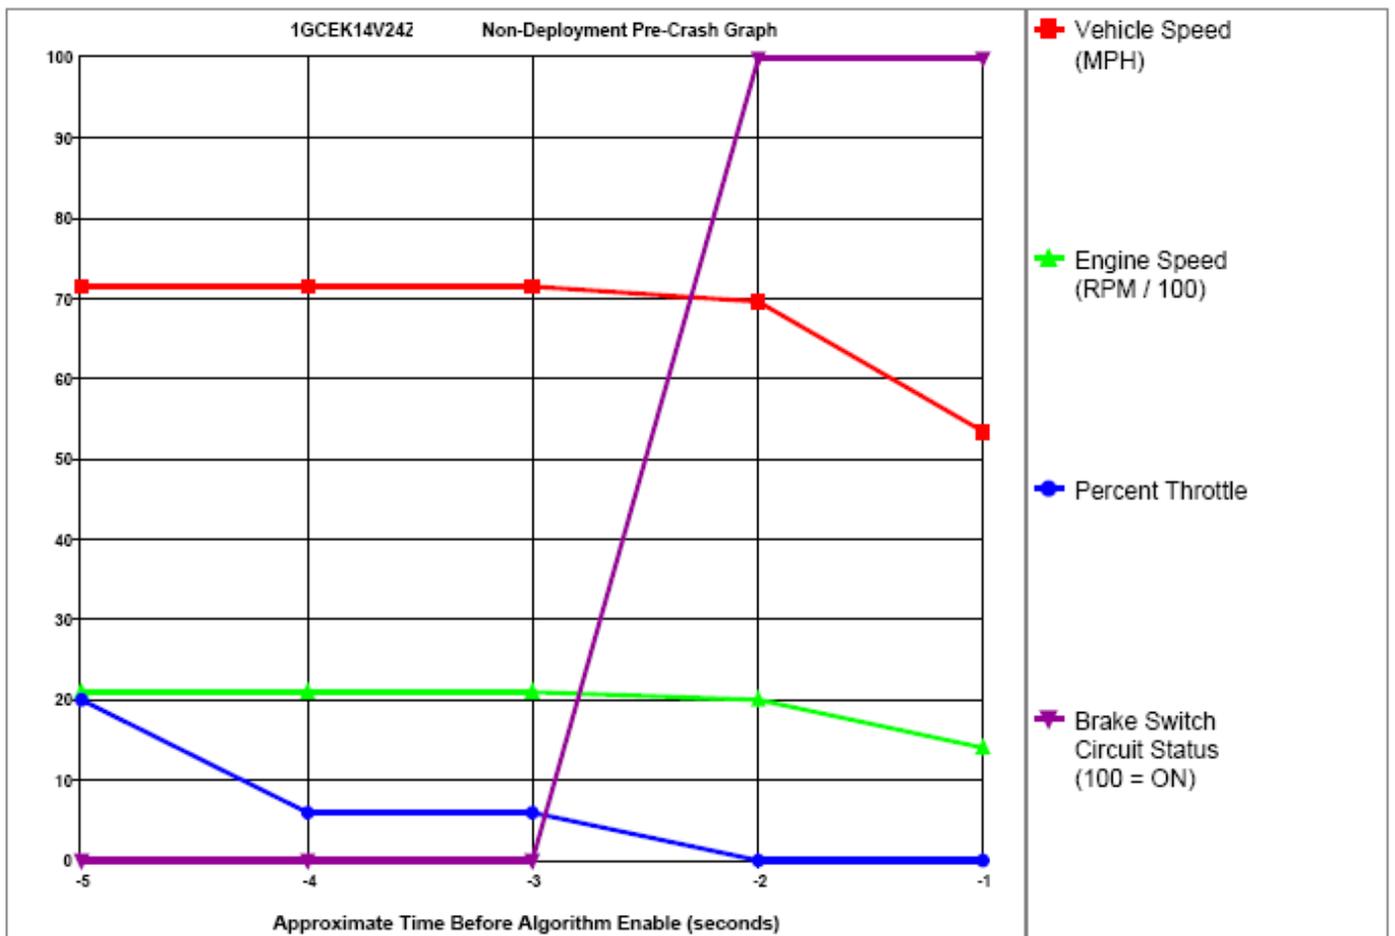
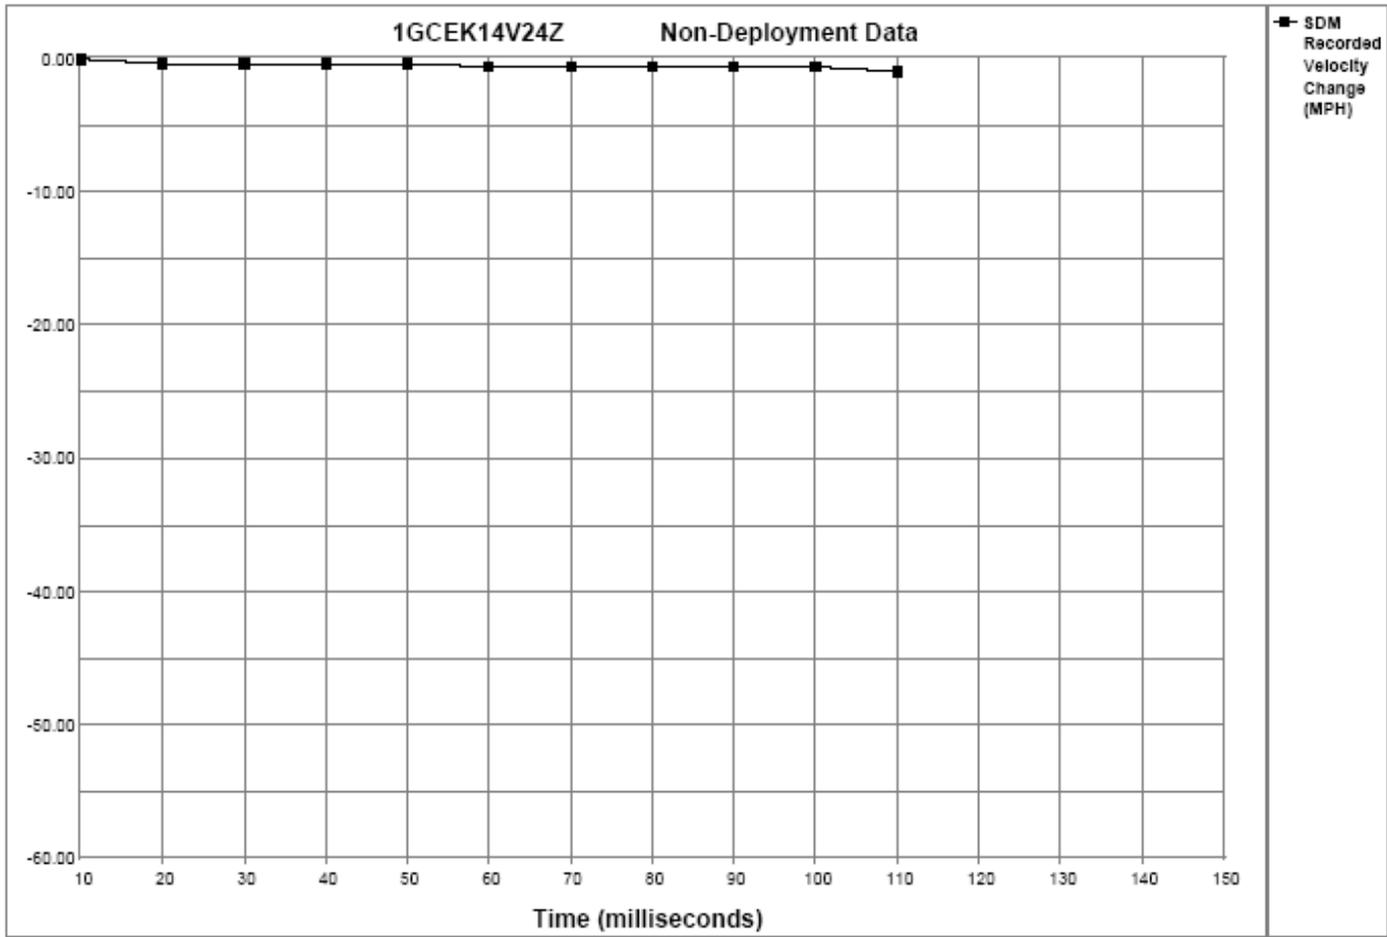
SIR Warning Lamp Status	OFF
Driver's Belt Switch Circuit Status	BUCKLED
Ignition Cycles At Non-Deployment	3186
Ignition Cycles At Investigation	3187
Maximum SDM Recorded Velocity Change (MPH)	-0.99
Algorithm Enable to Maximum SDM Recorded Velocity Change (msec)	110
Event Recording Complete	Yes
Multiple Events Associated With This Record	No
One Or More Associated Events Not Recorded	No

Seconds Before AE	Vehicle Speed (MPH)	Engine Speed (RPM)	Percent Throttle	Brake Switch Circuit Status
-5	71	2112	20	OFF
-4	71	2112	6	OFF
-3	71	2112	6	OFF
-2	70	1984	0	ON
-1	53	1408	0	ON

Time (milliseconds)	10	20	30	40	50	60	70	80	90	100	110	120	130	140	150
Recorded Velocity Change (MPH)	0.00	-0.31	-0.31	-0.31	-0.31	-0.62	-0.62	-0.62	-0.62	-0.62	-0.93	N/A	N/A	N/A	N/A
