Remote Investigation / Rollover, 15 Passenger Van
Dynamic Science, Inc. / Case Number: DS04011
2003 Ford Econoline E350 van
Washington
December, 2003

1. Report No. DS04011	2. Government Accession No.		3. Recipient Catalog No.	
4. Title and Subtitle Remote Investigation / 15 Passenger Van			5. Report Date July 11, 2006

Dynamic Science, Inc.
Crash Investigation
Case Number: DS04011

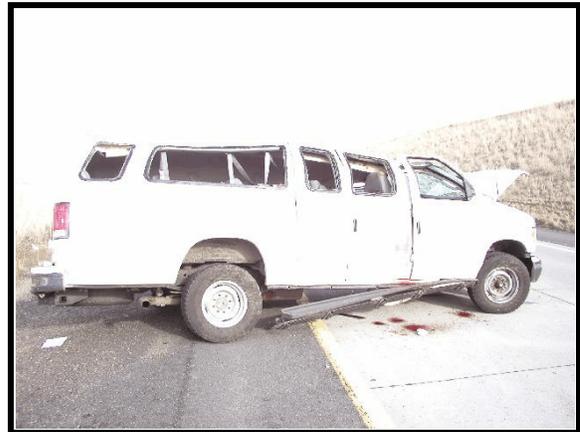
Figure 1. Right side, Ford Econline van

Damage Description: Moderate roof and side damage consistent with a rollover crash. Left side tires were both off the rims.

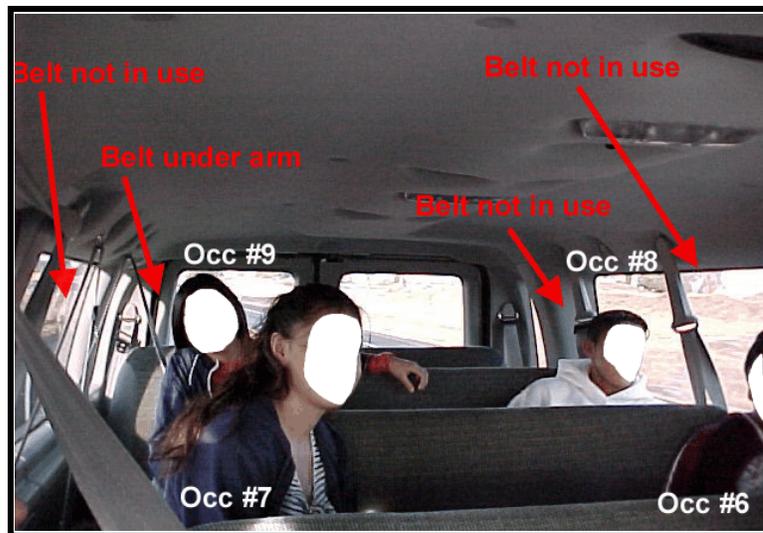
Figure 11. Digital photo taken during trip by front seat occupant

Occupant 9 (seated in position 11) was wearing the available lap and shoulder belt incorrectly. Belt usage was based on a photo taken by a front seat occupant showing the belt worn under the occupant's arm.

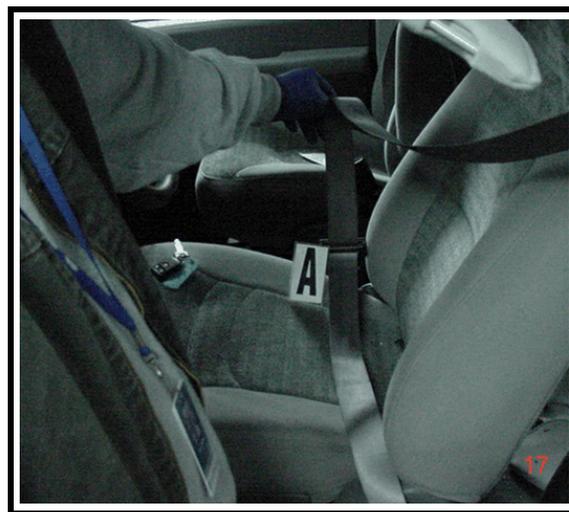
Figure 13. Driver's seated position

The 35-year-old driver of the case vehicle was seated in an upright fashion. He was wearing the manual 3-point lap and shoulder belt. The seat belt shoulder adjustment was in the full down position. As the vehicle encountered the frost/ice, the driver began to make sharp steering movements. As he lost control of the vehicle, the vehicle began a clockwise rotation. As the vehicle rotated approximately 90 degrees from its initial path of travel, the vehicle tripped and began to rollover about its longitudinal axis with its left side leading. The vehicle overturned three times as it continued on for an additional 46 m (152 ft) before coming to rest on its wheels facing generally east. The driver likely shifted from right to left during the steering maneuver, and then shifted sharply to the right as the vehicle rolled to the left. He remained in his seat, with the seat belt fastened, throughout the rollover sequence. He sustained a lumbar strain. He was transported to a local hospital where he was treated and released.

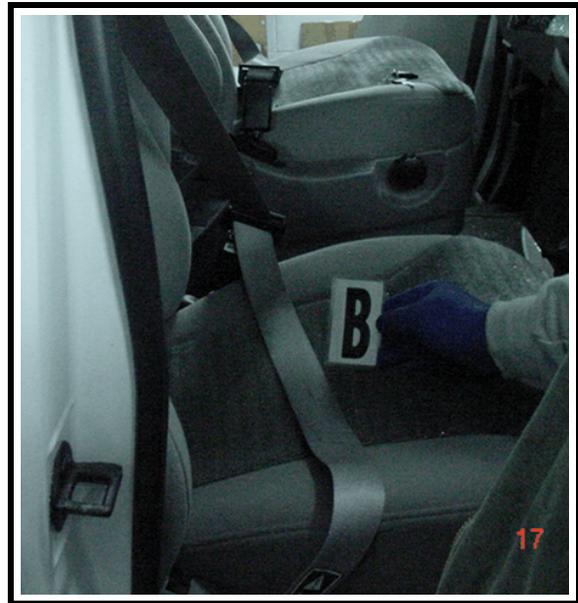
Figure 14. Front right seat occupant seated area

The 16-year-old female front right occupant was seated in an upright fashion. She was wearing the manual 3-point lap and shoulder belt. The seat belt shoulder adjustment was an unknown position. As the vehicle encountered the frost/ice, the driver began to make sharp steering movements. As he lost control of the vehicle, the vehicle began a clockwise rotation. As the vehicle rotated approximately 90 degrees from its initial path of travel, the vehicle tripped and began to rollover about its longitudinal axis with its left side leading. The vehicle overturned three times. This occupant likely shifted from right to left during the steering maneuver, and then shifted sharply to the right as the vehicle rolled to the left. This occupant likely struck the

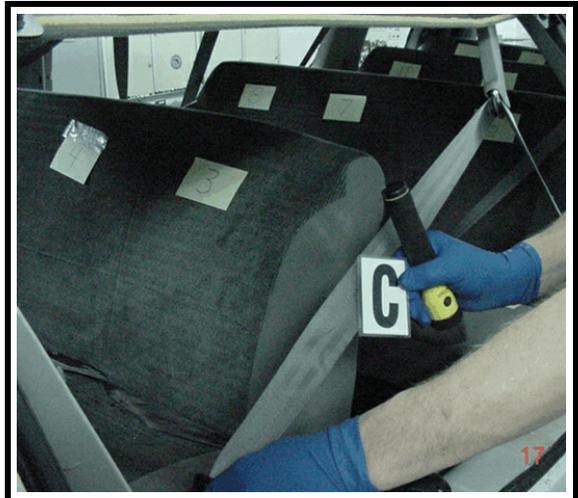
Figure 15. Second row left occupant seated position

Occupant 3 (seated in position 3) was not restrained. Belt usage was based on the post crash location of the belt. The police found it jammed between the left side of the vehicle and seat back.

The 16-year-old female second row left occupant was seated in an upright fashion. She was not wearing the manual 3-point lap and shoulder belt. As the vehicle encountered the frost/ice, the driver began to make sharp steering movements. As he lost control of the vehicle, the vehicle began a clockwise rotation. As the vehicle rotated approximately 90 degrees from its initial path of travel, the vehicle tripped and began to rollover about its longitudinal axis with its left side leading. The vehicle overturned three times. This occupant likely shifted from right to left during the steering maneuver, and then shifted sharply to the right as the vehicle rolled to the left. She was likely pitched out of her seat at various times throughout the rollover sequence. She sustained an 8.0 cm (3.1 in) laceration to the left lower leg, a laceration to the left ankle, bilateral lacerations to both knees, and abrasions to the left wrist and leg. She was transported to a local hospital where she was treated and then released.

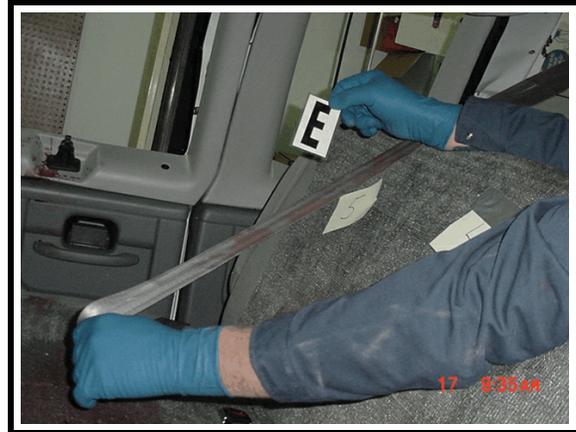
Figure 16. Second row right and middle seat positions

The 15-year-old male second row middle occupant was seated in an upright fashion. He was not wearing the manual lap belt. As the vehicle encountered the frost/ice, the driver began to make sharp steering movements. As he lost control of the vehicle, the vehicle began a clockwise rotation. As the vehicle rotated approximately 90 degrees from its initial path of travel, the vehicle tripped and began to rollover about its longitudinal axis with its left side leading. The vehicle overturned three times. This occupant likely shifted from right to left during the steering maneuver, and then shifted sharply to the right as the vehicle rolled to the left. He was likely pitched out of his seat at various times throughout the rollover sequence. He sustained a contusion to the left lower leg, possibly from the seat back.

The 16-year-old female second row right occupant was seated in an upright fashion. She was wearing the manual 3-point lap and shoulder belt improperly. It appears that the shoulder harness was not being used. The shoulder harness had been wrapped around the right side coat hook. As the vehicle encountered the frost/ice, the driver began to make sharp steering movements. As he lost control of the vehicle, the vehicle began a clockwise rotation. As the vehicle rotated approximately 90 degrees from its initial path of travel, the vehicle tripped and began to rollover about its longitudinal axis with its left side leading. The vehicle overturned three times. This occupant likely shifted from right to left during the steering maneuver, and then shifted sharply to the right as the vehicle rolled to the left. She was likely pitched out of her seat at various times throughout the rollover sequence. She was partially ejected through the right side window and was fatally injured. She remained outside of the window as the vehicle came to rest but was pulled inside by other occupants shortly after the vehicle came to rest. According to the certificate of death, she sustained a blunt head trauma and neck injuries. She had been partially ejected. The interval between the crash and the time of death was listed as instantaneously.

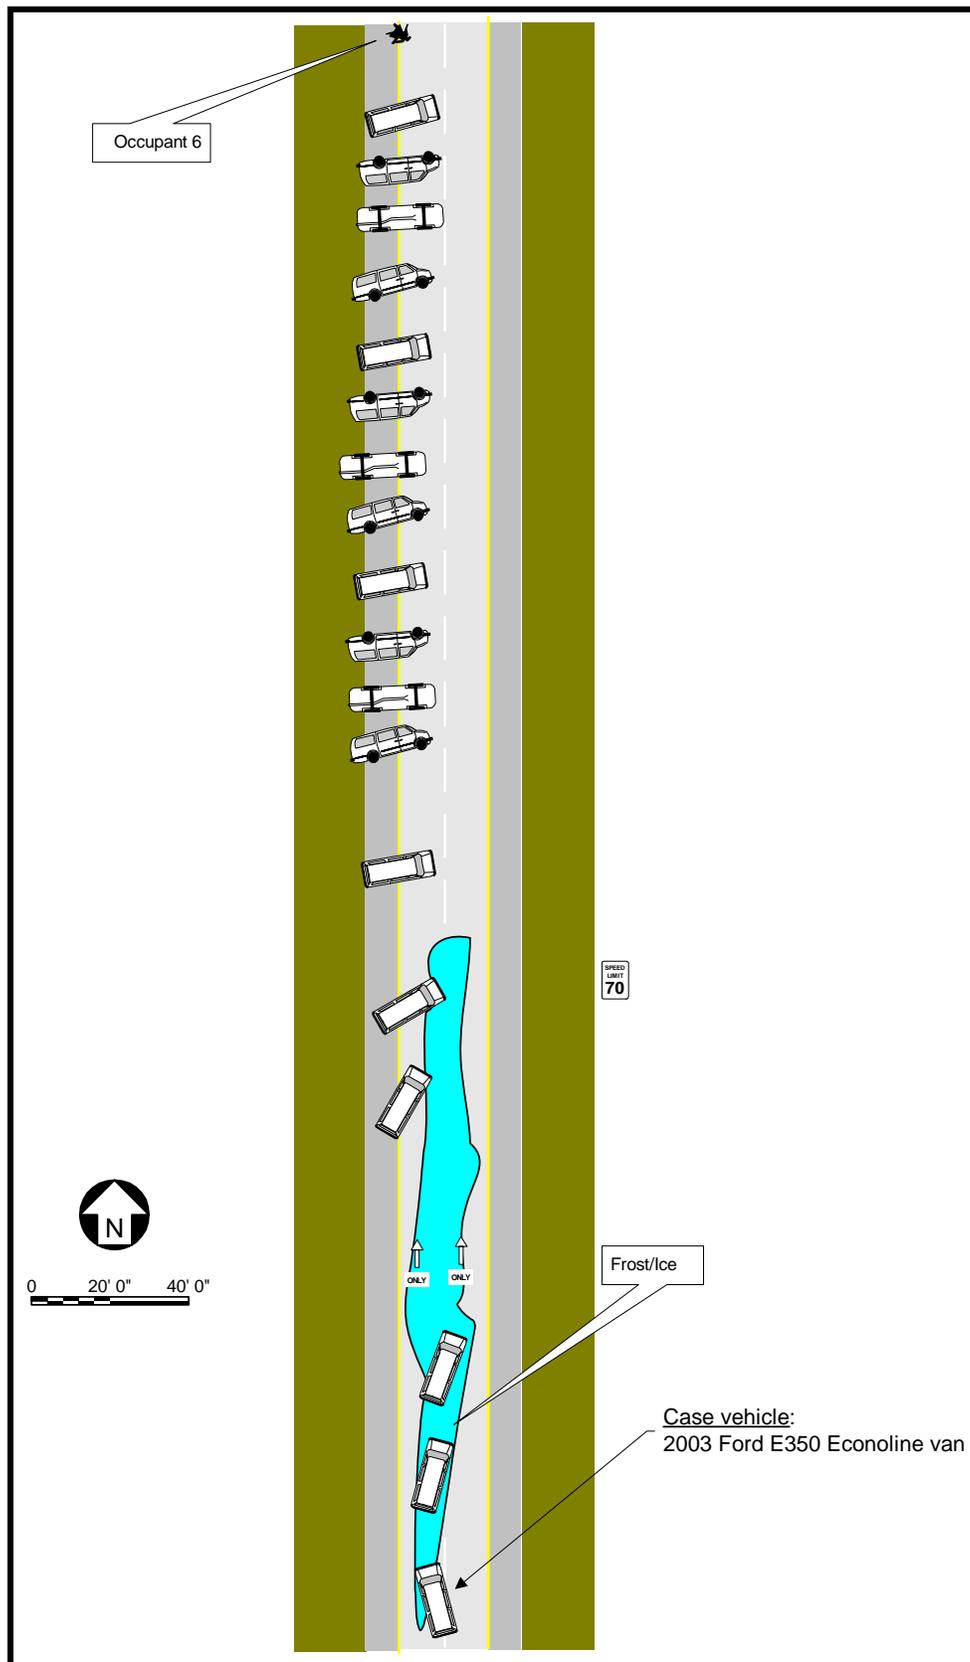
Attachment 1. Scene Diagram

The case vehicle crossed into the shadowed area and struck a patch of ice/frost. The vehicle began to fishtail to the right. The driver overcorrected to the right and the vehicle went into a clockwise yaw. The yaw continued for 56 m (183 ft) until the vehicle had reached approximately a 45 degree angle and the rear tires had entered the left side shoulder. The vehicle tripped at this point with its left side leading. The vehicle overturned three times as it continued on for an additional 46 m (152 ft) before coming to rest on its wheels facing generally east.
