# INDIANA UNIVERSITY

## ON-SITE POTENTIAL SAFETY-RELATED DEFECT INVESTIGATION

CASE NUMBER - IN-04-018

VEHICLE - 1998 FORD E350, SUPER EXTENDED CLUB WAGON XLT

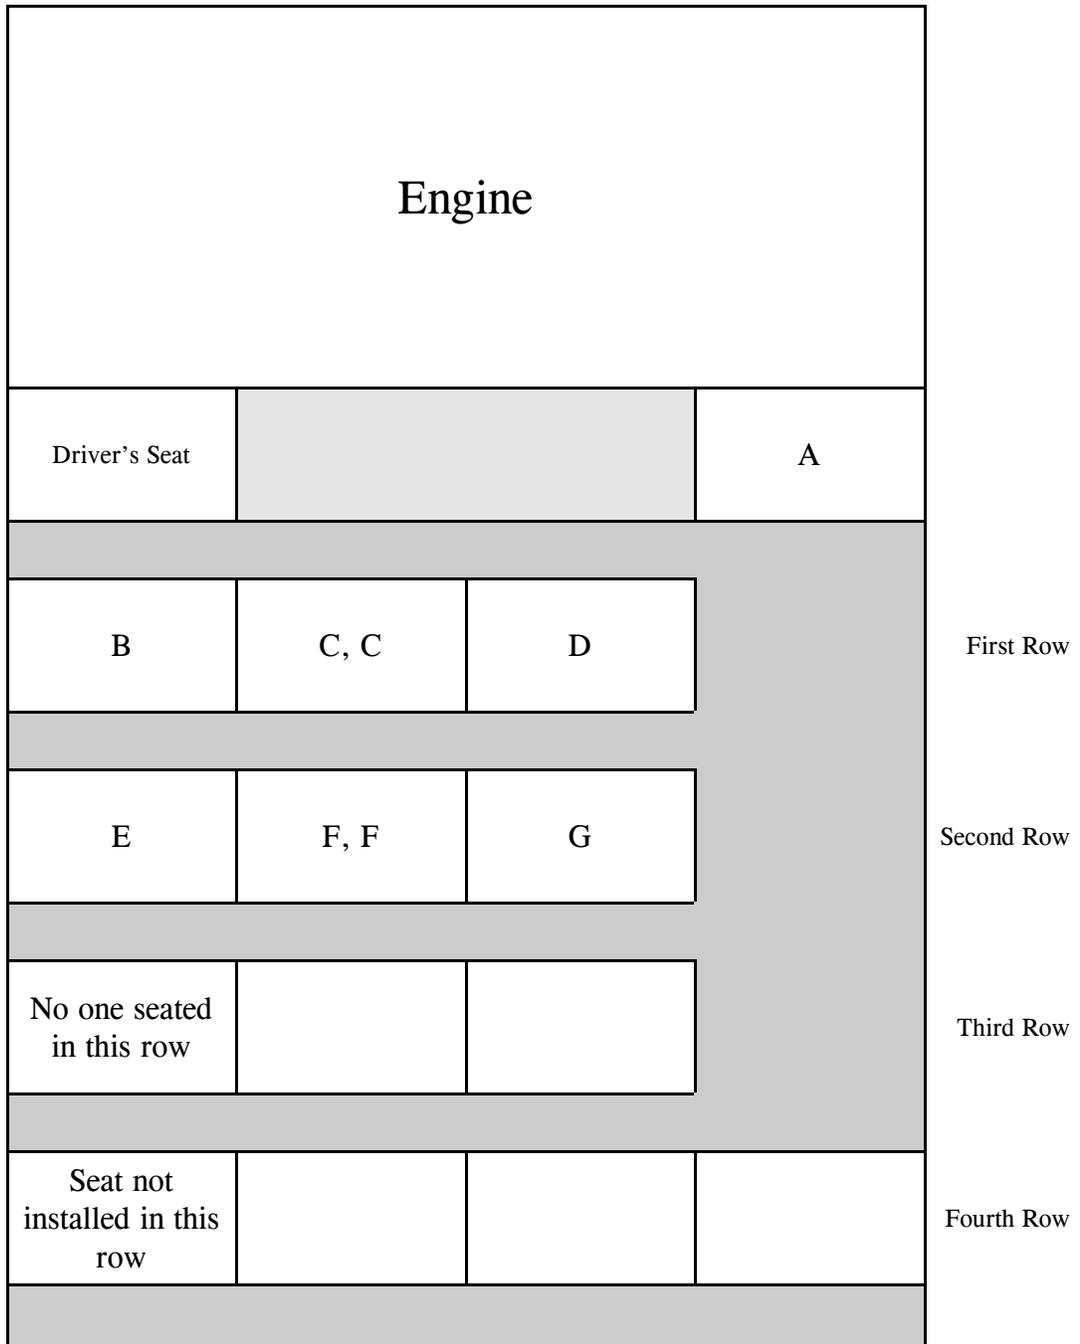
Shaded areas represent either an aisle or the area in front of a seat, refer to next page for occupant information

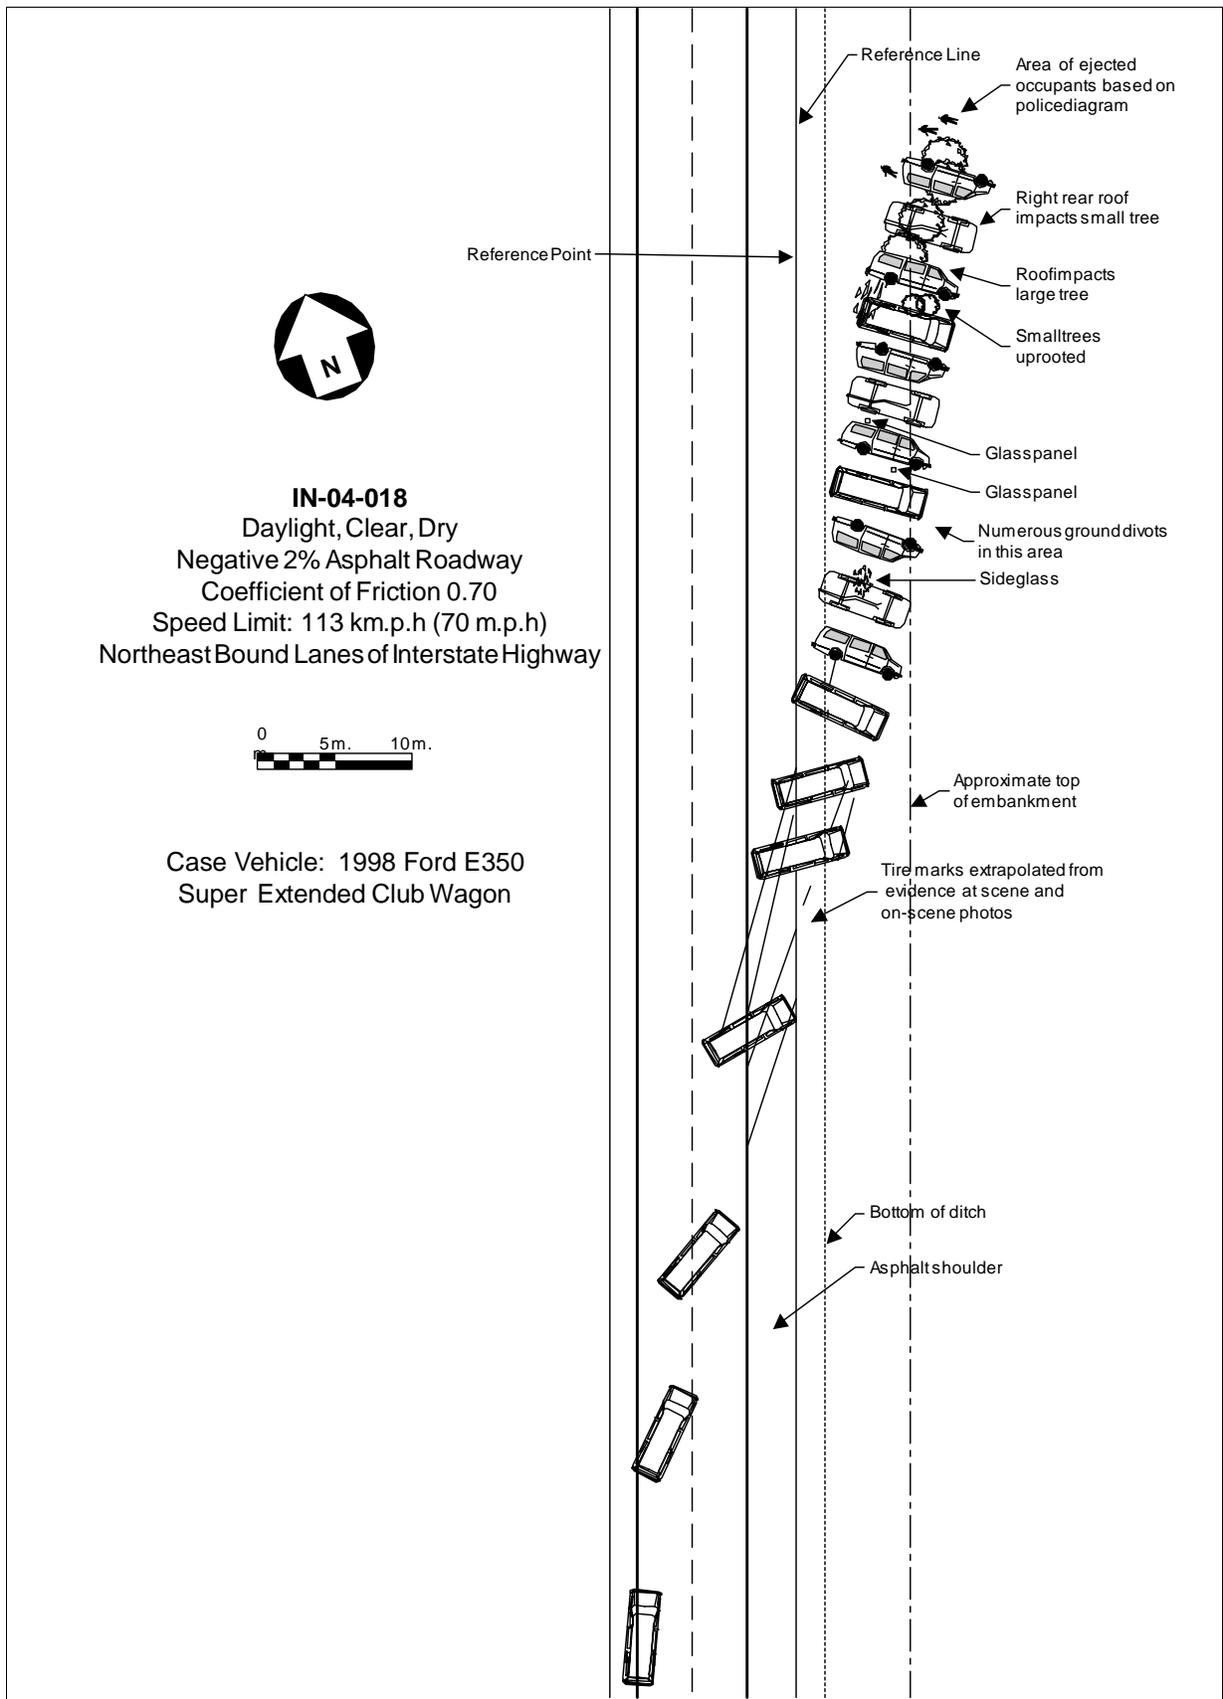
**IN-04-018**  
Daylight, Clear, Dry  
Negative 2% Asphalt Roadway  
Coefficient of Friction 0.70  
Speed Limit: 113 km.p.h (70 m.p.h)  
Northeast Bound Lanes of Interstate Highway
