ON-SITE AIR BAG RELATED CHILD FATALITY INVESTIGATION
CALSPAN CASE NO: CA04-027

VEHICLE – 1997 CADILLAC CATERA
LOCATION – FLORIDA
CRASH DATE – JUNE 2004

**ON-SITE AIR BAG RELATED CHILD PASSENGER FATALITY INVESTIGATION
CALSPAN CASE NO: CA04-027**

**VEHICLE: 1997 CADILLAC CATERA
LOCATION: FLORIDA
CRASH DATE: JUNE, 2004**

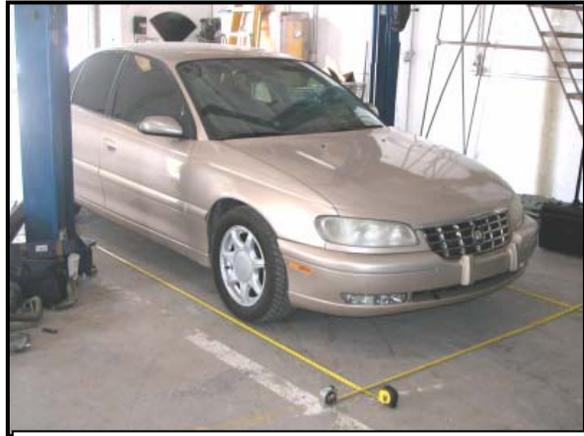
This investigation focused on the crash dynamics and fatal injury mechanisms of a 2 year old female seated on the lap of the front right passenger in a 1997 Cadillac Catera, **Figure 1**. The 1997 Cadillac was equipped with a Supplemental Inflatable Restraint (SIR) that consisted of driver and front right passenger air bags. The Cadillac was involved in a low speed undercarriage impact with a 15 cm (5.75 in) tall curb in a convenience store/service station parking lot. The driver misjudged the speed and position of the vehicle as it entered the parking stall and suddenly applied the brakes prior to impacting the curb. The crash pulse generated by the impact was sufficient to deploy the frontal air bags in the vehicle. The 2 year old was removed from the vehicle and was reportedly crying as she was carried into the store. The store manager reported that the child's condition deteriorated over the next several minutes. The child was transported to a Level 1 pediatric trauma center via helicopter and was admitted in critical condition. Medical efforts to revive the child over the course of her hospitalization were unsuccessful. The child expired two days post-crash of a Diffuse Axonal Injury to the brain (AIS 5). The child also sustained subdural and subarachnoid brain hemorrhages, bilateral lung contusions and multiple soft tissue facial injuries as a result of the expanding front right passenger air bag. The Cadillac's 18 year old female driver and 39 year old male front right passenger were not injured in the event.

Figure 1: 1997 Cadillac Catera.

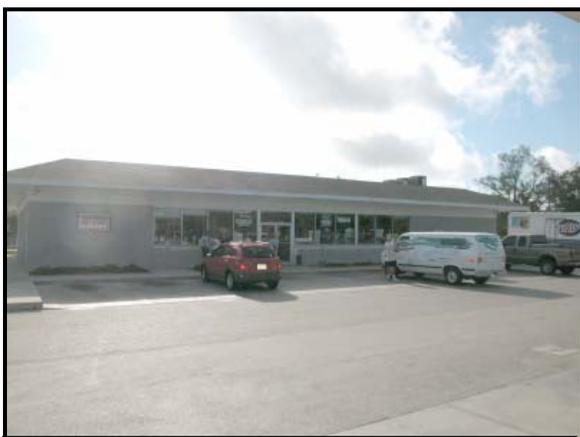
Figure 2: View of the convenience store looking eastward.

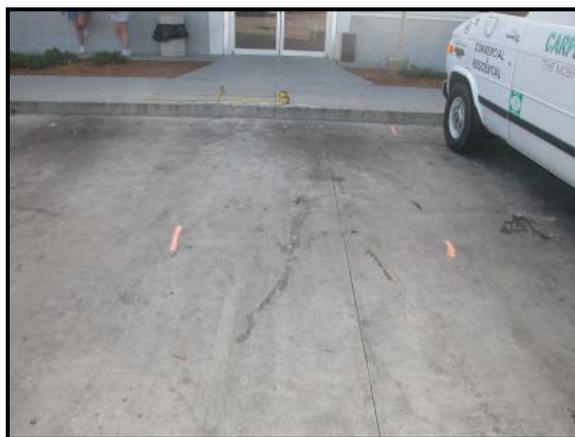
Figure 3: View of the point of impact at the store front.

While the occupants of the Cadillac were in the store, the vehicle began to roll backward. Apparently, the driver shifted the transmission of the (now stalled) vehicle into neutral after the crash. The ignition interlock would have prevented the transmission from a shift into park. Bystanders ran out of the store, stopped the vehicle and then pushed it back to the curb. During this maneuver, the position of the vehicle was displaced approximately 0.8 m (2.7 ft) south relative to impact position. The position of the Cadillac documented by the police investigation (**Figure 3**) was not its position at the time of the impact or final rest.

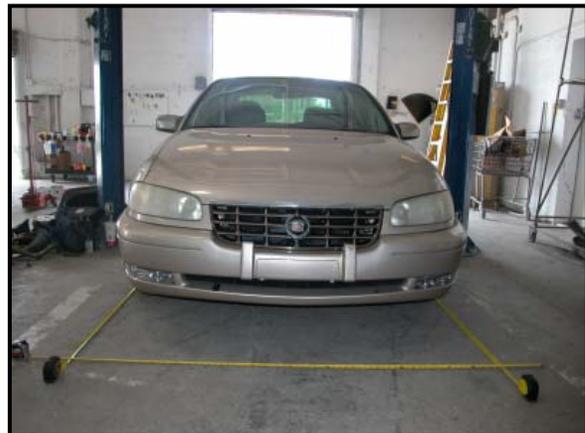
Figure 5: Front view of the Cadillac.

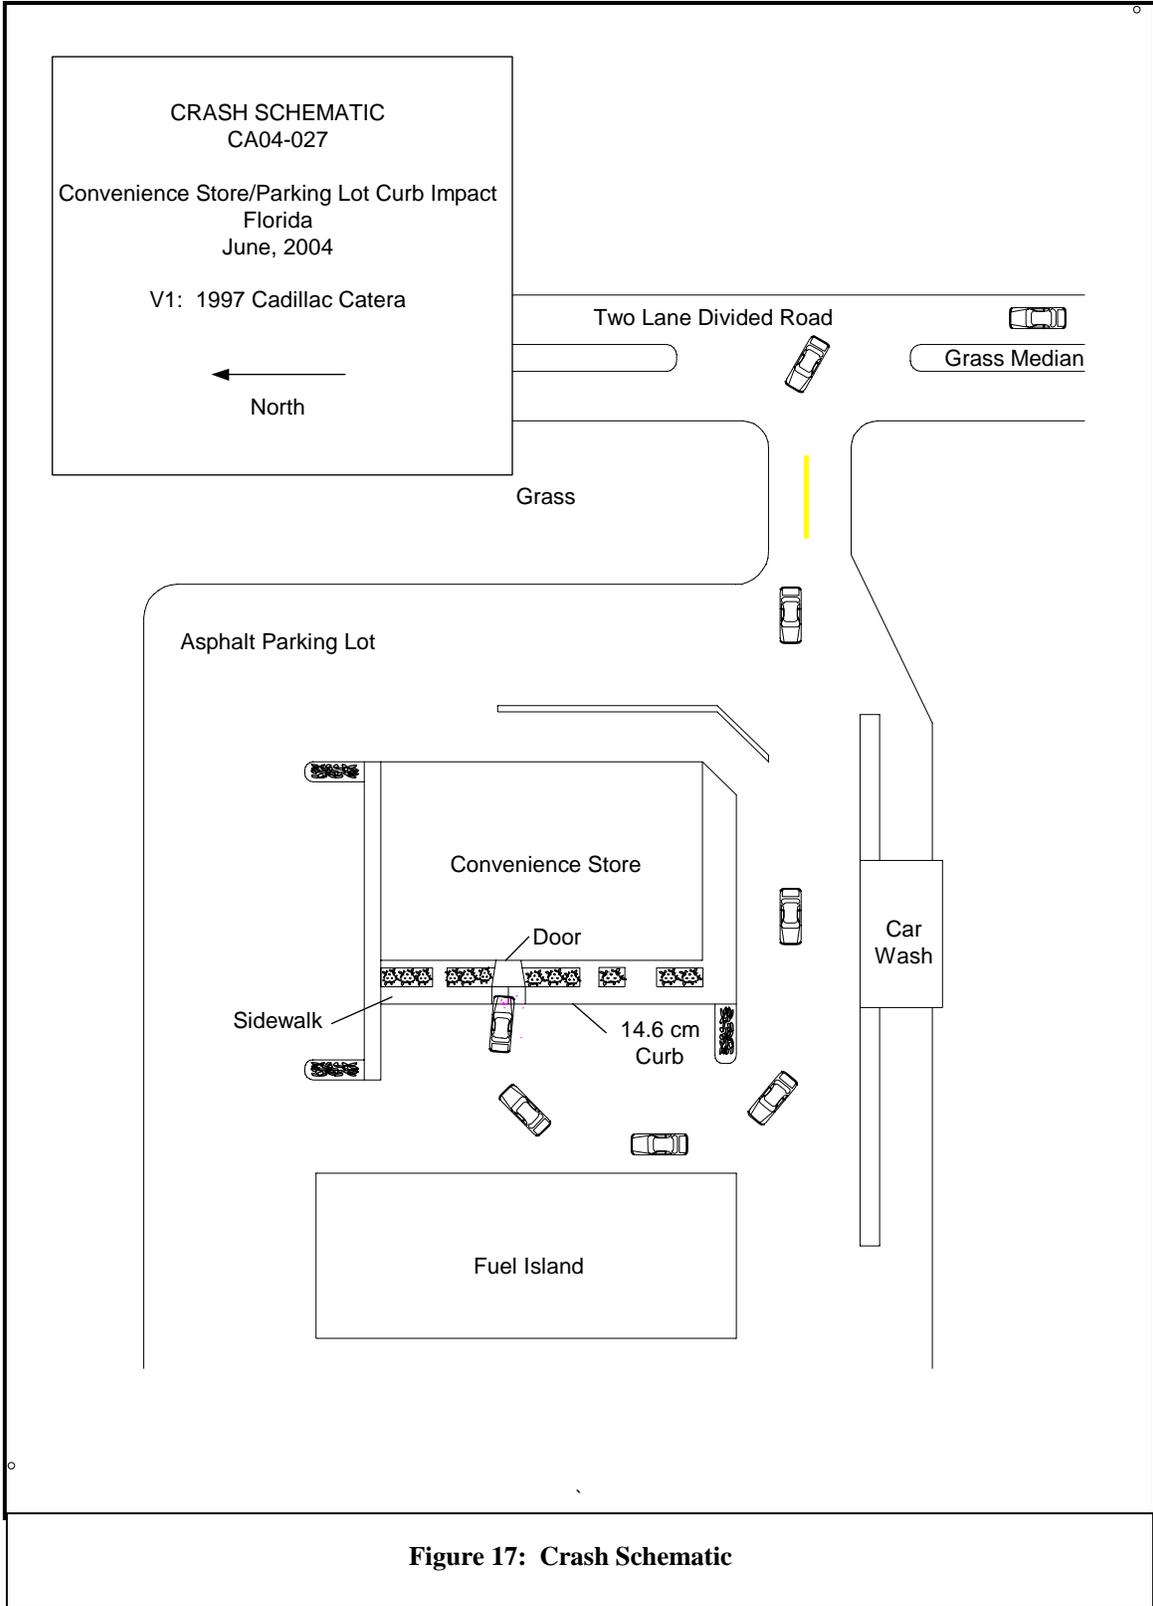
Figure 17: Crash Schematic

divided local road in the state of Florida. This business consisted of a convenience store, a fuel island with twelve gas pumps, and a car wash. The convenience store measured 38.3 m x 23.6 m (97.4 ft x 60.0 ft) and was bordered on three sides by a 15 cm (5.75 in) tall concrete barrier curb and sidewalk. The long dimension of the building was oriented in the north/south direction. Traffic entered the property from the west off of the US route or from the east via the local road. Vehicles conducting business at the store maneuvered through the parking lot and parked perpendicular to the curb on the north and west sides of the building. The subject crash occurred directly in front of the entrance doors to the store on the west side of the building. The crash was captured on video by surveillance cameras covering the front of the store. **Figure 2** is an overall view of the convenience store. **Figure 3** is a view of the entrance doors and the point of impact. A schematic of the crash is attached to the end of this narrative report, **Figure 17**.
