CALSPAN ON-SITE CHILD SAFETY SEAT CRASH INVESTIGATION

CASE NO: CA05-055

VEHICLE: 1994 PLYMOUTH VOYAGER

CRASH DATE: OCTOBER 2005

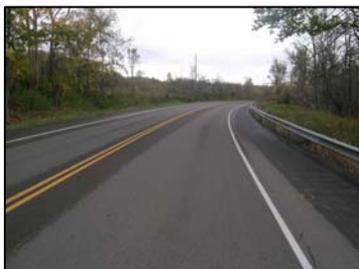
Figure 2 - Eastbound approach of Plymouth Voyager.

The 50-year old female driver of the Plymouth Voyager was traveling in an easterly direction on a two-lane roadway negotiating a right curve (**Figure 2**). According to a witness the vehicle was driving erratically weaving in out of the eastbound lane. As the Plymouth was negotiating the curve it entered the westbound lane and impacted a 1993 Chevrolet K-1500 pickup truck that was westbound on the same roadway (**Figure 3**). The 43-year old male driver of the Chevrolet applied and locked up his brakes prior to the impact evidenced by a 6.9 m (22.6') long skid mark from the front right tire. Roadway gouging was also present at the point of impact (**Figure 4**).

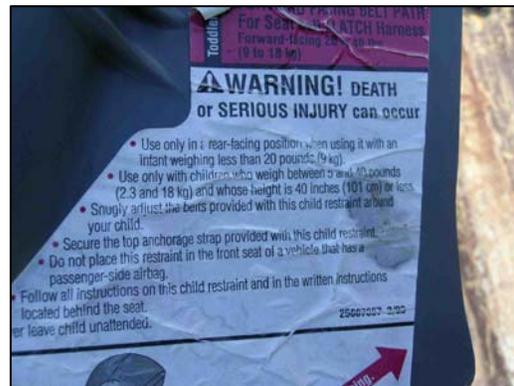
Figure 17 - CSS labeling.

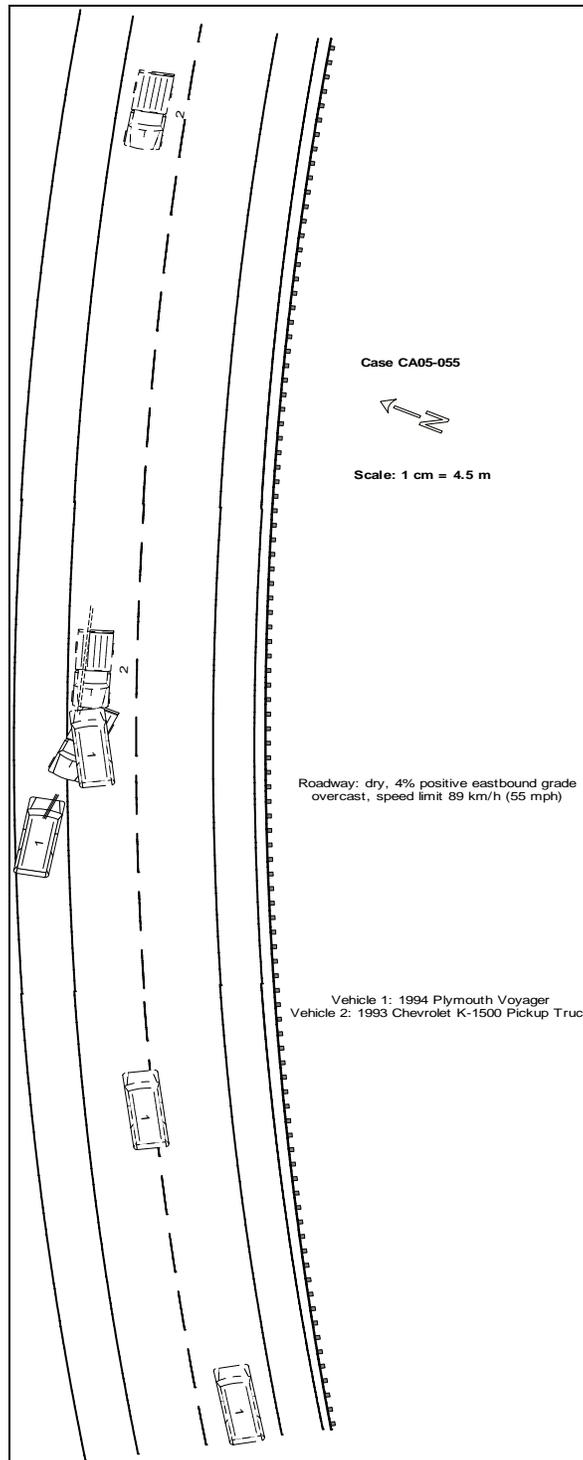
Figure 19 – Scene Schematic

This two vehicle crash occurred on a well traveled two-lane east/west rural roadway in October 2005. At the time of the crash, the asphalt roadway was dry and there were no adverse weather conditions. The east/west roadway was configured with one lane in each direction that was separated by a painted double-yellow centerline. The travel lanes were 3.7 m (12.1') in width and were bordered by a 2.7 m (8.9') north side and a 2.1 m (6.9') wide south side paved shoulder. The roadway was curved with a radius of curvature calculated at 288 meters (940'). The roadway experienced a 4 percent positive grade in the eastbound direction. The posted speed limit for the roadway was 89 km/h (55 mph). Physical evidence in the form of skid marks and roadway gouging was identified during the scene investigation. The skid marks were attributed to the front right tire and began 3.2 m (10.5') inboard of the east road edge and terminated 4.9 m (16.1') from the same. The total length of the tire mark was 6.9 m (22.6'). The roadway gouging was located 3.6 m (11.8') inboard of the east road edge at the area of impact. The SCI scene schematic is included as **Figure 19** at the end of this narrative report.
