CALSPAN ON-SITE CHILD SAFETY SEAT CRASH INVESTIGATION

CASE NO.: CA05-061

VEHICLE: 2002 FORD EXCURSION

DATE OF CRASH: DECEMBER 2005

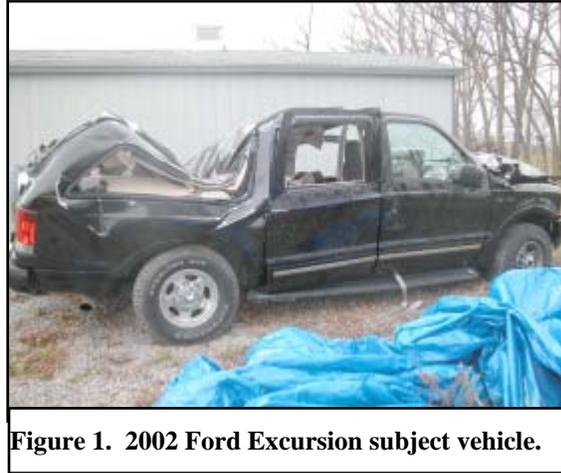
This on-site investigative effort focused on the performance of two child safety seats and the resulting injuries to the 1 and 3-year-old female passengers of a 2002 Ford Excursion (**Figure 1**). The 1-year-old female was restrained by the five-point harness in a forward facing manner within a convertible child safety seat in the second row left position. Due to the severity of her injuries, she was transported to the hospital within the child safety seat where it was subsequently discarded. The 3-year-old female was seated in a Cosco Voyager belt positioning booster seat in the third row right position. The belt positioning booster seat was captured by intrusion in the Ford and was inspected in this position. The Ford was also occupied by a restrained 31-year-old female driver and a restrained 13-year-old male front right passenger.

Figure 1. 2002 Ford Excursion subject vehicle.

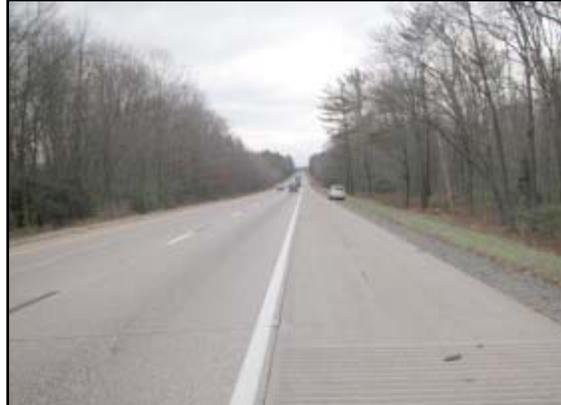
The 31-year-old female driver was operating the vehicle westbound on the right lane (**Figure 2**) at high speed. As the vehicle continued westbound, the driver allowed the Ford to drift to the left. The Ford traversed the left travel lane and entered the inboard (south) shoulder. The driver applied a sharp right steering input to return to the roadway. Due to the right steering input, the Ford re-entered the roadway and began to yaw clockwise (CW). The vehicle traversed both travel lanes and departed the north roadside at angle of 45 degrees in relation to the roadway. A 10.2 meter (33.5 feet) left rear yaw mark was present on the shoulder, which continued onto the embankment. Also present were a 2.1 meter (6.8 feet) left front tire and 2.0 meter (6.6 feet) right front yaw marks and on the shoulder.

Figure 2. Ford's pre-crash travel.

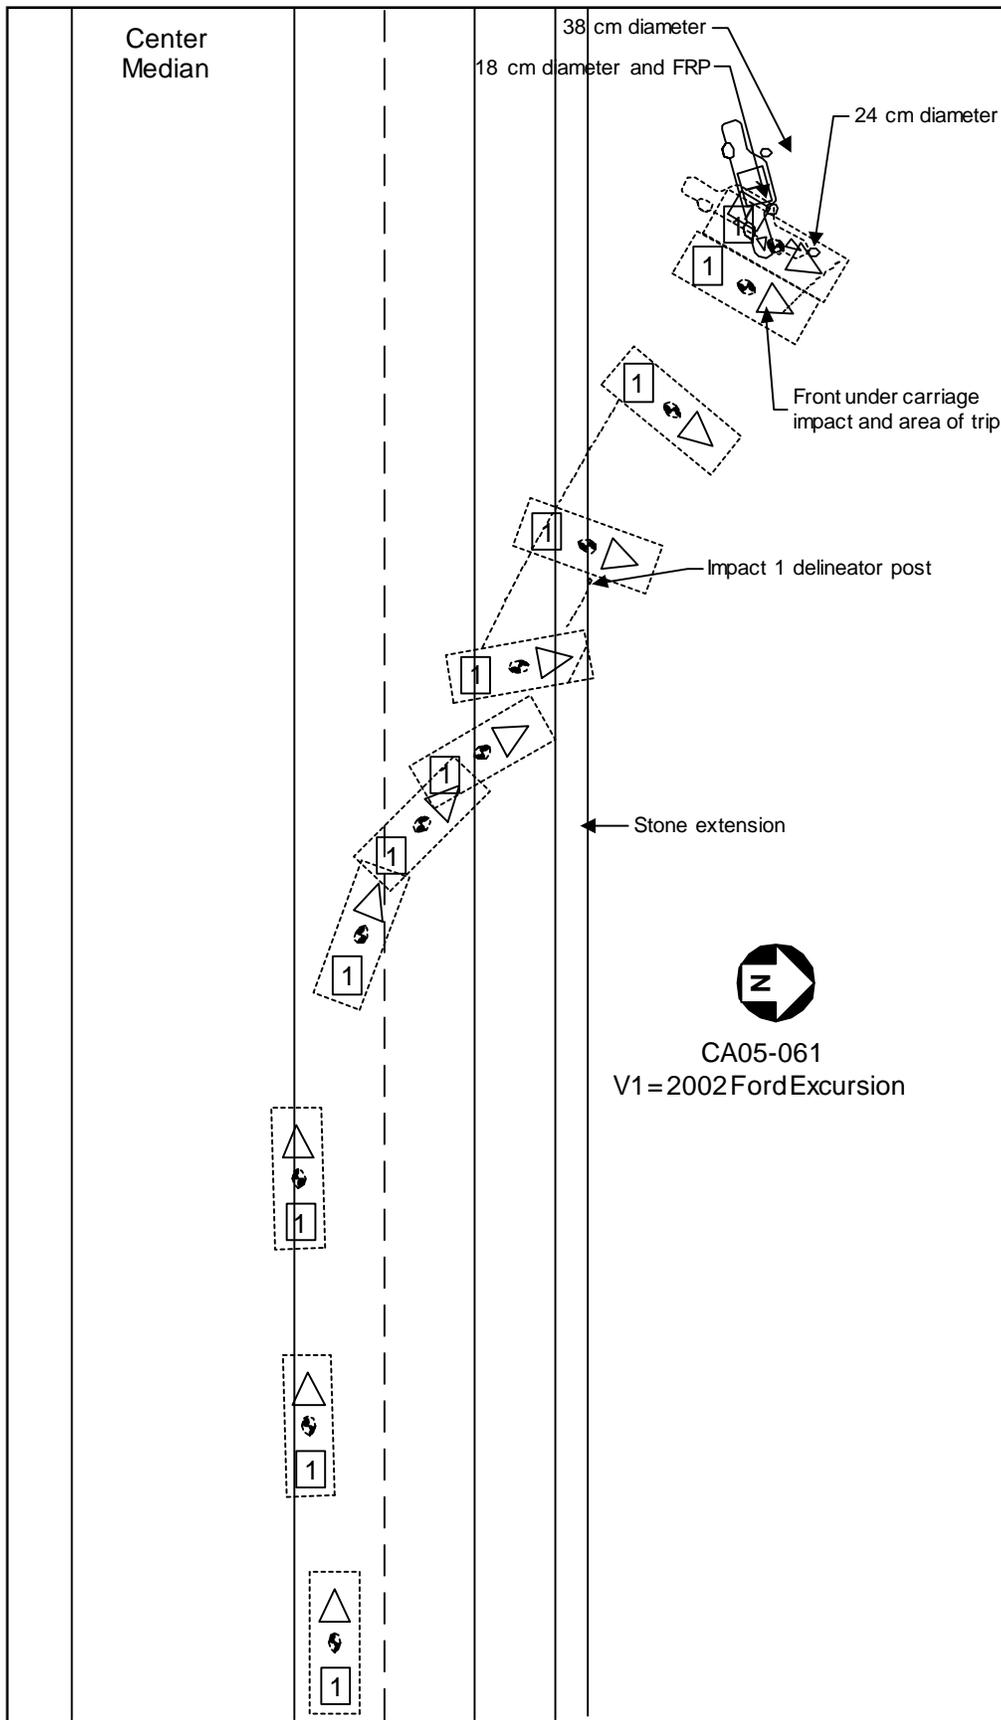
Figure 11: Scene Schematic

This run-off road crash occurred on the north roadside of a four-lane east/west interstate. The travel lanes were constructed of concrete and were delineated by broken white lane lines and bordered by a white fog line on the north edge and a yellow fog line on the south edge. Outboard of the north fog line was a 3.3 meter (10.8 feet) concrete shoulder with perpendicular rumble strips. The north roadside consisted of an 8.6 meter (28.2 feet) wide grass embankment with a negative grade and a tree line. The struck trees were 24 cm (9.4”), 18 cm (7.1”), and 38 cm (15.0”) in diameter, respectively. The posted speed limit was 105 km/h (65 mph). The scene schematic is included as **Figure 11** of this report.
