**CALSPAN ON-SITE CHILD SAFETY SEAT CRASH INVESTIGATION  
GRACO SNUG RIDE REAR FACING CHILD SAFETY SEAT**

**CASE NO: CA06-008**

**VEHICLE: 2000 FORD EXPLORER**

**CRASH DATE: MARCH 2006**

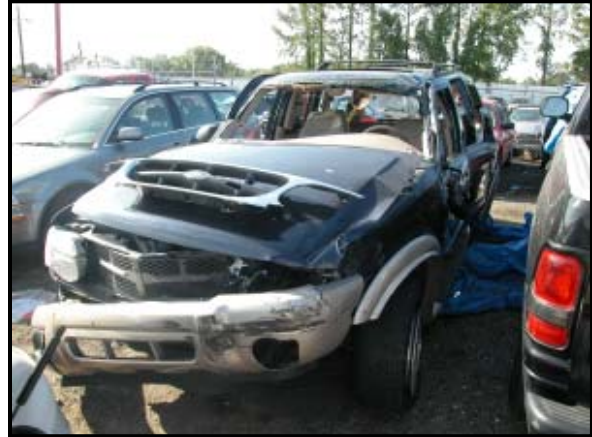
This investigation focused on the performance of a Graco Snug Ride rear-facing Child Safety Seat (CSS) installed in the center rear position of a 2000 Ford Explorer that was involved in a rollover crash, **Figure 1**. The Ford was driven by a 23 year old restrained female and occupied by a 5 month old female restrained within the child safety seat. The Ford was eastbound in the center lane of a three-lane, limited access divided highway at a reported speed of 97 km/h (60 mph). An active road construction zone was in place at the time of the crash. The eastbound Ford encountered a utility ladder blocking the lane and the driver steered right to avoid the obstruction. In the process of this maneuver, the front right aspect of the Explorer sideswiped the left rear aspect 1998 Ford (unknown model) work truck. The driver then over-steered the subject vehicle back to the left and lost control. The Ford tripped over the right front tire and rolled four-quarter turns. As the vehicle came back onto its tires, the left aspect of the Ford's front plane struck the center Jersey-style construction barrier. A witness trailing the Ford notified the authorities of the crash via the 9-1-1 system and stopped to render aid. As the witness approached the Ford Explorer, he saw that the driver had sustained a visible arm injury and heard the infant crying from the rear seat. With the assistance of a police officer, the witness opened the rear door and found the infant still restrained within the child safety seat. She was not injured. The infant was taken by ground ambulance to a local hospital for observation and released. The driver was removed from the Ford Explorer, transported by ground ambulance, and hospitalized for nine days. She sustained a deep abrasion to her left forearm (near the wrist) and tendon lacerations due to ground contact during the rollover sequence. The driver of the 1998 Ford work truck was not injured in the crash and the vehicle was driven from the scene at the conclusion of the police investigation.

**Figure 1: Front view of the Ford Explorer.**

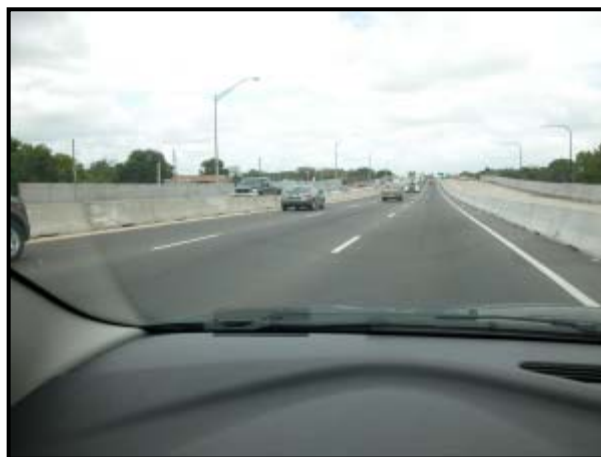
This rollover crash occurred during the afternoon hours of March 2006. At the time of the crash, it was daylight and the weather was not a factor. The crash occurred on the eastbound lanes of a three-lane, limited access interstate highway that was undergoing reconstruction. An active construction zone was in place over an estimated 24 km (15 mile) section of the interstate that further reduced access to the highway due to construction at several of the entrance/exit ramps. The construction zone was still in place at the time of the SCI scene inspection and prevented a detailed scene inspection because of safety concerns. **Figure 2** is an eastbound view of the highway near the reported crash location.

As depicted, the respective outboard aspects of the roadway were bordered by Jersey barriers that channeled traffic through the construction zone. The traffic lanes were an estimated 7.5 m (12 ft) in width and separated by broken white lines. The respective shoulders (outboard the travel lanes) were narrow with an estimated 1 m (3 ft) width. The speed limit in the area of the crash was 97 km/h (60 mph).

**Figure 2: Eastward view at the crash site.**

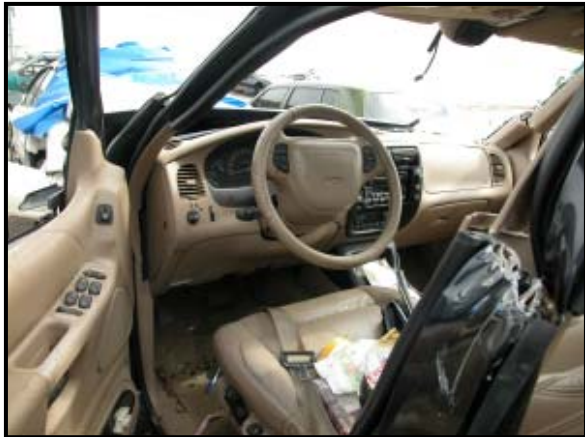
Inspection of the vehicle's interior was limited due to the terminated cooperation with the tow yard. There was no noted interior damage or intrusion related to the exterior force of the crash sequence. There were no noted interior occupant contacts. The driver seat was adjusted to an estimated mid-track position consistent with the driver's stature. **Figures 8 and 9** are views of the Explorer's driver interior and second row respectively.

**Figure 8: Driver's interior view.**

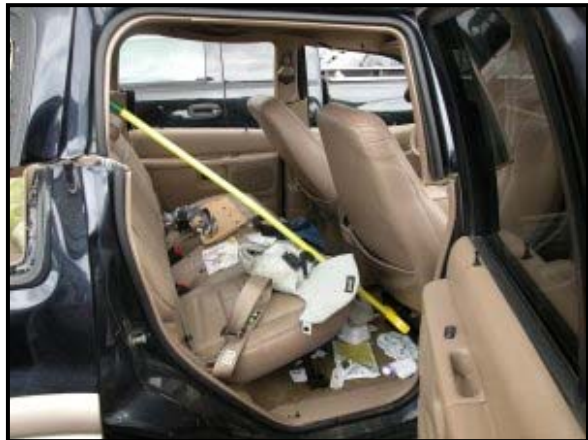
**Figure 9: Right view of the second row.**
