Certified Advanced 208 Compliant Investigation / Vehicle to Vehicle
Dynamic Science, Inc. / Case Number: DS06009
2006 Chevrolet Impala
Colorado
January, 2006

1. Report No. DS06009	2. Government Accession No.		3. Recipient Catalog No.	
4. Title and Subtitle Certified Advanced 208 Compliant Air Bag Investigation			5. Report Date May 7, 2006

The focus of this on-site investigation was on the Certified Advanced 208 Compliant air bags installed in a 2006 Chevrolet Impala. The multi-stage air bags were certified by the manufacturer to meet the advanced air bag requirement of Federal Motor Vehicle Safety Standard (FMVSS) No. 208. The Chevrolet Impala was occupied by a 21-year-old female restrained driver. The Impala was traveling westbound on a curved, two lane roadway. A 2002 Toyota Tacoma pickup truck was traveling eastbound. The driver of the Impala lost control of her vehicle in the turn and entered the eastbound travel lane. The driver of the Impala braked and was likely skidding before being struck

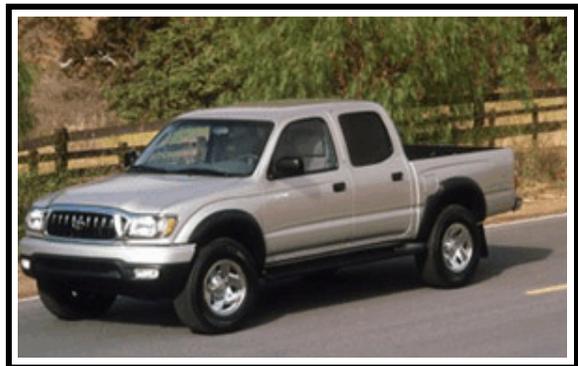
Figure 4. Exemplar view, 2002 Toyota Tacoma double cab

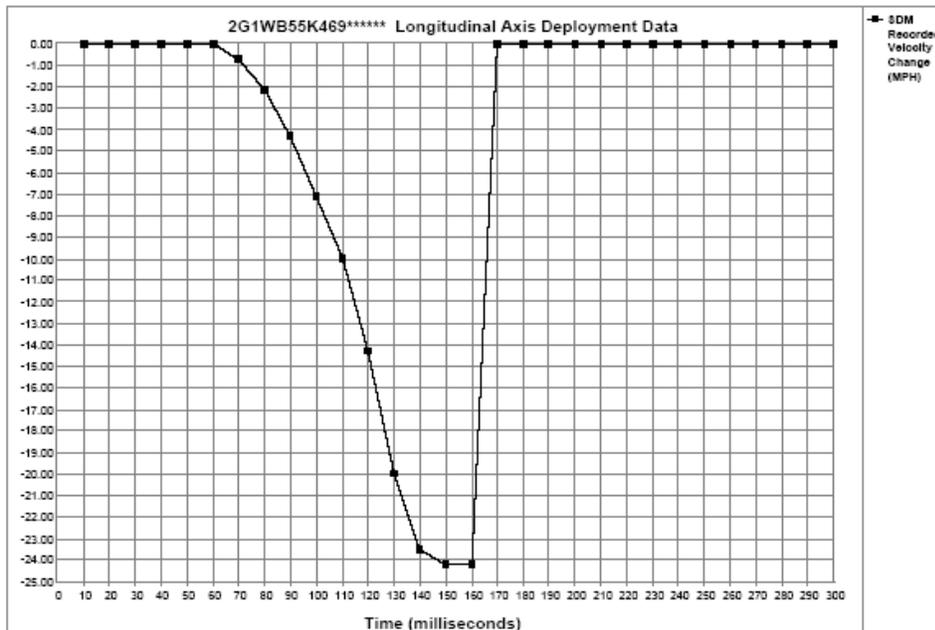
Time (milliseconds)	10	20	30	40	50	60	70	80	90	100	110	120	130	140	150
Longitudinal Axis Recorded Velocity	0.00	0.00	0.00	0.00	0.00	0.00	-0.71	-2.14	-4.28	-7.13	-9.98	-14.26	-19.96	-23.52	-24.24
Time (milliseconds)	160	170	180	190	200	210	220	230	240	250	260	270	280	290	300
Longitudinal Axis Recorded Velocity	-24.24	0.00	0.00	0.00	0.00	0.00	0.00	0.00	0.00	0.00	0.00	0.00	0.00	0.00	0.00

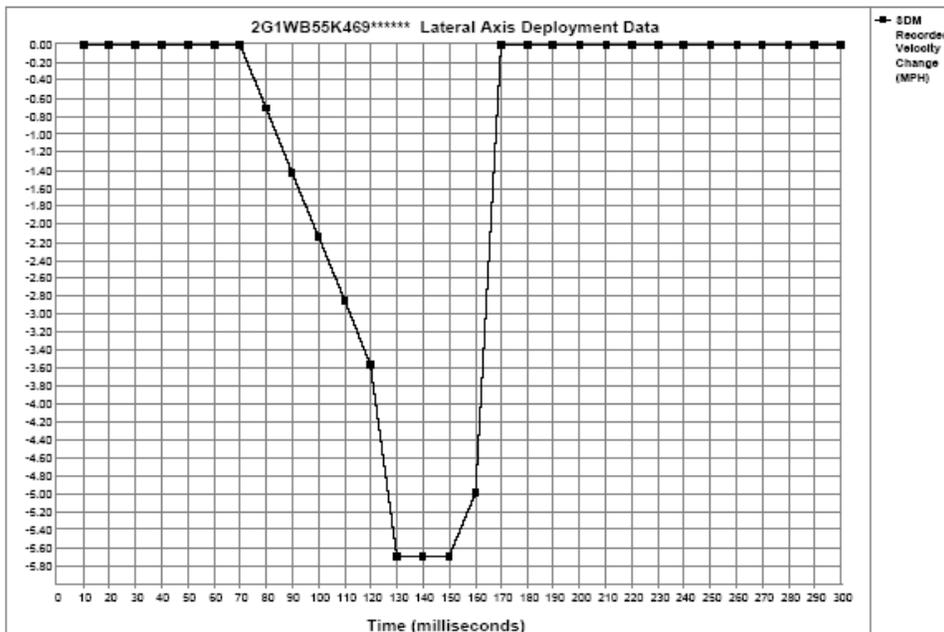
Time (milliseconds)	10	20	30	40	50	60	70	80	90	100	110	120	130	140	150
Lateral Axis Recorded Velocity Change (MPH)	0.00	0.00	0.00	0.00	0.00	0.00	0.00	-0.71	-1.43	-2.14	-2.85	-3.56	-5.70	-5.70	-5.70
Time (milliseconds)	160	170	180	190	200	210	220	230	240	250	260	270	280	290	300
Lateral Axis Recorded Velocity Change (MPH)	-4.99	0.00	0.00	0.00	0.00	0.00	0.00	0.00	0.00	0.00	0.00	0.00	0.00	0.00	0.00
