**CALSPAN ON-SITE CERTIFIED ADVANCED 208-COMPLIANT VEHICLE
CRASH INVESTIGATION**

SCI CASE NO.: CA06-013

VEHICLE: 2004 FORD F-150 SUPERCAB PICKUP TRUCK

CRASH DATE: MAY 2006

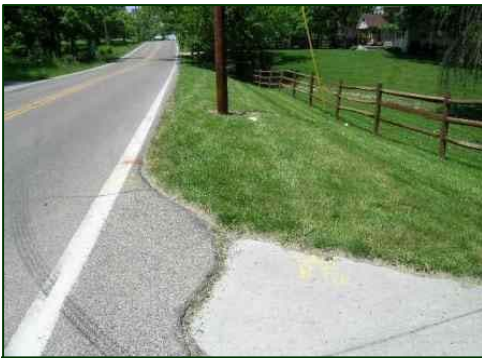
Figure 2. Trajectory of the F-150 and the location of the struck utility pole.

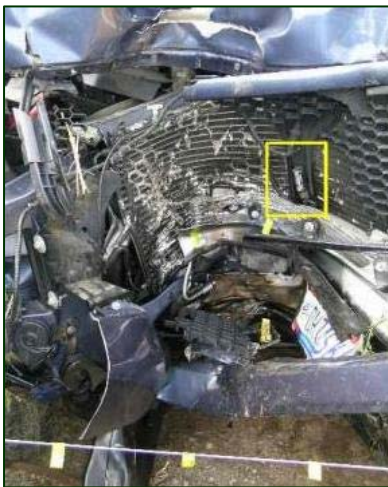
The air bag system utilized a passenger compartment mounted Restraints Control Module (RCM) that provided crash sensing, system diagnostics, and Event Data Recording (EDR). This EDR was not supported by the current Vetronix software version (Version 2.8) that is available to the SCI program. In addition to the RCM, the F-150 was equipped with an external electronic crash sensor that was mounted to the hood latch bracket (**Figure 11**), forward of the air conditioning condenser. This vertically mounted sensor was designed to assist in the electronic sensing of narrow object impacts that occur between the front frame rails. This sensor was rotated by the exterior deformation; however, it was not damaged by the tree impact.

Figure 11. Center front external crash sensor.

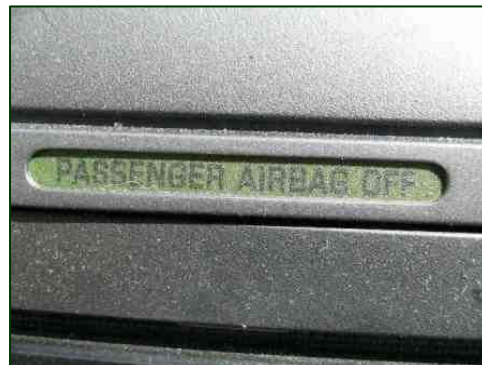
Figure 12. Passenger air bag on/off status lamp.

The front right air bag was incorporated into the right instrument panel and concealed by a vinyl cover flap. There was no occupant present in this position at the time of the crash; therefore the front right air bag would have been suppressed. The front right air bag activation lamp (**Figure 12**) was located in the upper mid instrument panel, above the CD player.
