Rollover Investigation / Vehicle to Objects  
Dynamic Science, Inc. / Case Number: DS06019  
2006 Mercedes-Benz CLK500  
Washington  
July 2006

1. Report No. DS06019		2. Government Accession No.		3. Recipient Catalog No.	
4. Title and Subtitle  Rollover Investigation		5. Report Date March 23, 2007		6. Performing Organization Report No.

This on-site investigation focused on the rollover of a 2006 Mercedes-Benz CLK500. This single vehicle crash occurred in July 2006 at 1528 hours in an urban area of Washington. The crash occurred on a four lane, two way, undivided city street.

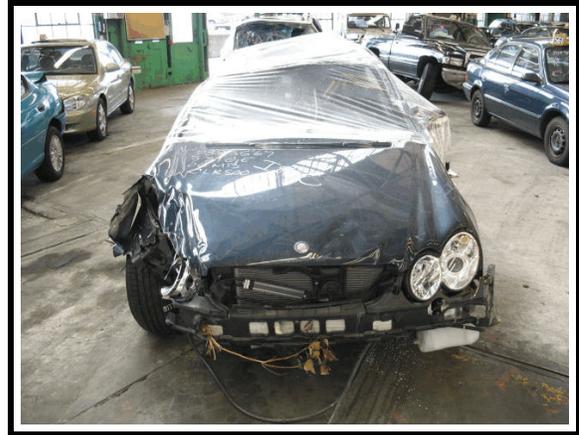
**Figure 1.** Front - 2006 Mercedes-Benz CLK500

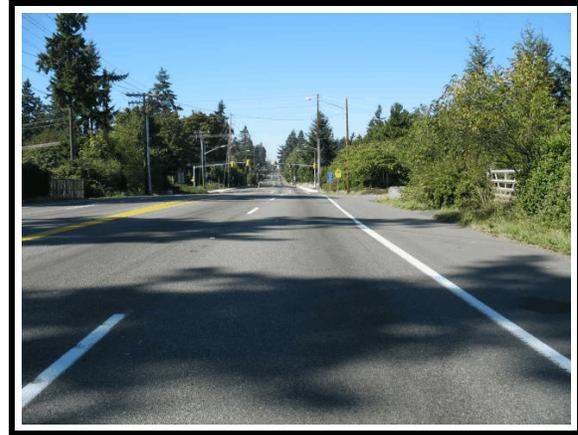
**Figure 3.** Overview of the case vehicle’s precrash area (west)

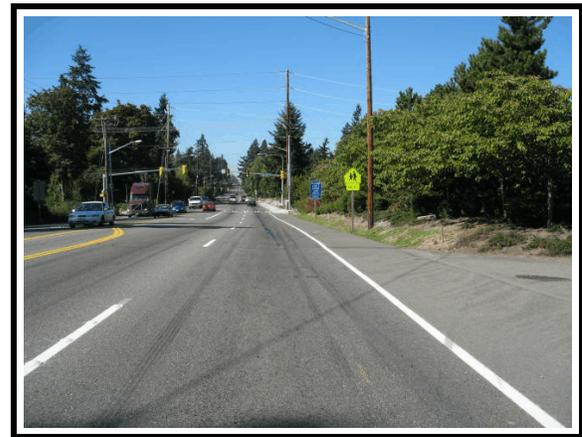
**Figure 4.** Approach of case vehicle to approximate roadway departure area (west)

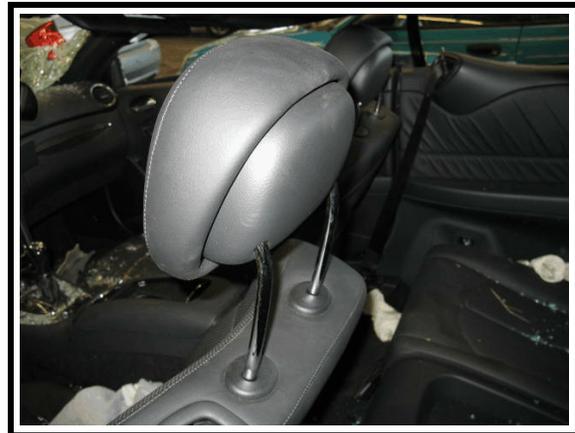
The front row seating in the 2006 Mercedes-Benz CLK500 was configured with dual leather covered bucket seats with folding backs. The seats were equipped with adjustable, active head restraints that were not damaged. During a rear-end collision, the active head restraints are designed to move forward in order to provide more head and neck support. The second row was configured as a leather covered split bench seat with folding backs. Both second row seating positions were equipped with adjustable, folding head restraints equipped with a tilt feature.

**Figure 9.** LF active head restraint

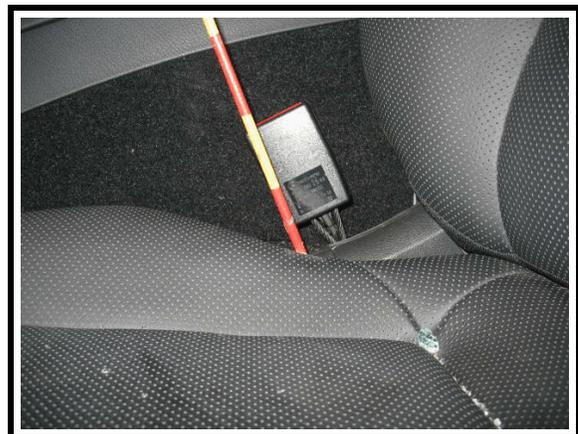
There were signs of occupant loading to the driver's seat belt. The shoulder belt showed signs of stress and the lap portion had friction burns to a small section of the belt material. All four of the Mercedes-Benz's seat belts were equipped with Emergency Tensioning Devices (ETDs) and seat belt force limiters. The front left and two second row seat belt ETDs activated during the crash. See the Manual Restraints section of this report for more information on these seat belt devices.

**Figure 21.** Driver's seat belt buckle

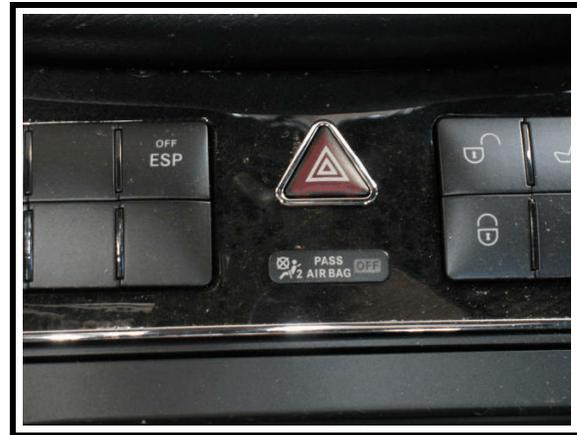
**Figure 23.** Passenger Air Bag Off indicator

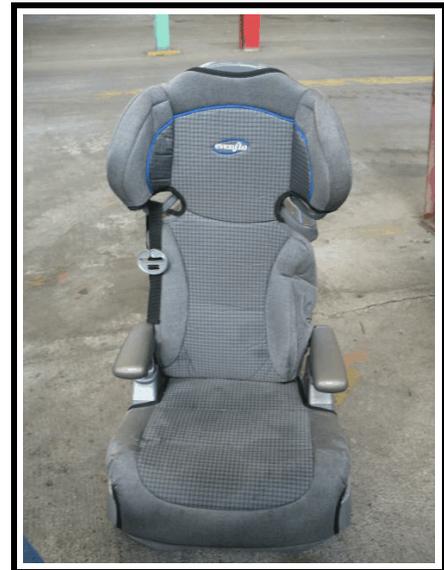
**Figure 28.** Child safety seat - found in vehicle/not secured/not in use

The Evenflo booster seat was found rearward facing in the second row center seating area and was not anchored to the vehicle. There is no seat or seat belt available in this location. The center drink holder, which folds into the second row seat back, was found pressing against the center of the child safety seat and left an indentation in the seat's padding. It was confirmed with the driver that this child safety seat was unoccupied and not in use at the time of the crash.

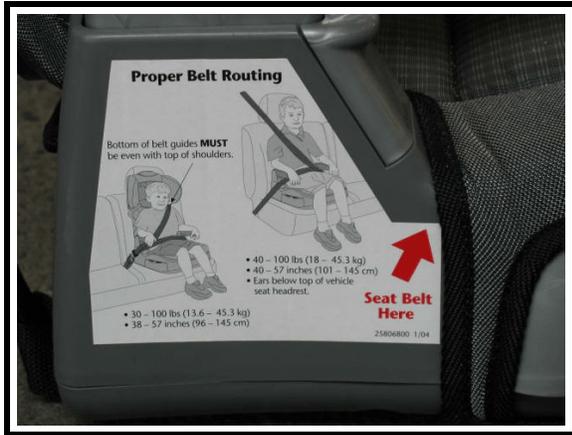
The Evenflo Big Kid Booster seat was manufactured on July 5, 2004 with a model number of 3371482. According to the label affixed to the side of this particular seat, it was designed to be used by children weighing between 13.6 - 45.3 kg (30.0 - 100.0 lb) and with a height up to 145.0 cm (57.0 in) tall.

**Figure 29.** Evenflo child safety seat label information

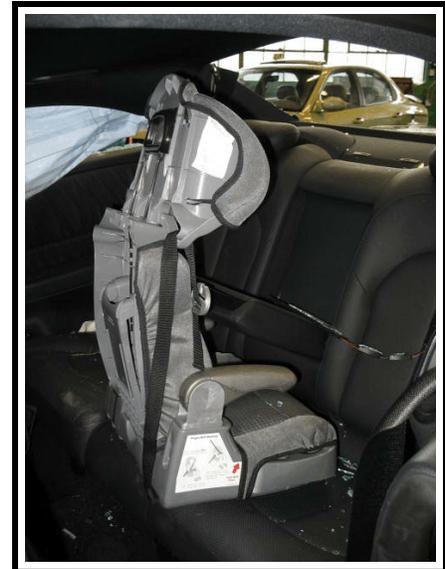
**Figure 30.** Evenflo Big Kid booster seat as found (not secured/not in use during crash)

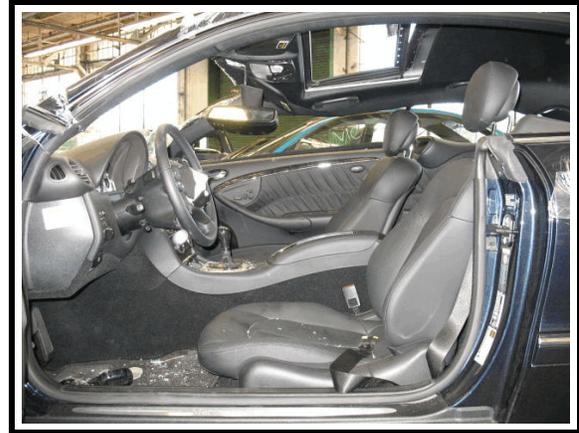
As the Mercedes-Benz departed the roadway, the front of the case vehicle struck a sign post. This was a low delta V event and the driver likely remained within his general seating area. The Mercedes continued forward and traveled into a shallow ditch. The front right of the Mercedes impacted a large wooden utility pole, resulting in the deployment of the driver's front air bag and the actuation of the driver's seat belt Emergency Tensioning Device (ETD). This crash event caused the male driver to initiate a forward trajectory towards the 12 o'clock direction of force, loading his seat belt and possibly contacting the deploying front air bag with his face, although no visible occupant contact evidence was found on the bag. The driver reported during the interview that his seat belt held him very tightly in place, resulting in bruising to his chest and abdomen. The impact sheared the pole from its base, and the case vehicle rotated clockwise while continuing to travel in a westerly direction. The uneven terrain, vehicle speed and rotation caused the Mercedes-Benz to rollover to the left. As the vehicle rolled three quarter turns, the driver possibly contacted the left front door panel with his left arm, although there was no visible occupant contact evidence found. The driver sustained a sprain to his left arm and reported during the interview that he was still experiencing soreness in that extremity. The right side impact curtain deployed when the right side of the vehicle contacted the ground during the rollover event. There was no visible evidence of occupant contact to the side curtain. The driver was held within his general seating area due to the activated seat belt ETD.

**Figure 31.** Driver's seating area
