CALSPAN ON-SITE CVPI REAR CRASH/FIRE INVESTIGATION

SCI CASE NO.: CA06-023

VEHICLE: 2005 FORD CROWN VICTORIA POLICE INTERCEPTOR

CRASH DATE: SEPTEMBER 2006

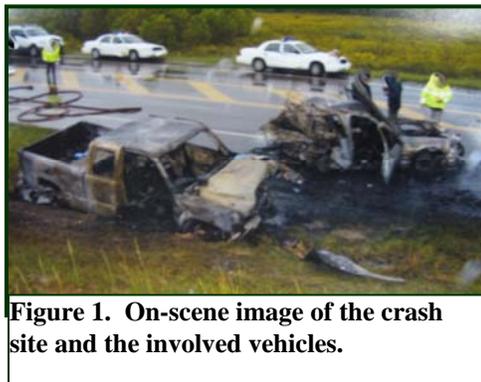
Figure 1. On-scene image of the crash site and the involved vehicles.

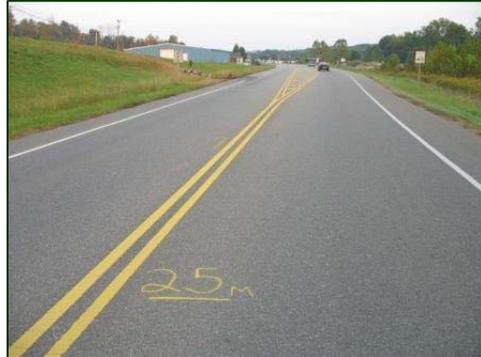
Figure 2. Trajectory of the CVPI at 25 m prior to impact.

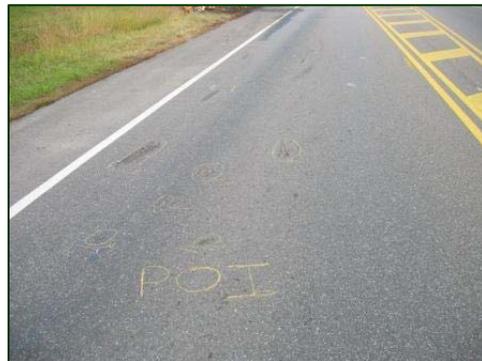
Figure 3. CVPI's trajectory at the point of impact.

The eastbound momentum of the Ford arrested the forward motion of the Chevrolet as the vehicles reached maximum engagement. The force of the impact reversed the travel direction of the Chevrolet and the vehicles separated and headed on their post-crash trajectories (**Figure 3**). The Chevrolet was displaced rearward 24.3 m (79.7') and came to rest off the north side of the shoulder facing west. The Ford CVPI came to rest straddling the white edge line 26.1 m (85.6') east of the point of impact facing

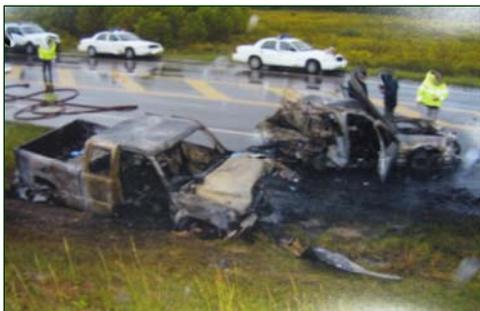
southwestward. **Figure 4** is an on-scene police image of the vehicles at final rest. The damage algorithm of the WINSMASH program calculated delta Vs of 69 km/h (42.9 mph) and 71 km/h (44.1 mph) for the Ford and Chevrolet respectively. The WINSMASH calculated delta Vs were consistent with the values calculated from the speed reconstruction.

Figure 4. On-scene image of the vehicles at final rest.

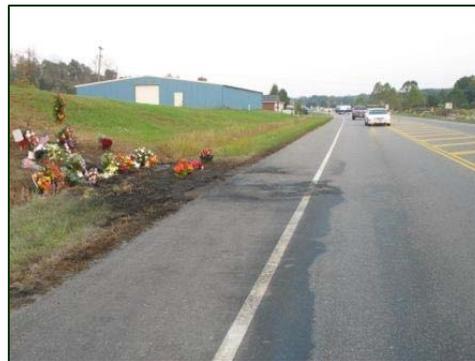
Figure 5. Final rest position with respect to the roadway.

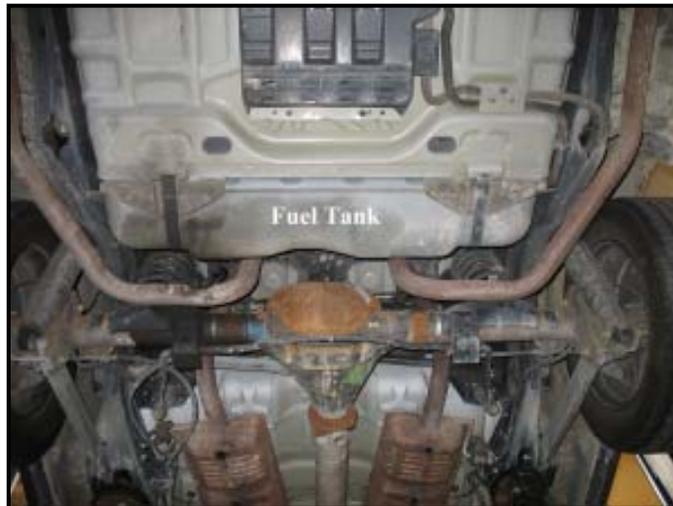
Figure 14 is an undercarriage view of an exemplar 2005 Ford Crown Victoria Police Interceptor depicting the layout of the rear undercarriage and fuel tank. **Figure 15** is a similar view of the undercarriage of the subject CVPI. The front of the vehicles is toward the bottom in both images. The fuel tank was located immediately forward of the trunk wall, approximately 25 cm (10") aft of the rear axle. The steel fuel tank was secured to the front wall of the trunk by two band straps attached to the upper and lower aspects of

Both the exemplar CVPI and the subject CVPI were equipped with the factory installed shield kits. The kit included two molded fiberglass reinforced plastic shields that covered the sway bar brackets on the respective sides of the vehicle, a molded rubber guard that covered the lower rear aspect of the differential cover and recessed the bolt heads and two rubber guards that protected the tank in the area of the lower tank straps. The purpose of the kit was to provide a layer of protection between the fuel tank and the rear axle/suspension components during a rear impact. Referring to the subject vehicle, the remnants of the burned fiberglass shields are visible and the rubber guards remained in place.

Figure 14: Exemplar CVPI undercarriage view.
